Cite this: *Environ. Sci.: Water Res. Technol.*, 2015, 1, 787

Decontaminating chemically contaminated residential premise plumbing systems by flushing†

K. S. Casteloes,^a R. H. Brazeau^b and A. J. Whelton^{*a}

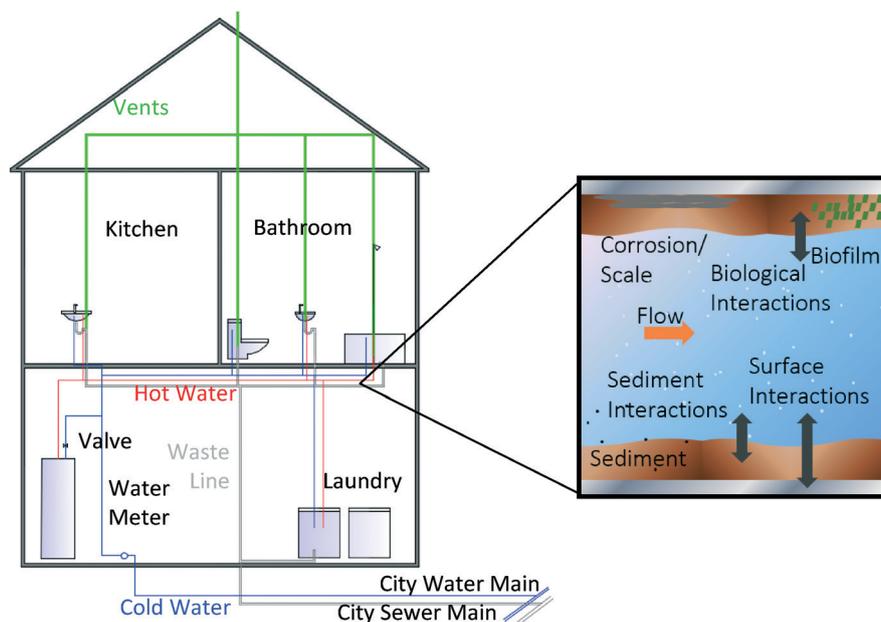
Fig. 1 Example premise plumbing layout for a residential home with a standard water heater that does not re-circulate.

biofilm, and contaminant properties. Fig. 1 shows a typical trunk and branch premise plumbing design for a two story residential home with traditional storage water heating. The average single family U.S. residence has about 280 feet (ft) [85.3 meters (m)] of plumbing pipe (140 ft, or 42.7 m, each for hot and cold water) and uses an average of 180 gallons per day (gpd) [681.3 liters per day (L per day)].¹⁰ Cold and hot water supply pipes generally range from 0.25 in [0.64 cm] to 0.75 in [1.9 cm] diameter in residences. Copper is the most common metal plumbing pipe used for cold and hot potable water supply, though a variety of plastic pipes are increasingly being installed (Table 1).¹¹

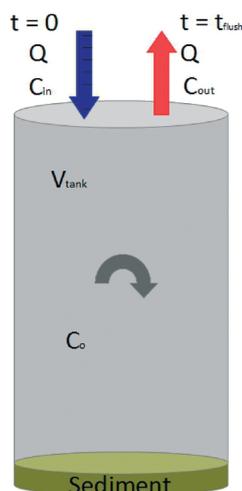
Fig. 2 Water heater control volume.

where C is the concentration leaving the system (equal to the concentration within the water heater), C_{in} is the concentration entering the water heater, C_0 is the initial concentration within the water heater, Q is the flow rate, V is the tank volume, M is mass, and t is time. A diagram of the water heater model is displayed in Fig. 2.

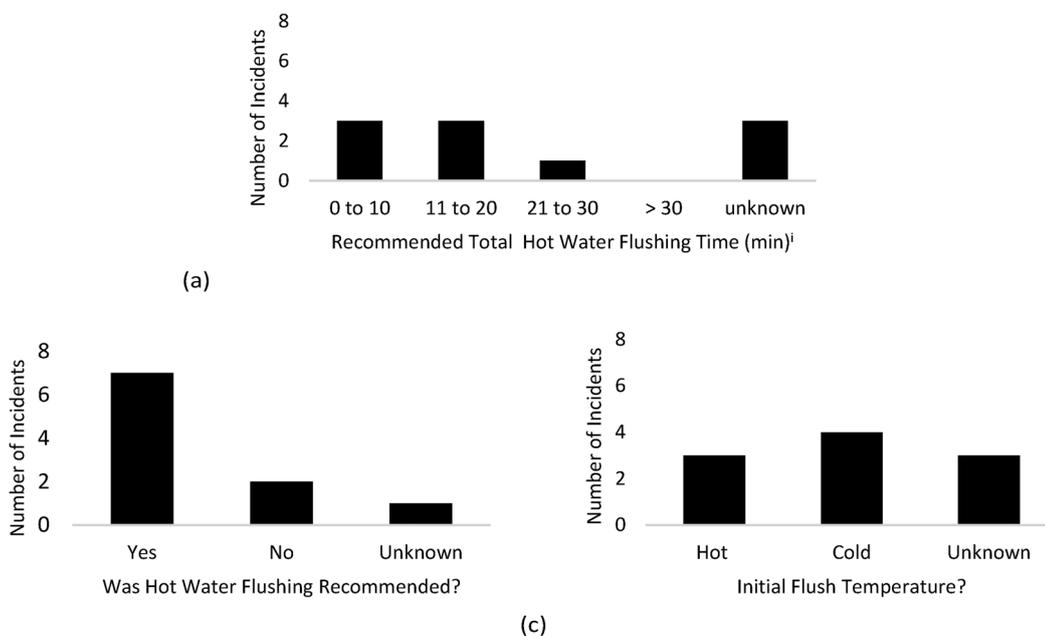
Fig. 3 Comparison of premise plumbing system flushing guidance for ten incidents. (a) Recommended hot water total flushing time, (b) number of incidents where residents were explicitly directed to flush hot water, (c) recommended water temperature for the initial flush. Incidents represent those events presented in Table 4. ⁱWest Virginia septic tank flushing procedure not included.

odor should be used as an end point, and if indoor ventilation precautions were issued and the specificity of those precautions (Fig. 3 and Table 4). Additionally, several premise plumbing flushing protocols did not seem to include the time needed to remove contaminated water from residential

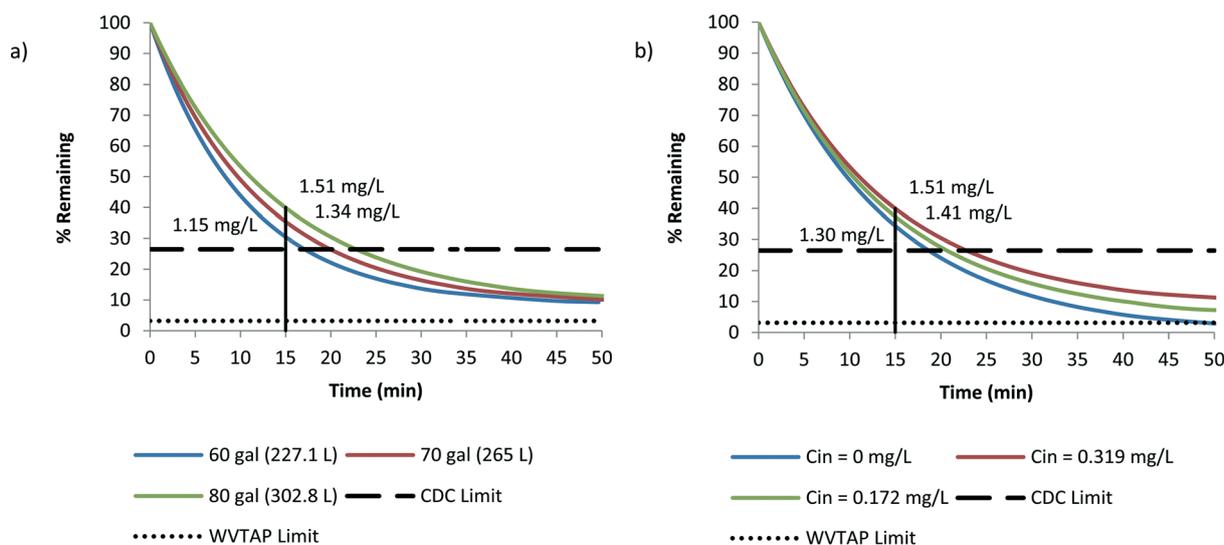
Fig. 4 West Virginia example: new two story single family home with water saving fixtures, initial 4-MCHM concentration of 3.773 mg L^{-1} . (a) with tank volume 60–80 gallons [227.1–302.8 liters] and influent concentration 0.319 mg L^{-1} , (b) with tank volume of 80 gallons [302.8 liters] and variation of influent concentration 0 – 0.319 mg L^{-1} . CDC and WVTAP health based screening levels were 1 mg L^{-1} and 0.120 mg L^{-1} .

The water utility and State of West Virginia flushing guidelines were examined for the West Virginia incident. Because the total flushing durations of each protocol were the same, the impact of flushing on water heaters by both protocols can be discussed singularly. The model revealed several water heater flushing scenarios where the 4-MCHM concentration was not reduced below the CDC's health limit (Tables SI-2–SI-5†). Of the 120 scenarios modeled for the manufactured home, 14 did not reduce 4-MCHM concentrations below the CDC limit. For the two story single family home, 24 scenarios of 200 examined did not result in a 4-MCHM concentration below the CDC limit. The water heater influent

concentration, storage tank volume, and flow rate were responsible for these exceedances (Fig. 4).

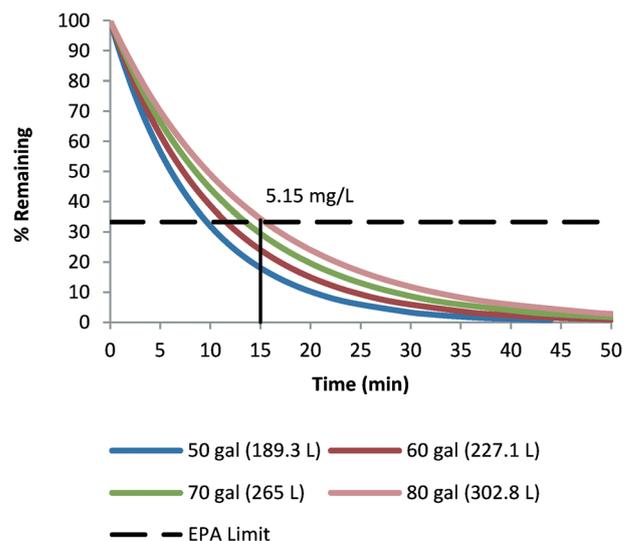
Fig. 5 Montana example: new two story single family home with water saving fixtures, initial benzene concentration of 15 µg L⁻¹, and EPA MCL of 5 µg L⁻¹.

In contrast to model results from the West Virginia incident, only 2 scenarios of 32 examined for the Montana crude oil contaminated water incident resulted in benzene exceeding the drinking water health limit (Fig. 5). These Montana scenarios (one for the two story single family home and one for the manufactured home) involved buildings with water saving fixtures and the largest size water heater. A limitation of the Montana modeling effort was that no post-flushing premise drinking water quality test results were found to validate the model.
