Case study: the crude MCHM chemical spill investigation and recovery in West Virginia USA

A. J. Whelton,^{*a} L. McMillan,^b C. L.-R. Novy,^b K. D. White^c and X. Huang^a

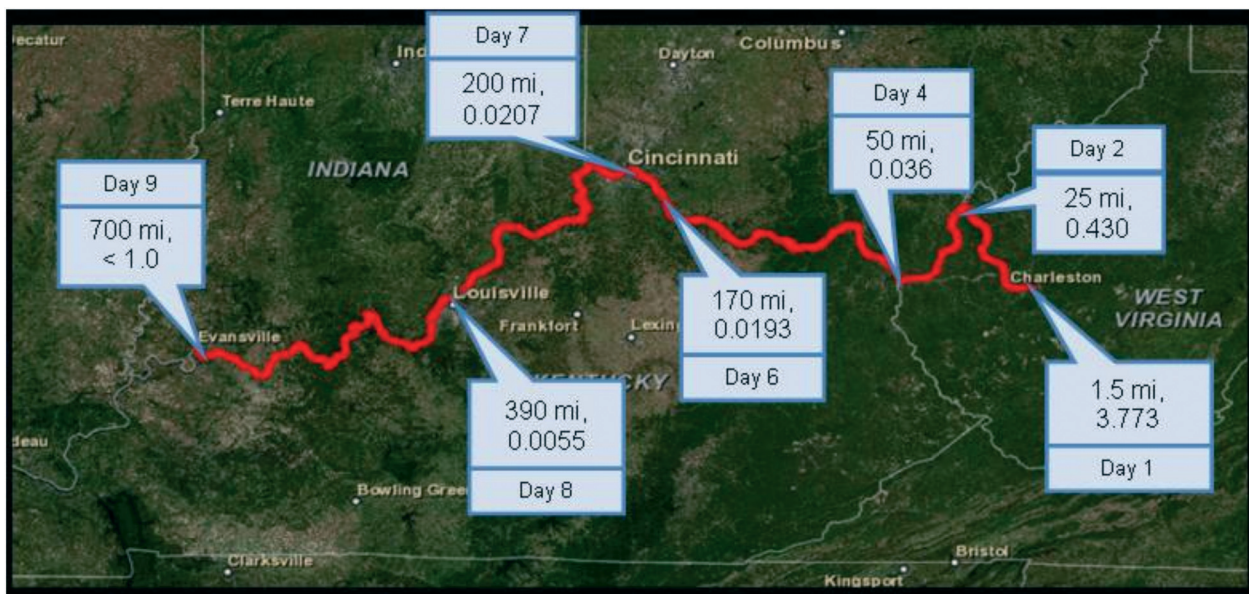
Fig. 1 Maximum known 4-MCHM concentration (ppm) in river water reported as distance downstream from the spill site starting January 9, 2015 as water flowed down the Elk River, into the Kanawha River, and Ohio River.

At the water intake. The day after the spill was discovered, RESP began analysing 4-MCHM concentrations in Elk River water at the KVVWTP. 4-MCHM concentrations in river water decreased during the next several days (Fig. 1). On January 10, ATTY also conducted grab sampling near the KVVWTP intake and found 0.57 ppm 4-MCHM,³⁴ a concentration much lower than the 3.3 ppm detected at the KVVWTP that same day. This difference is likely due to the ATTY collecting grab samples at the surface of the Elk River whereas RESP water originated from lower in the water column where the intake structure was installed. This difference highlights the importance of consistent water sampling and how methodology can impact the data reported.

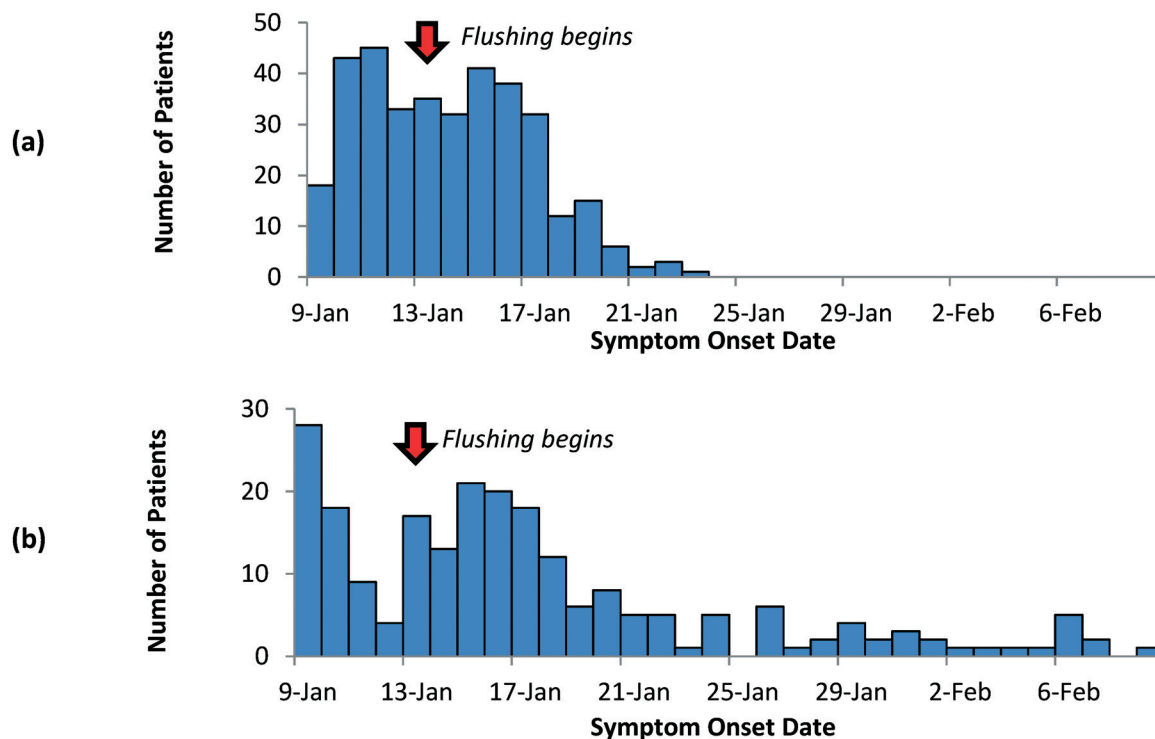
Fig. 4 (a) Visits to emergency departments reported by the U.S. Centers for Disease Control and West Virginia Bureau of Public Health (b) syndromic surveillance cases of clinically defined chemical exposure from January 9 through February 9, 2014. Records represent 10 emergency medical departments with 356 patients and 10 physician offices with 224 patients, respectively (source: open-access¹⁹).

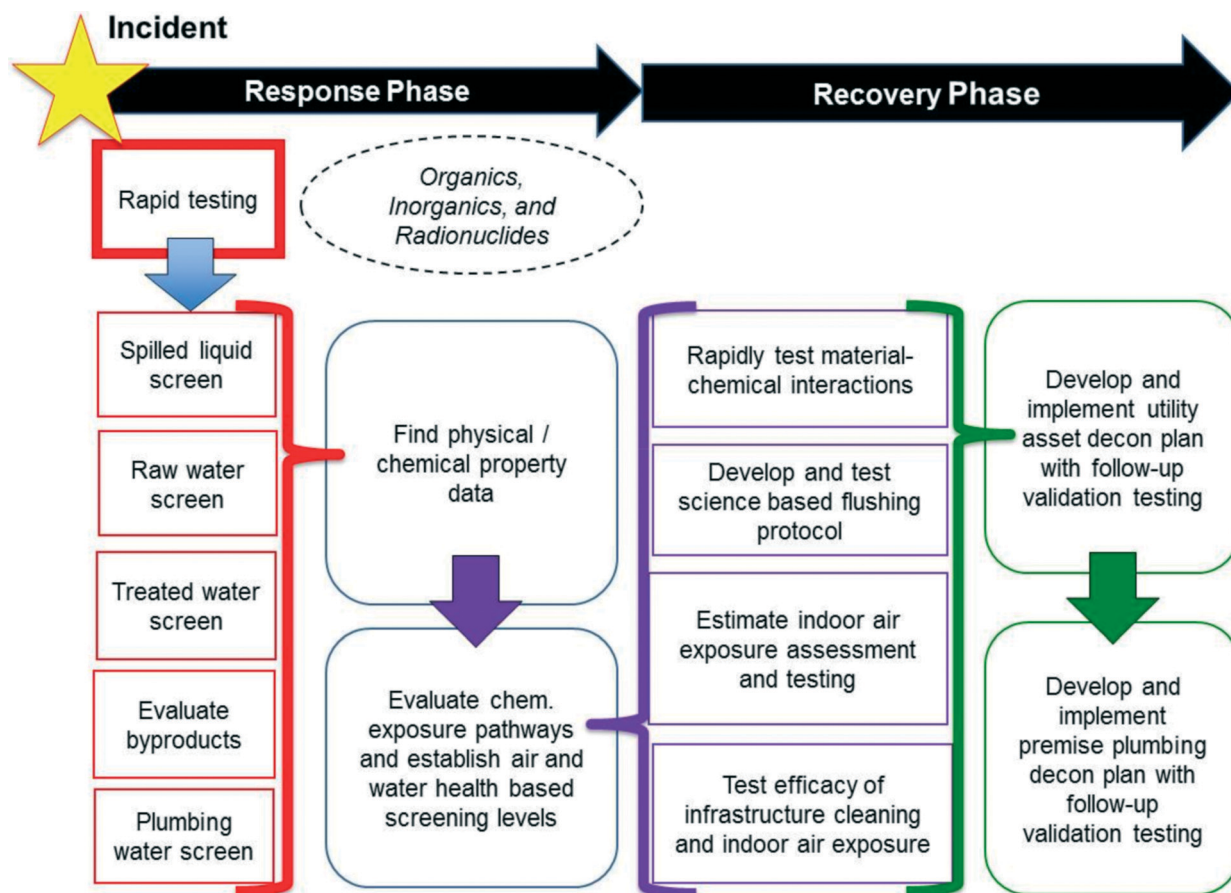
Fig. 5 Stepwise approach for investigating large-scale drinking water chemical contamination incidents.
