Cite this: *Environ. Sci.: Water Res. Technol.*, 2017, 3, 312

## Case study: the crude MCHM chemical spill investigation and recovery in West Virginia USA

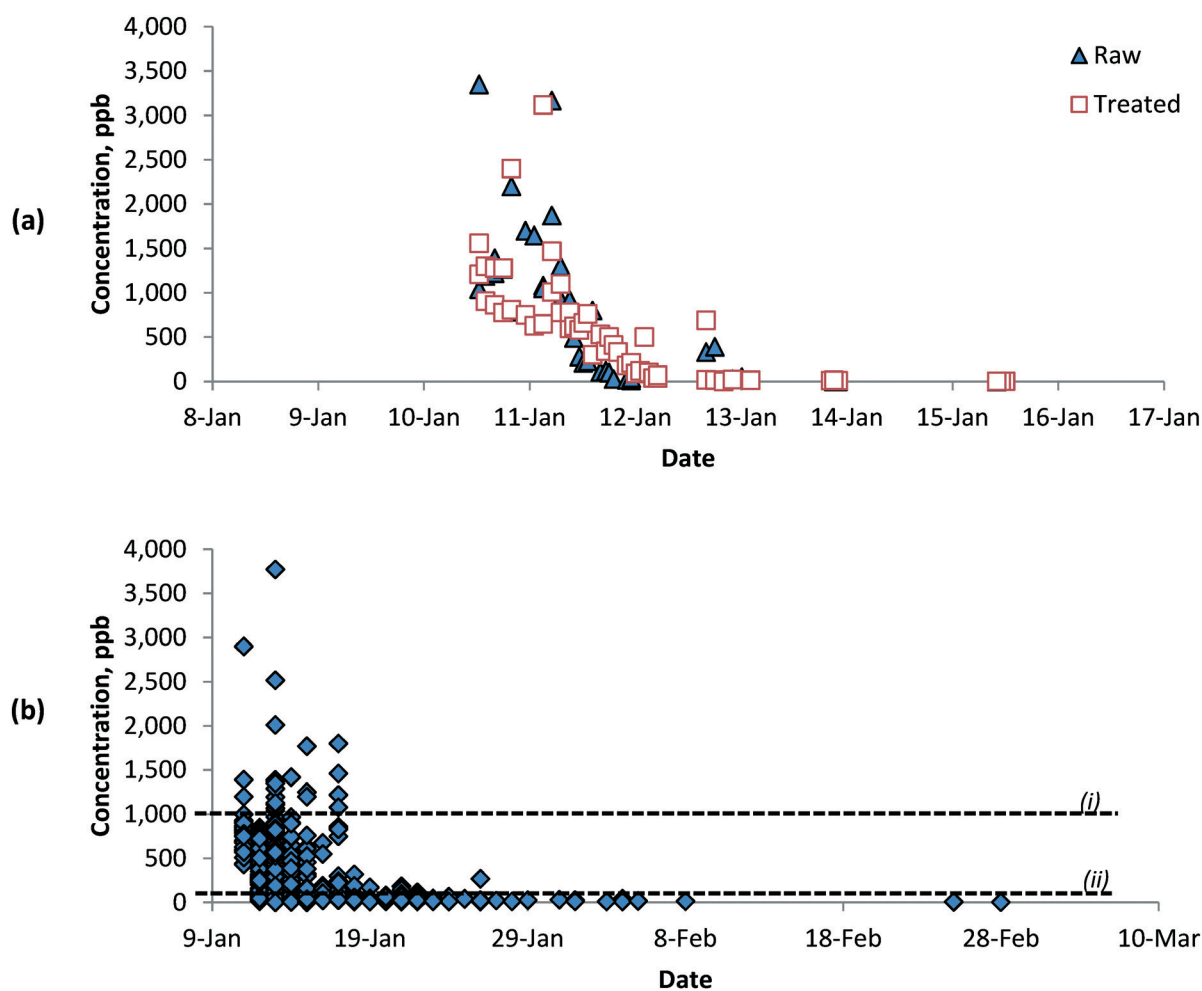
Fig. 2 4-MCHM concentration at the (a) Kanawha Valley water treatment plant and (b) water distribution system. The dotted lines represent the (i) CDC's 1 ppm health-based 4-MCHM screening level, and (ii) WVTAP's health-based 4-MCHM 0.120 ppm screening level. Reproduced from Whelton *et al.*<sup>19</sup>

**Water treatment plant.** The day after the spill, RESP began monitoring finished drinking water exiting the Charleston KVVWTP for 4-MCHM (Fig. 2), and the highest 4-MCHM concentration detected in the finished water leaving the treatment plant was 3.35 ppm. After Freedom Industries, Inc. disclosed that stripped PPH was present in the tank liquid, archived water samples were re-analysed and 10 ppb PPH and 11 ppb DiPPH were detected. No additional testing for these compounds was conducted and the reasoning for this decision was not found.

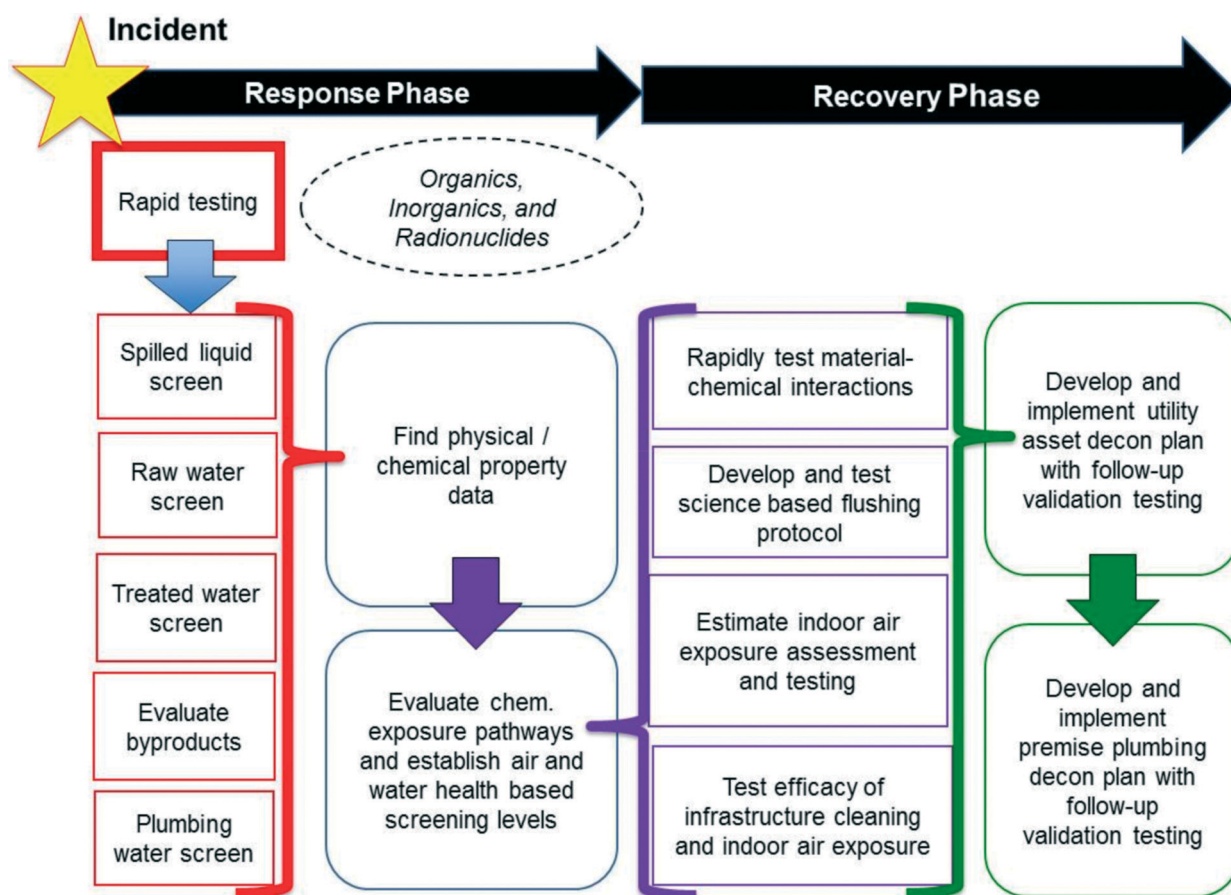
Fig. 5 Stepwise approach for investigating large-scale drinking water chemical contamination incidents.
