Cite this: *J. Mater. Chem. A*, 2020, **8**, 17399Received 17th July 2020
Accepted 11th August 2020

DOI: 10.1039/d0ta06985j

Characterization of mechanical degradation in an all-solid-state battery cathode†

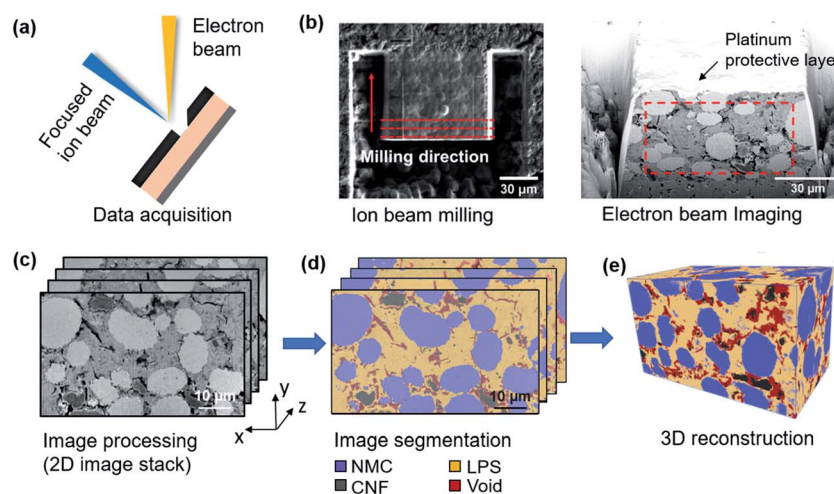
Fig. 2 Workflow for FIB-SEM tomography. (a) Schematic illustration of data acquisition set-up in FIB-SEM. (b) Ion-beam milling and BSE electron beam imaging were performed iteratively during serial sectioning. (c) 2D image stack obtained after image processing. (d) Corresponding four-phase segmentation results and (e) reconstructed 3D volume of the cathode composite (the final 3D volumes were slightly different for the three samples but were all $\sim 60 \times 40 \times 30 \mu\text{m}^3$).

To directly observe and verify the possible contact loss between the cathode and solid electrolyte, FIB-SEM tomography was used to characterize the microstructural evolution in the composite cathode during cycling. Three SSB cells (before cycling, after 10 cycles, and after 50 cycles) were extracted in the discharged state and evaluated using FIB-SEM tomography. The workflow for the FIB-SEM tomography experiment is presented in Fig. 2. The SSB full cell was tilted at a 52° angle with the cathode composite perpendicular to the ion beam. The ion beam was first used to mill trenches surrounding the area of interest, exposing the cross-section to the top-mounted electron beam at a 52° angle. A backscattered electron (BSE) image was acquired to provide 2D morphology information on the cathode composite. Then, a thin slice (50 nm) was milled away from the cross-section with the ion beam, and another BSE image was taken. After repeating this process several hundred times, the image stack was aligned, cropped, and combined into a 2D image stack (Fig. 2(c)) (see ESI Fig. S2 and S3† for the detailed image process procedures). The 2D image stack and corresponding four-phase segmentation image are presented in Fig. 2(c) and (d), respectively, whereby the NMC cathode (blue), LPS solid electrolyte (yellow), carbon (black), and void (red) can be accurately distinguished. The segmented image stacks were then reconstructed into a 3D volume. The reconstructed structures of the composite cathodes before and after electrochemical cycling are presented in Fig. 3.
