# Environmental and private property contamination following the Norfolk Southern chemical spill and chemical fires in Ohio†

In February 2023, a train derailment in Ohio caused a chemical spill and fires releasing contaminants into the air, soil, waterways, and buildings. The authors conducted a rapid response which included six field investigations and bench-scale experiments to understand the chemical identity, fate, and exposure pathways after the evacuation order was lifted. Multiple buildings were chemically contaminated and silicone wristband products inside a commercial building were found to have adsorbed derailment-related chemicals. The indoor air of this commercial building was found to be contaminated for 4.5 months after the derailment. Derailment chemicals were also found on building exteriors 5 weeks after the incident. Railcar chemicals were detected in the nearby creeks. Cleanup activities (sorbent pads, aerators) as well as creek hydraulic and environmental conditions influenced chemical fate in creeks. Creek mechanical aeration activities prompted VOC emission that contributed to human exposures and vapor intrusion. Atmospheric modeling revealed that the chemica

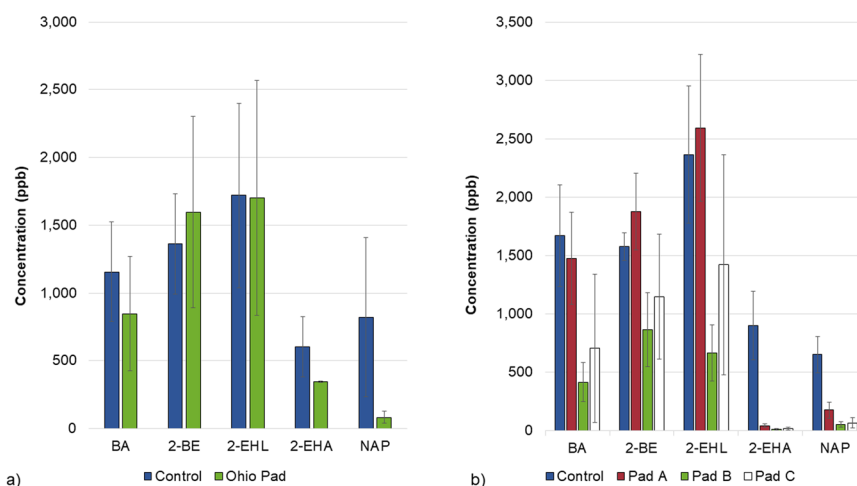
**Fig. 4** Bench-scale experiments revealed that (a) sorbent pads used in Sulphur Run (b) and sorbent pads purchased from suppliers did not remove detectable amounts of the polar BA, 2-BE, or 2-EHL compounds from water, but the more nonpolar compounds (2-EHA and NAP) were significantly removed. Concentrations selected were lower than the maximum reported levels by RESP in the creeks (BA: 180 000 ppb; 2-BE: 848 000 ppb; 2-EHA: 122 000 ppb; 2-EHL: 580 ppb and NAP: 2.8 ppb). Mean and standard deviation values are shown for three replicates.

**3.3.3 Chemical removal by creek sorbent pads.** Bench-scale tests revealed that sorbent pads in Sulphur Run removed the more nonpolar chemicals (*i.e.*, 2-EHA, NAP) from a dilute aqueous solution but removed little to none of the more polar chemicals (*i.e.*, BA, 2-BE, or 2-EHL) (Fig. 4). ATR FTIR analysis

indicated that the new sorbent pads and those that were collected in the field were composed of polypropylene. The chemical sorption ability of a pad used in Sulphur Run cleanup and three distinct brands of new pads (pads A, B, and C) revealed varying removal effectiveness. Pad A performed similarly to the pads used in Sulphur Run, while pads B and C removed greater amounts of the chemicals examined. Chemicals not removed from the creeks by sorbent pads likely remained in the water, sorbed to sediment, or volatilized into the air. These findings highlight the complex challenges associated with the use of sorbent pads for environmental remediation in waterways like Sulphur Run. Future strategies should consider optimizing sorbent material selection and deployment methods to improve removal efficiencies across a broader range of contaminants, particularly those with polar characteristics that pose ongoing environmental and human health concerns.
