## CRITICAL REVIEW

## Ongoing legacy contamination from a military radar station in Iceland: a case study

This paper is a summary of environmental impacts from a former US military DEW line radar station in Iceland which operated from the mid-1950s to the 1970s. This station was one of four DEW line station stations that operated in Iceland during the Cold War era. During the time of operation and when dismantled, nearly all waste from the station was dumped in unlined pits on the mountain. Very limited cleaning of the site has been performed and the site is contaminated with PCBs, PHCs, PAHs and some inorganic elements.

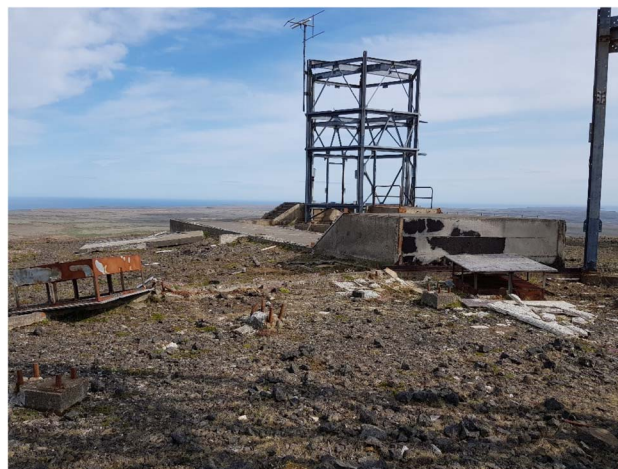
Fig. 4 The H-2 Station Radome area at Heiðarfjall, 26. 7. 2021 (M. J. Gunnarsdottir).

The sites chosen for sampling by the ESG, see Fig. 3, were: (1) the Dump area (*ca.*  $18.000 \text{ m}^2$ ) where debris, both during operating and later during clean-up, had been buried; (2) the Tropo area, with a communication building (still standing), and where two tropospheric communication dishes once stood; (3) the Sewage Outfall area; (4) the POL (petroleum oil and lubricant) Tank area, where a large fuel storage tank used to be situated. Sites 3 and 4 were on the southern edge of the summit area, directly above the Eiði farm; (5) the Garage area; (6) the Barracks area; (7) the Powerhouse area, and (8) Radome area (sites 5, 6, 7, and 8 are all situated at the Station area); (9) the lower-lying Catchment area, where a concrete drainage pipe was observed leading to a small pond; and (10) the Eiði stream area. Fig. 4 shows a recent picture of the Station area.
