Cite this: *Environ. Sci.: Water Res. Technol.*, 2021, 7, 274

DOI: 10.1039/d0ew00836b

## Drinking water contamination from the thermal degradation of plastics: implications for wildfire and structure fire response†

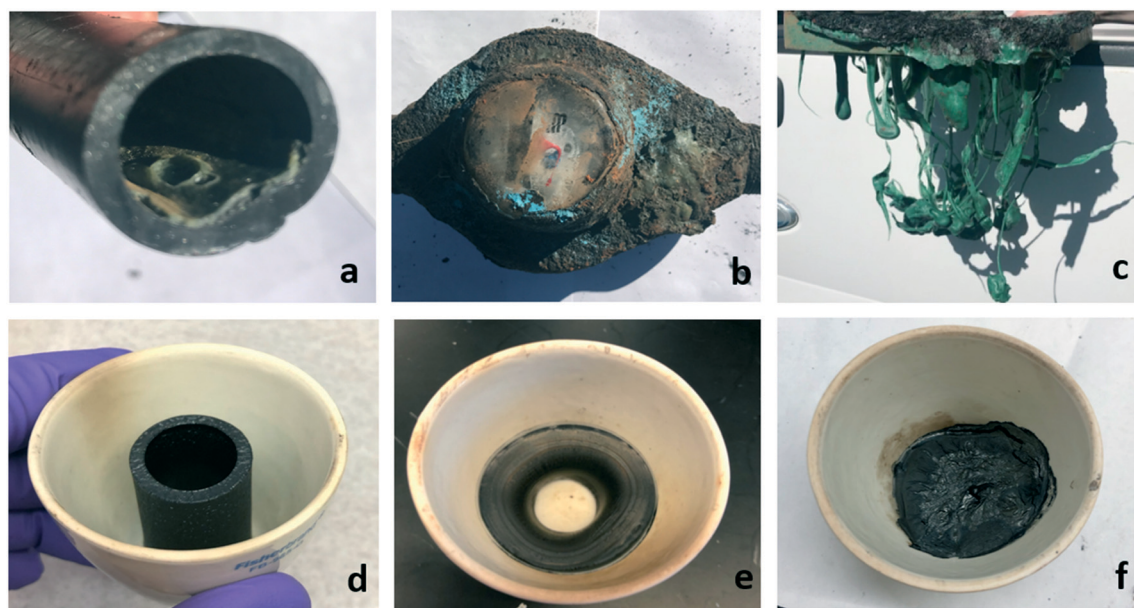
**Fig. 1** Images of fire-damaged water system components including (a) a HDPE plastic pipe, (b) a water meter, and (c) a water meter cover following the Camp Fire. Thermally degraded pipe samples in laboratory experiments include the (d) PEX-c pipe degraded at 300 °C, (e) HDPE pipe degraded at 300 °C, and (f) HDPE pipe degraded at 400 °C.
