# Combined crystallographic study of king scallop (*Pecten maximus*) shells using SEM, EBSD and Raman spectroscopy

Lise Guichaoua,<sup>a</sup> Natalie Reznikov,<sup>b</sup> Bryce D. Stewart,<sup>c</sup> Roland Kröger<sup>e</sup> and Raynald Gauvin<sup>a</sup>

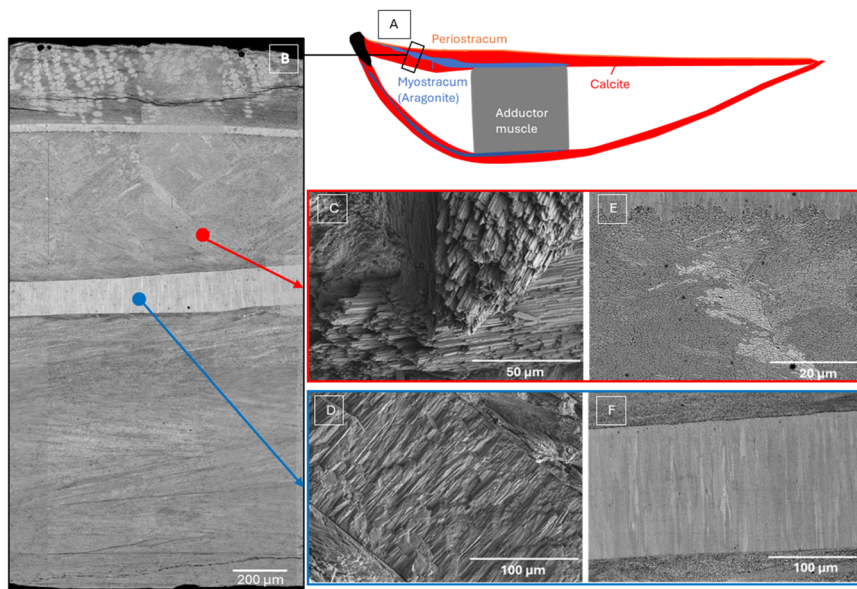
**Fig. 1** (A) Schematic longitudinal section of a king scallop (*Pecten maximus*) shell, both valves. Of the organic parts only the adductor muscle is indicated showing its attachment to the shell via an aragonitic calcium carbonate layer. (B) Backscattered electrons stitched SEM images of a king scallop sample from a non-contaminated area after surface polishing. SEM images of king scallop in calcite (red) area: (C) secondary electron image of calcite foliated grains on laser cut surface and (E) backscattered electron image of calcite foliated grain after surface polishing. SEM images of king scallop myostracum aragonite prismatic layer (blue) area: (D) secondary electron image of myostracum layer on laser cut surface and (F) backscattered electron image of myostracum layer after surface polishing.

The soft tissues are attached to the shells *via* the myostracum layer (also known as the adductor muscle scar, see Fig. 1(A)), which bears tremendous contractile force and is crucial for the survival of molluscs.<sup>4</sup> Previous studies have shown that this myostracum layer is generally composed of prismatic aragonite.<sup>5</sup> However, to date, there are very few studies on the myostracum of king scallops *Pecten maximus* and its structural role for the bivalve including its impact on the fracture toughness.

Fig. 1 illustrates the scanning electron microscope (SEM) images of the cross-sectional surface of a king scallop sample from a non-contaminated area, as previously reported.<sup>11,12</sup> Fig. 1(B) displays a secondary electron SEM image of sample's section after polishing, revealing the general distribution of calcite and myostracum aragonite layers in king scallop shell from a non-contaminated site. Fig. 1(C) and (E) highlight the well-oriented, foliated calcite with sharp, thin laths with asymmetrical triangular endings, arranged in parallel clusters, while Fig. 1(D) shows the myostracum aragonite layer after Er:YAG dental laser cut with clearly oriented prismatic grains. Fig. 1(F) presents the same section after polishing, where the myostracum exhibits clearly elongated grains, with visible backscattered electron (BSE) channeling contrast indicative of the high crystallinity of the aragonite phase.

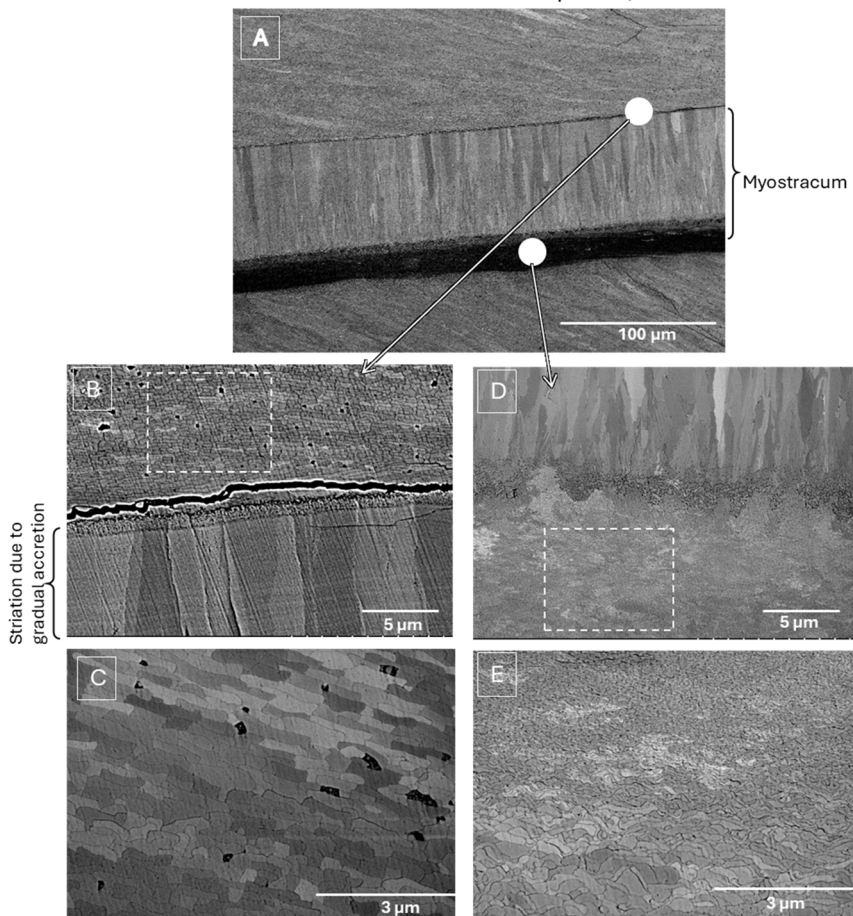
Non-contaminated site scallop shell, *Bradda*

Fig. 4 BSE micrographs of the myostracum region for the scallop shell collected in the non-contaminated Bradda area. (A) A general view of the region of interest. (B) The upper boundaries between the myostracum and the shell bulk. (C) The microstructures of the scallop in the region at the top of the myostracum. (D) The lower boundaries between the myostracum and the shell bulk. (E) The microstructures of the shell in the region below the myostracum.

Fig. 4(A) and 5(A) display an overall microstructural organization for the longitudinal section around the myostracum region of scallop shells respectively from non-contaminated and contaminated sites. These backscattered electron images show channeling contrast and provide an overview of crystal orientation variations, particularly within the myostracum, which is, in both types of scallops, clearly visible and sandwiched between two foliated calcite areas. This allows us

First, it is observed that the overall organization was similar for both types of scallops. Focusing on the myostracum, it consists of elongated, oriented grains. However, the grains in the lower part of both myostracum layers are notably fine and small. These grains gradually increase in both length and width towards the upper part of the myostracum, while maintaining a consistent growth orientation, resulting in a clear size gradient. Despite this similarity between the two types of shells, a noticeable difference in morphology and distribution is observed. The grains in the myostracum within the shell from the non-contaminated site appear more elongated and regularly arranged.

Examining the calcitic regions surrounding the myostracum reveals notable differences in microstructure. Fig. 4(B), (C), 5(B) and (C) provide a closer view of the region above the myostracum. In both shell types, the shape and grain distribution are uniform and consistent in size (around 1 micron in size). The boundary between the aragonite myostracum and the calcitic bulk is clearly defined, with homogeneous grains in the upper calcitic region, contrasting with the larger, elongated grains of the upper myostracum. The contrast variations between the grains are due to slight differences in their relative orientations, due to the BSE channeling contrast.

The boundary between the two microstructures in the lower myostracum appears less distinct as can be observed in Fig. 4(D) and 5(D). Again, there is little

Near the myostracum, the calcite grains are nanocrystalline (see Fig. 4(E) and 5(E)) and a size gradient is observed as the distance from the myostracum increases. In the shell from contaminated site, this gradient extends over a larger

Furthermore, growth lines can be identified in the Raman maps associated with the accretion sequence during the myostracum formation. These growth lines are also visible in the SEM image of samples from both contaminated and non-contaminated sites and are shown in Fig. 4(B) and 5(B).

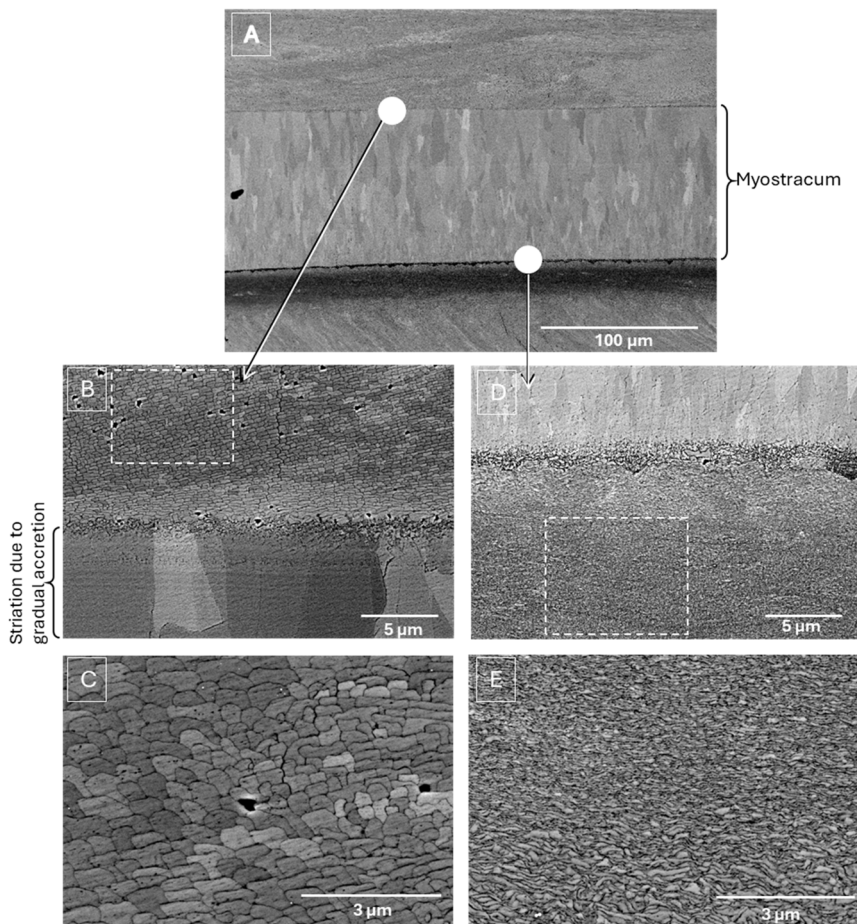
Contaminated site scallop shell, *Laxey*

Fig. 5 BSE micrographs of the myostracum region for the scallop shell collected in the contaminated Laxey area. (A) A general view of the region of interest. (B) The upper boundaries between the myostracum and the shell bulk. (C) The microstructures of the scallop in the region at the top of the myostracum. (D) The lower boundaries between the myostracum and the shell bulk. (E) The microstructures of the shell in the region below the myostracum.
