Ongoing legacy contamination from a military radar station in Iceland: a case study

Cite this: *Environ. Sci.: Adv.*, 2024, 3, 972

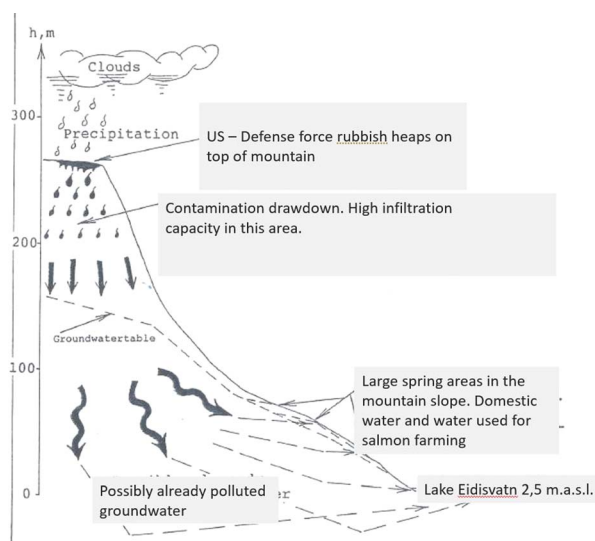
Fig. 2 Transport model of pollution spread at Heiðarfjall.⁴²

The engineering consultant's conclusion was that groundwater pollution would mostly spread southwards towards the farm, the estuary lake Eiðisvatn and the sea as shown in Fig. 2. Calculations of the pollution infiltration flow from the top of the mountain indicate that it would take at least 30 years to reach the springs on the south side of the mountain flowing to Eiði

and it would take at least another 70 years until it had disappeared, but some dilution could be expected.⁴²

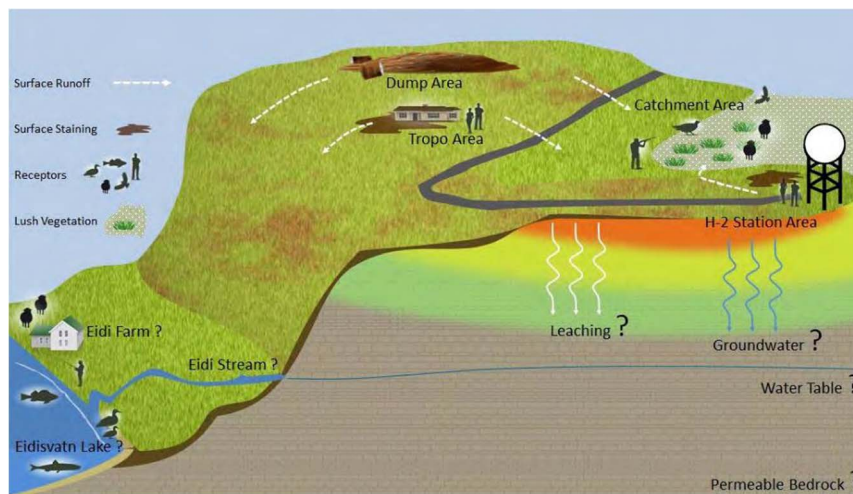
Fig. 3 Schematic picture of Heiðarfjall and the sites investigated by the ESG in 2017.¹⁰ Water source for Eidi farm is at the Eidi stream.

The sites chosen for sampling by the ESG, see Fig. 3, were: (1) the Dump area (*ca.* 18.000 m^2) where debris, both during operating and later during clean-up, had been buried; (2) the Tropo area, with a communication building (still standing), and where two tropospheric communication dishes once stood; (3) the Sewage Outfall area; (4) the POL (petroleum oil and lubricant) Tank area, where a large fuel storage tank used to be situated. Sites 3 and 4 were on the southern edge of the summit area, directly above the Eiði farm; (5) the Garage area; (6) the Barracks area; (7) the Powerhouse area, and (8) Radome area (sites 5, 6, 7, and 8 are all situated at the Station area); (9) the lower-lying Catchment area, where a concrete drainage pipe was observed leading to a small pond; and (10) the Eiði stream area. Fig. 4 shows a recent picture of the Station area.

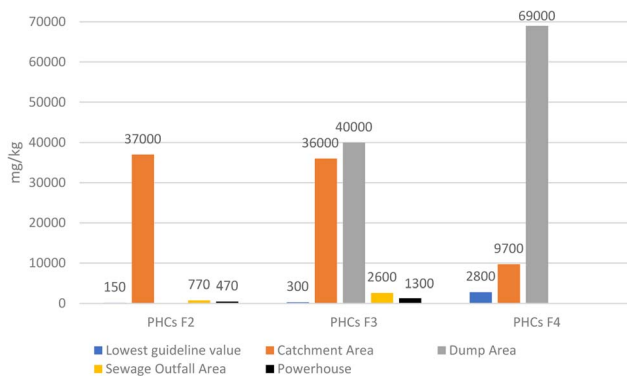
Fig. 6 PHCs (mg kg⁻¹) detected above the lowest guideline value for F2, F3 and F4 (150, 300, and 2800, respectively) at four areas. The highest value in each area of the four is shown in the figure.

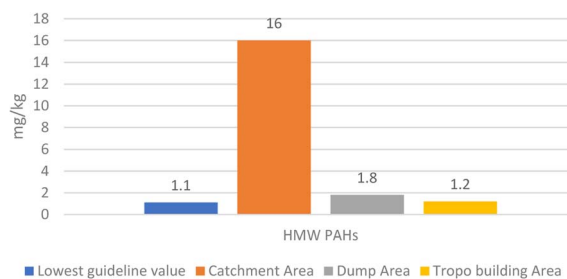
Fig. 7 HMW PAHs (mg kg⁻¹) tested in five areas with the content exceeding the lowest guideline value (1.1 mg kg⁻¹) in three areas. The highest values detected in the three areas are shown.

PAHs are released during incomplete combustion of petroleum products or from petroleum spill. They are persistent in the environment and several have multiple adverse health effects.²⁷ PAHs were summarized in two categories, low molecular weight PAHs (LMW PAHs) and high molecular weight PAHs (HMW PAHs), with the latter being more toxic and carcinogenic.⁵¹ Fifteen PAHs were tested (5 LMW and 10 HMW) in nine samples from five areas (Dump, Tropo, Sewage outfall, Powerhouse and Catchment), see Table 1, and found to exceed the lowest guideline value at three areas: Catchment, Dump and Tropo areas. The highest values in both categories (LMW and HMW) were found at the Catchment area (Table 2). See Fig. 7 for results for HMW PAHs.
