Cite this: *Environ. Sci.: Water Res. Technol.*, 2016, 2, 164

## Survey of green building water systems reveals elevated water age and water quality concerns†

William J. Rhoads,\* Amy Pruden and Marc A. Edwards

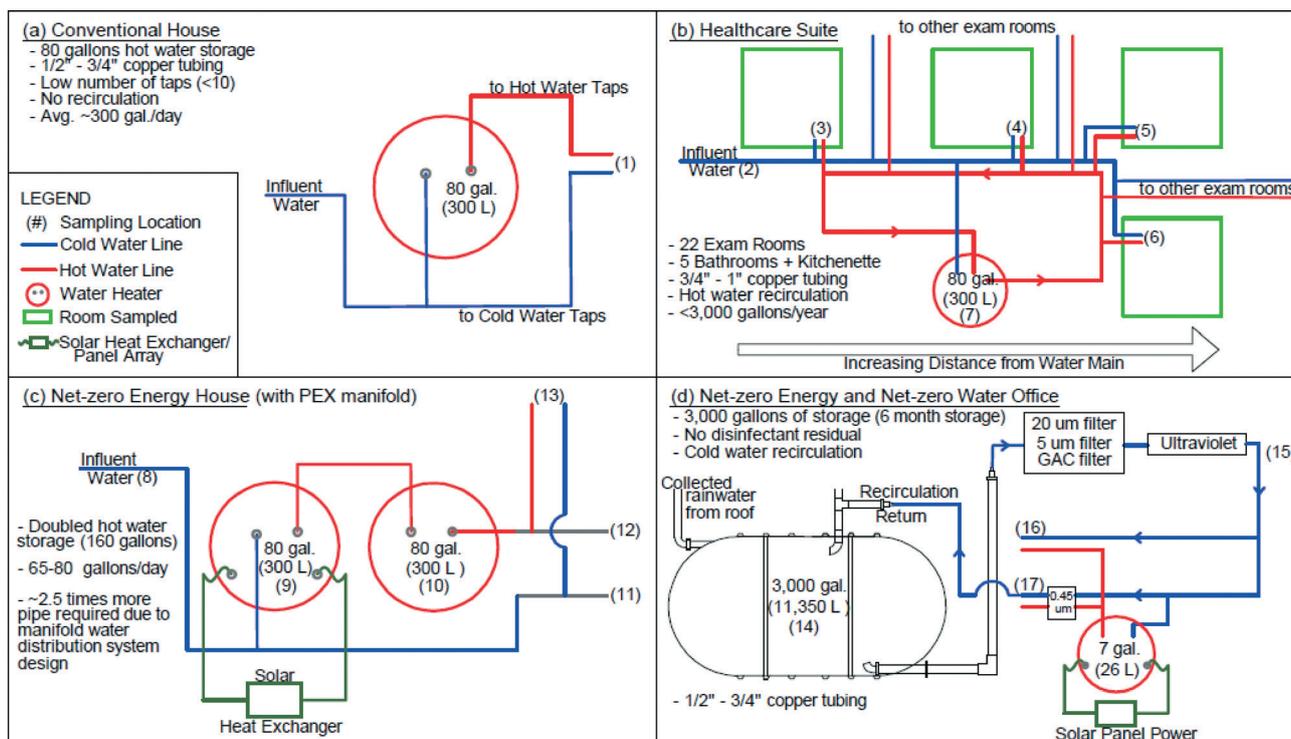
Fig. 1 Plumbing schematics and sampling locations for each field site.

Note: Numbers 1-17 in parentheses indicate sampling locations referred to in Table 2.

Four buildings with a cross-section of energy and water conservation strategies were surveyed and sampled to explore effects of green plumbing systems on water quality (Table 1). The buildings included a conventional house with no conservation features (Fig. 1a), a healthcare suite (Fig. 1b), a net-zero energy house (Fig. 1c), and a net-zero energy and net-zero water office building (Fig. 1d).

This study provided detailed documentation of the potable water systems in three innovative green buildings (Fig. 1). After reviewing the characteristics of each water system and closely examining trends in disinfectant residuals within the buildings, we provide an overview of microbial sampling from each building.

minutes of flushing was necessary to establish a chloramine residual similar to that present in the main distribution system (Fig. 2a). Taps at these locations are typically used for 15–30 seconds at a time; therefore, it is unlikely that a chloramine residual is ever present in portions of this plumbing system. Approximately 30 minutes of flushing was required at the net-zero energy house to establish a residual in the cold water system during the first site visit. In contrast, the conventional home had a residual of 0.71 mg L<sup>-1</sup> chlorine as Cl<sub>2</sub> in stagnant cold water. The water heaters at the net-zero house had <0.15 mg L<sup>-1</sup> chlorine as Cl<sub>2</sub> during a 20 minute flush due to the added storage volume and water age associated with the solar heater (Fig. 1c).

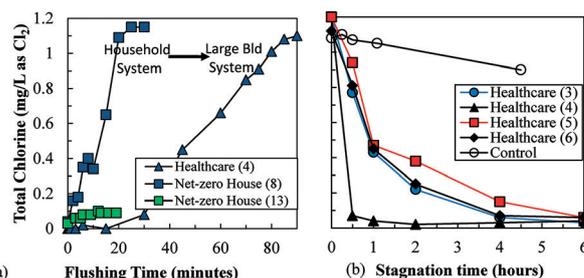
Note: Sampling locations indicated in parenthesis in the figure legends correspond to sample locations depicted in Figure 1.

**Fig. 2** Total chlorine residual concentrations (a) as a function of stagnation in one room at the healthcare suite (large building system above), a tap near the head of the building at the net-zero house (household system above), and during three showering events at net-zero house, and (b) as a function of stagnation in several rooms at FS#1 (control represents identical water placed in a glass container with no head space).

The healthcare suite also showed evidence of very rapid disinfectant residual decay. In all four exam rooms monitored, the first-order decay rate of chloramine in the plumbing was 20–144 times greater than in well-flushed (>80 minutes) water collected from the same tap and placed into a glass container with no headspace (*i.e.*, “control,” Fig. 2b). The highest rate of decay (sample location 4) was observed in
