Cite this: *Environ. Sci.: Water Res. Technol.*, 2021, 7, 274

DOI: 10.1039/d0ew00836b

# Drinking water contamination from the thermal degradation of plastics: implications for wildfire and structure fire response†

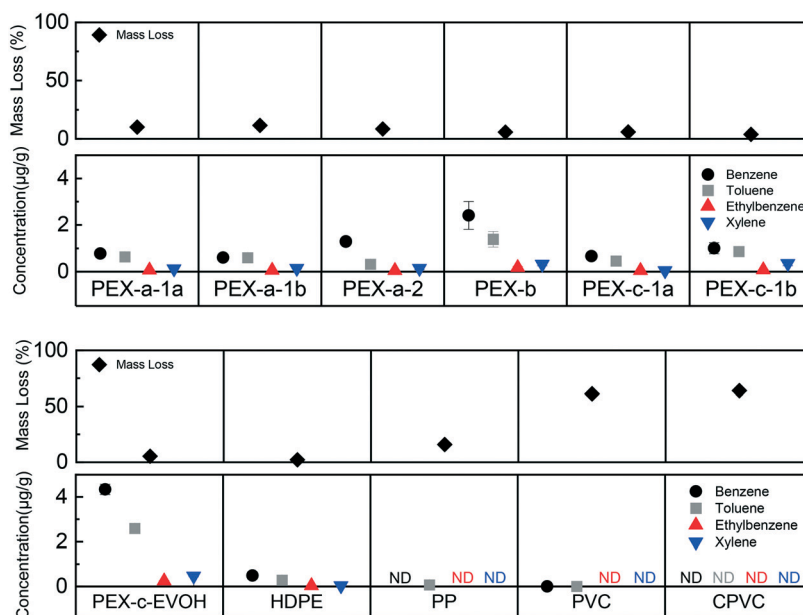
Fig. 2 Average amount of benzene, toluene, ethylbenzene, and xylene leaching observed after burning each material at 400 °C and extracting in water for 7 days. The error bars reflect the standard deviation of the measurements ( $n = 3$ ). If no error bars are visible, this indicates the error bars are smaller than the symbol size. ND indicates the compound was not detected above the MDL.

Results showed that plastic pipe thermal exposure can generate BTEX, which can then leach from cooled plastics into water. BTEX was not found from new and non-thermally degraded plastics in water, while 10 of 11 thermally degraded plastic pipes leached at least one BTEX component (Fig. 2). The chemical leaching differences between products is likely attributed to differences between plastic characteristics and experimental conditions. PE materials lost less mass due to isothermal heating (5 wt% to 10 wt%) compared to the PVC and CPVC samples (61 wt% and 64 wt%, respectively) (Fig. 2). A detectable, but significantly lower amount of benzene and toluene was observed for the PVC pipe, and no BTEX was found for the CPVC pipe (Fig. 2). Additionally, there was a general trend of compound concentration leaching across the plastics where benzene > toluene > ethylbenzene ≈ xylene (Fig. 2). This trend could be attributed to several factors including compound production, water solubility, air volatilization, polymer solubility parameters, and/or partitioning into the aqueous phase. Octanol-water coefficients and solubility values mirror the trend of concentrations observed (Table S4<sup>†</sup>), indicating that benzene would most readily partition into the aqueous phase.

Little to no BTEX was found for the PP pipe, which has a similar structure to HDPE. The onset degradation temperature of the PP pipe (416 °C) was lower than that of the HDPE and PEX materials (Table 1), and unsurprisingly, the PP had more mass loss (~15 wt%) (Fig. 2) at the same temperature. In previous PP studies, benzene has been found in the air after pyrolysis between 300 °C to 600 °C.<sup>53,54</sup> No prior studies were found that examined BTEX release into water from thermally damaged PP materials.
