Cite this: *Environ. Sci.: Water Res. Technol.*, 2016, 2, 164

Survey of green building water systems reveals elevated water age and water quality concerns†

William J. Rhoads,* Amy Pruden and Marc A. Edwards

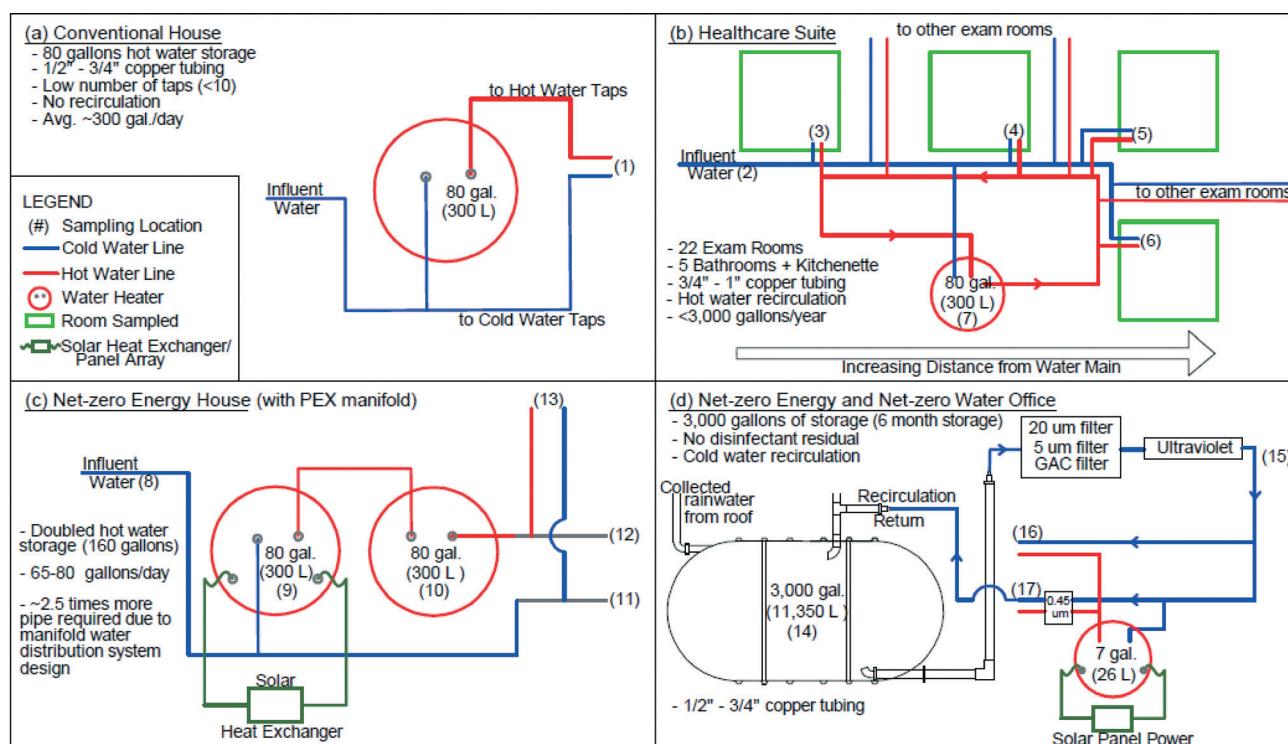
Note: Numbers 1-17 in parentheses indicate sampling locations referred to in Table 2.

Fig. 1 Plumbing schematics and sampling locations for each field site.

Four buildings with a cross-section of energy and water conservation strategies were surveyed and sampled to explore effects of green plumbing systems on water quality (Table 1). The buildings included a conventional house with no conservation features (Fig. 1a), a healthcare suite (Fig. 1b), a net-zero energy house (Fig. 1c), and a net-zero energy and net-zero water office building (Fig. 1d).

This study provided detailed documentation of the potable water systems in three innovative green buildings (Fig. 1). After reviewing the characteristics of each water system and closely examining trends in disinfectant residuals within the buildings, we provide an overview of microbial sampling from each building.

minutes of flushing was necessary to establish a chloramine residual similar to that present in the main distribution system (Fig. 2a). Taps at these locations are typically used for 15–30 seconds at a time; therefore, it is unlikely that a chloramine residual is ever present in portions of this plumbing system. Approximately 30 minutes of flushing was required at the net-zero energy house to establish a residual in the cold water system during the first site visit. In contrast, the conventional home had a residual of 0.71 mg L⁻¹ chlorine as Cl₂ in stagnant cold water. The water heaters at the net-zero house had <0.15 mg L⁻¹ chlorine as Cl₂ during a 20 minute flush due to the added storage volume and water age associated with the solar heater (Fig. 1c).
