Ongoing legacy contamination from a military radar station in Iceland: a case study

Contamination in and around military radar stations in the Arctic has been an ongoing concern since first identified in the 1980s. This study reports on the environmental impact from a DEW line US military station that was operated on Heiðarfjall mountain in northeast Iceland from 1957 to 1970. This review is conducted as a part of work of the POPs Expert Group of the Arctic Monitoring and Assessment Program (AMAP) for an assessment report on local sources vs. long-range transport of Persistent Organic Pollutants (POPs) in the Arctic. The main resource for this summary is an evaluation of results from several reports on Heiðarfjall Langanes, one from an Icelandic Environmental Authority in 1993 and another from the Canadian Environmental Science Group (ESG) at the Royal Military College of Canada, which was commissioned in 2017 by the owners of the land that was used for the station. The results are compared to findings in scientific papers and reports for contamination at other military radar stations in Canada and Alaska. This review shows considerable contamination on Heiðarfjall over 50 years a

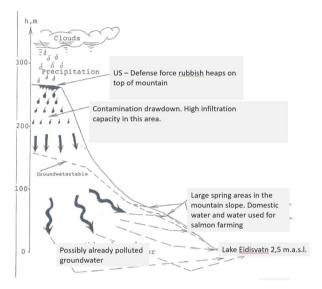
Transport model of pollution spread at Heiðarfjall. 42

The engineering consultant's conclusion was that groundwater pollution would mostly spread southwards towards the farm, the estuary lake Eiðisvatn and the sea as shown in Fig. 2. Calculations of the pollution infiltration flow from the top of the mountain indicate that it would take at least 30 years to reach the springs on the south side of the mountain flowing to Eiði

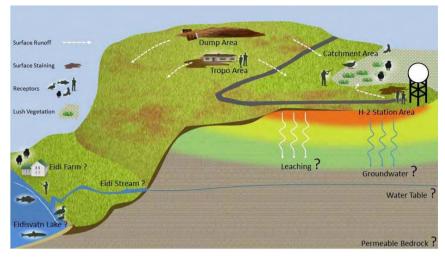
Fig. 3 Schematic picture of Heiðarfjall and the sites investigated by the ESG in 2017.10 Water source for Eidi farm is at the Eidi stream.

The sites chosen for sampling by the ESG, see Fig. 3, were: (1) the Dump area (*ca.* 18.000 m²) where debris, both during operating and later during clean-up, had been buried; (2) the Tropo area, with a communication building (still standing), and where two tropospheric communication dishes once stood; (3) the Sewage Outfall area; (4) the POL (petroleum oil and lubricant) Tank area, where a large fuel storage tank used to be situated. Sites 3 and 4 were on the southern edge of the summit area, directly above the Eiði farm; (5) the Garage area; (6) the Barracks area; (7) the Powerhouse area, and (8) Radome area (sites 5, 6, 7, and 8 are all situated at the Station area); (9) the lower-lying Catchment area, where a concrete drainage pipe was observed leading to a small pond; and (10) the Eiði stream area. Fig. 4 shows a recent picture of the Station area.
