Cite this: *Energy Environ. Sci.*, 2025, 18, 264

# Removal of residual contaminants by minute-level washing facilitates the direct regeneration of spent cathodes from retired EV Li-ion batteries†

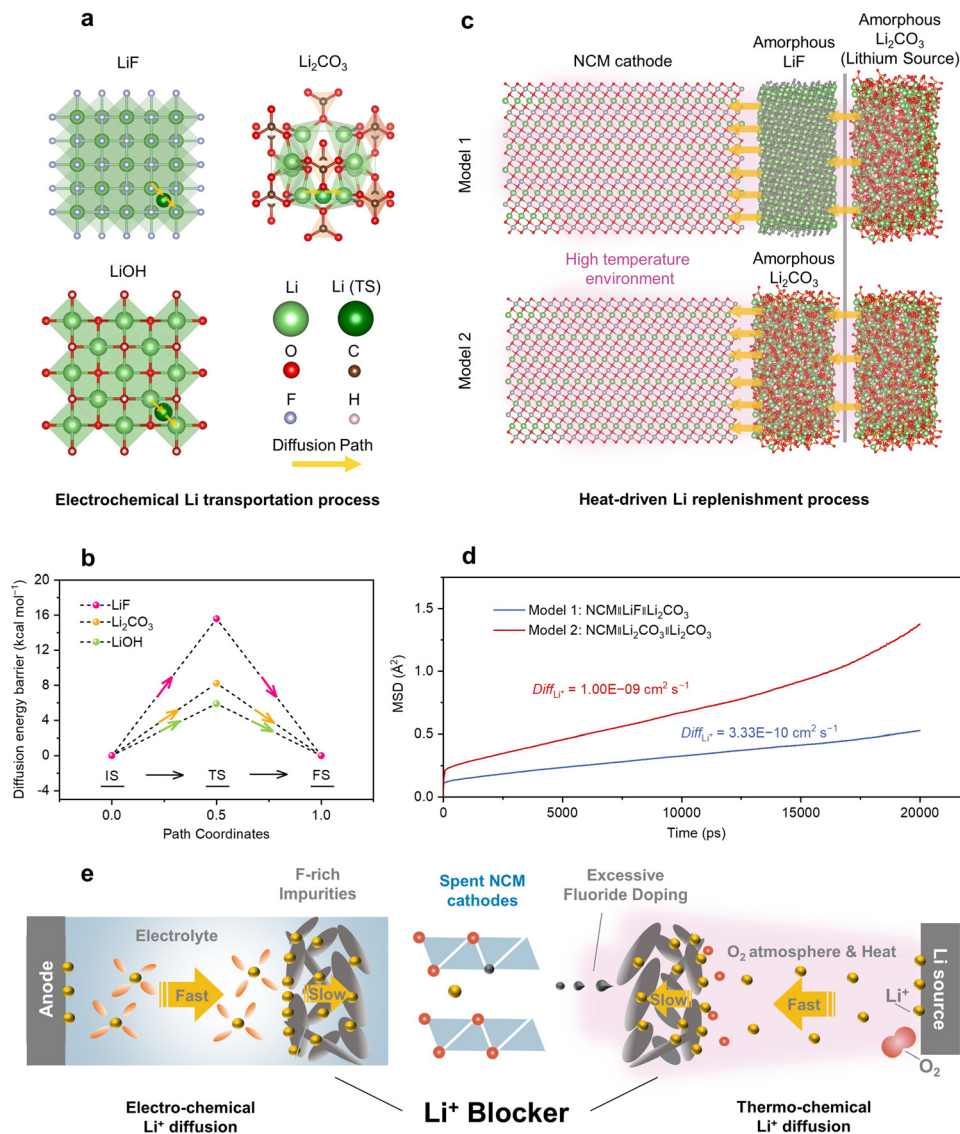
**Fig. 5** Role of the F-rich impurities as a blocker in electrochemical and thermochemical  $\text{Li}^+$  diffusion as ascertained from thermodynamic and kinetic simulations. (a) Illustrations of the selected migration pathways with a similar distance for  $\text{Li}^+$  inside the crystal lattice of three common components. The initial state, transition state, and final state of  $\text{Li}^+$  transportation are denoted as IS, TS, and FS, respectively. (b) Calculated energy diffusion barrier for Li ions in selected phases. (c) Two models for stimulating the kinetics of Li transportation in direct regeneration. Model 1 consists of the NCM cathode substrate, the amorphous LiF layer, and  $\text{Li}_2\text{CO}_3$  as a lithium source in direct regeneration, which is denoted as NCM||LiF|| $\text{Li}_2\text{CO}_3$ . In Model 2 (NCM|| $\text{Li}_2\text{CO}_3$ || $\text{Li}_2\text{CO}_3$  in short), the middle LiF layer is replaced by a common residual alkali ( $\text{Li}_2\text{CO}_3$ ), which is used to simulate the regeneration of NCM cathodes after cleaning pretreatment. Each shape symbol is the same as for Fig. 5a. (d) MSD of the Li atoms in 20 ns and calculated  $\text{Li}^+$  diffusivity based on the above model. "E – 9" means  $10^{-9}$ . (e) Mechanism diagram for preventing the NCM cathodes from reusing and directly regenerating under the influence of impurities.

According to the above results (Fig. 1d, Fig. S6, S16 (ESI†), and Fig. 4h, i), the migration rate of lithium ions was significantly influenced by the residual impurities; therefore it was crucial to theoretically investigate their influence on capacity delivery in the reuse case and during direct regeneration. Considering the impurities were mostly concentrated at the surface before and after regeneration, and that F-rich residuals could be observed, as shown in Fig. S9 and S10 (ESI†) and Fig. 3c, we chose three representative inorganic components ( $\text{LiF}$ ,  $\text{Li}_2\text{CO}_3$ , and  $\text{LiOH}$ ) in the CEI layer<sup>48</sup> or residual alkali<sup>49</sup> to calculate the  $\text{Li}^+$  diffusion from a thermodynamic perspective, and their structures are shown in Fig. 5a. By maintaining a similar distance and concentration of mobile Li-ions, the diffusion energy barrier of lithium ions ( $\Delta E_{\text{Li}^+}$ ) during the cycling of spent cathodes within the different crystal structures (Fig. 5b) allowed valid comparisons. We found that the  $\Delta E_{\text{Li}^+}$  of the  $\text{LiF}$  phase, as a common inorganic component from CEI, was about 2 and 3 times higher than that of the  $\text{LiOH}$  and  $\text{Li}_2\text{CO}_3$  phases from

Fig. 5b. Therefore, this result confirmed that the presence of fluoride-rich impurity residuals on the cathode surface significantly increased the diffusion resistance of Li ions when cycling, ultimately exacerbating the cell impedance and interfacial parasitic reactions (Fig. 1d). To comprehend the larger-scale kinetic characteristics and understand the effect of impurity coatings during heating for regeneration of the spent cathodes, two molecular dynamics models were established for simulating  $\text{Li}^+$  transportation at 1000 K over 20 ns. Specifically, Model 1 was devised to include an impurity barrier consisting of a  $\text{LiF}$  layer (Fig. 5c and Fig. S33, ESI†). Through computing the mean square displacement (MSD) of Li atoms and fitting curves (Fig. 5d), we determined that the Li diffusivity ( $\text{Diff}_{\text{Li}^+}$ ) of Model 1 was  $3.33 \times 10^{-10}$ , which was an order of magnitude lower than that of Model 2 ( $1.00 \times 10^{-9}$ ). The differences in molecular dynamics models under practical conditions suggest that fluoride-rich impurity coatings increase the resistance to Li-ion diffusion into spent cathodes with Li deficiencies during thermo-driven regeneration, leading to inadequate compositional and structural recovery.

As illustrated in Fig. 5e, the impurity phase containing the F element served as an electro- and thermo-diffusion blocker of Li ions hindering the reuse and direct regeneration of the spent cathode. In the spent cathodes collected by physical pretreatment and collection from used lithium-ion batteries, the ubiquitous electrolyte was decomposed to form an ion barrier with slow ion diffusivity. However, these impurities have long been overlooked in most studies (Table S2, ESI†), mainly due to the use of lab-scale degraded cathodes and fine manual separation pretreatment. In previous studies,<sup>12–16,42</sup> the latent impact of the residual impurities on direct regeneration remains untouched because impurities are easily converted into other inconspicuous matter in extreme physical or chemical regeneration environments. Looking ahead, the direct regeneration of next-generation sensitive cathode materials, such as Li-rich Mn-based, Co-free, and ultra-high-Ni cathode materials, faces serious challenges from these latent impurities if they enter the recycling circle. From another perspective, establishing the controlling law for the inherent impurities doping within the closed-loop material flow could instructively enhance the performance of such recycled materials in the future. Moreover, only by revealing the effect of the overlooked impurities or by getting rid of impurities, can evolving technologies and mechanisms for direct regeneration and upcycling be reasonably evaluated.<sup>50</sup>
