## CRITICAL REVIEW

## Ongoing legacy contamination from a military radar station in Iceland: a case study

Contamination in and around military radar stations in the Arctic has been an ongoing concern since first identified in the 1980s. This study reports on the environmental impact from a DEW line US military station that was operated on Heiðarfjall mountain in northeast Iceland from 1957 to 1970. This review is conducted as a part of work of the POPs Expert Group of the Arctic Monitoring and Assessment Program (AMAP) for an assessment report on local sources vs. long-range transport of Persistent Organic Pollutants (POPs) in the Arctic. The main resource for this summary is an evaluation of results from several reports on Heiðarfjall Langanes, one from an Icelandic Environmental Authority in 1993 and another from the Canadian Environmental Science Group (ESG) at the Royal Military College of Canada, which was commissioned in 2017 by the owners of the land that was used for the station. The results are compared to findings in scientific papers and reports for contamination at other military radar stations in Canada and Alaska. This review shows considerable contamination on Heið

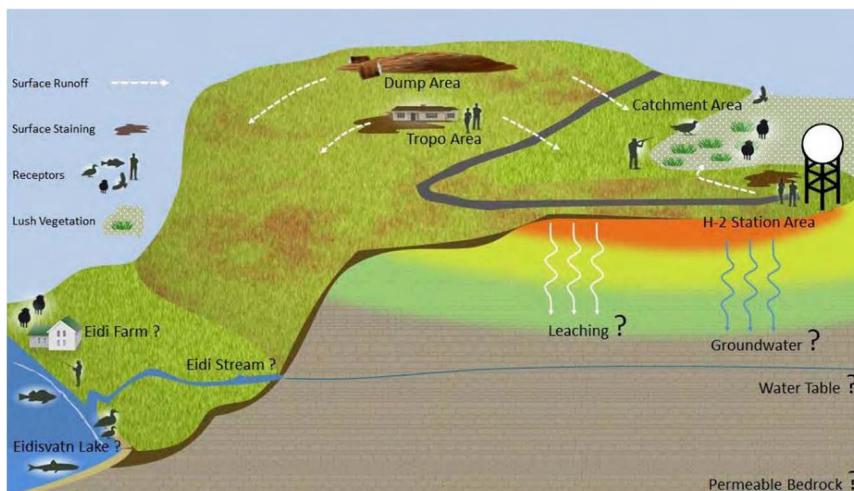
Fig. 3 Schematic picture of Heiðarfjall and the sites investigated by the ESG in 2017.<sup>10</sup> Water source for Eidi farm is at the Eidi stream.

The sites chosen for sampling by the ESG, see Fig. 3, were: (1) the Dump area (*ca.*  $18.000 \text{ m}^2$ ) where debris, both during operating and later during clean-up, had been buried; (2) the Tropo area, with a communication building (still standing), and where two tropospheric communication dishes once stood; (3) the Sewage Outfall area; (4) the POL (petroleum oil and lubricant) Tank area, where a large fuel storage tank used to be situated. Sites 3 and 4 were on the southern edge of the summit area, directly above the Eiði farm; (5) the Garage area; (6) the Barracks area; (7) the Powerhouse area, and (8) Radome area (sites 5, 6, 7, and 8 are all situated at the Station area); (9) the lower-lying Catchment area, where a concrete drainage pipe was observed leading to a small pond; and (10) the Eiði stream area. Fig. 4 shows a recent picture of the Station area.

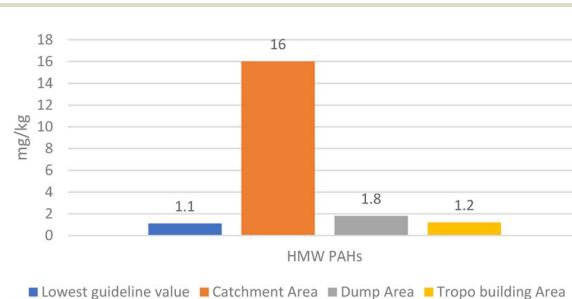
Fig. 7 HMW PAHs ( $\text{mg kg}^{-1}$ ) tested in five areas with the content exceeding the lowest guideline value ( $1.1\text{ mg kg}^{-1}$ ) in three areas. The highest values detected in the three areas are shown.

PAHs are released during incomplete combustion of petroleum products or from petroleum spill. They are persistent in the environment and several have multiple adverse health effects.<sup>27</sup> PAHs were summarized in two categories, low molecular weight PAHs (LMW PAHs) and high molecular weight PAHs (HMW PAHs), with the latter being more toxic and carcinogenic.<sup>51</sup> Fifteen PAHs were tested (5 LMW and 10 HMW) in nine samples from five areas (Dump, Tropo, Sewage outfall, Powerhouse and Catchment), see Table 1, and found to exceed the lowest guideline value at three areas: Catchment, Dump and Tropo areas. The highest values in both categories (LMW and HMW) were found at the Catchment area (Table 2). See Fig. 7 for results for HMW PAHs.

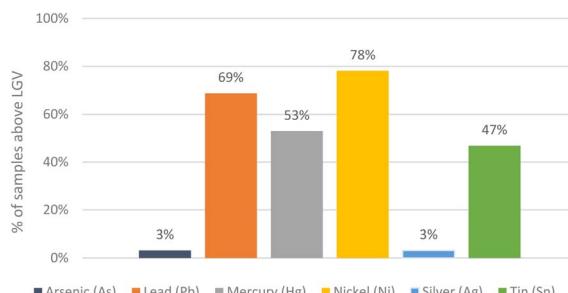
Fig. 8 Non-compliance with the lowest guideline value in samples of 6 primary trace elements, measured in 32 samples from the 10 areas chosen by the ESG for investigation at the H-2 area.<sup>10</sup>

aluminium, antimony, cobalt, copper, iron, manganese, vanadium, and zinc were frequently above the guideline values. None of the six primary inorganic elements were above the guideline values at the Eiði farm area. However, ten other inorganic elements (not shown here) exceeded the lowest guidelines at the Eiði farm area, especially vanadium and antimony which were 50 and 20-fold higher than the lowest guideline values. Others were aluminium, chromium, cobalt, copper, iron, manganese, sulphur, and zinc, ranging from 2 to 7-fold higher (Fig. 8).
