# Environmental and private property contamination following the Norfolk Southern chemical spill and chemical fires in Ohio†

In February 2023, a train derailment in Ohio caused a chemical spill and fires releasing contaminants into the air, soil, waterways, and buildings. The authors conducted a rapid response which included six field investigations and bench-scale experiments to understand the chemical identity, fate, and exposure pathways after the evacuation order was lifted. Multiple buildings were chemically contaminated and silicone wristband products inside a commercial building were found to have adsorbed derailment-related chemicals. The indoor air of this commercial building was found to be contaminated for 4.5 months after the derailment. Derailment chemicals were also found on building exteriors 5 weeks after the incident. Railcar chemicals were detected in the nearby creeks. Cleanup activities (sorbent pads, aerators) as well as creek hydraulic and environmental conditions influenced chemical fate in creeks. Creek mechanical aeration activities prompted VOC emission that contributed to human exposures and vapor intrusion. Atmospheric modeling revealed that the chemica

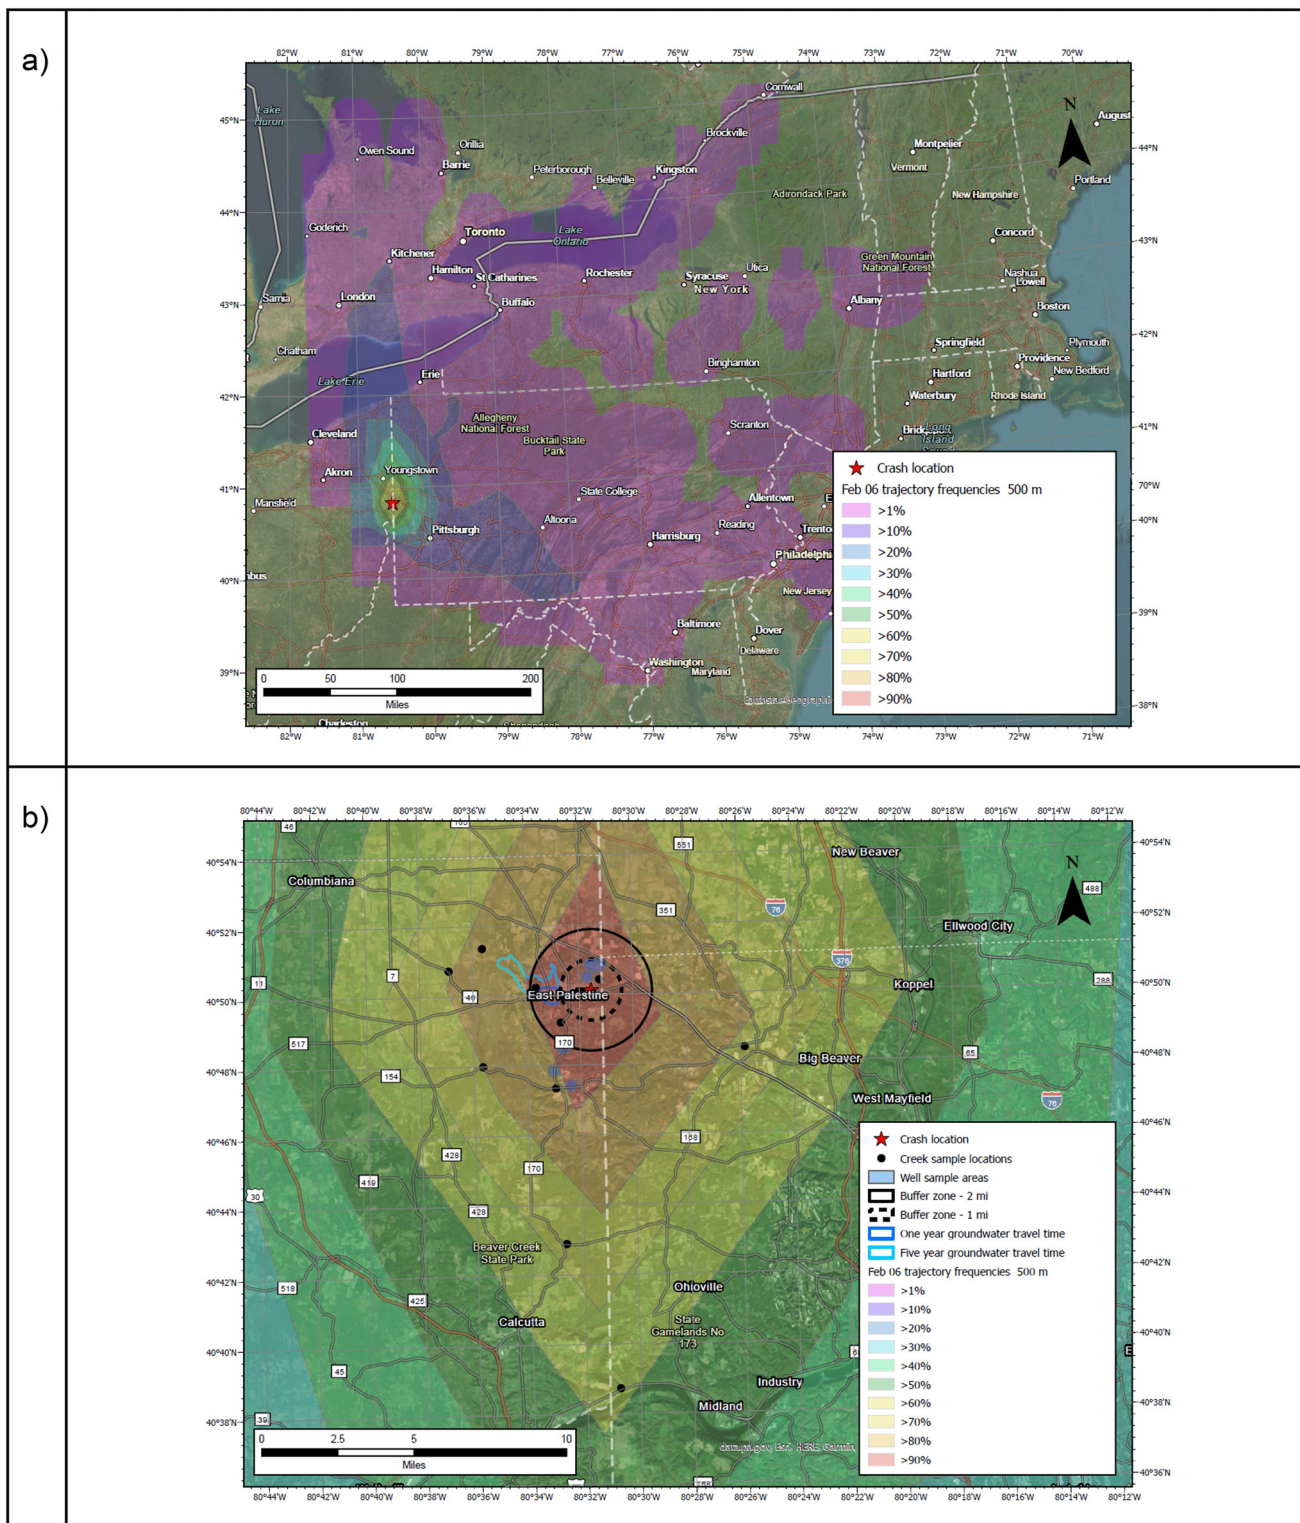
Fig. 3 (continued)

**Fig. 3** The chemical plume area of impact (a) was simulated with the HYSPLIT model, (b) the chemical plume extended outside both the 1 mile evacuation zone and the shelter-in-place zone plotted with the creek sampling locations<sup>52</sup> and (c) East Palestine area, with shelter in place and evacuation zones highlighting the areas where the study sampled private wells. Each image panel represents a different spatial scale.

To better interpret building occupant odor reports and the author's building chemical contamination results, the author's HYSPLIT model results and atmospheric simulations reported by other organizations were considered. All buildings visited by the authors were in the zone where >80% of the authors' HYSPLIT air trajectories were predicted (Fig. 3). The HYSPLIT modeling results indicated that chemicals were transported in the air from the derailment location in multiple

directions, extending beyond the 1 mile evacuation zone. Polluted air traveled mostly to the immediate north of the burn (more than 19 out of 24 trajectories), with some likely blowing over Lake Erie and reaching Canada (Fig. 3). Before the open burn, air appears to have blown mostly to the east of the site. After the burn, air primarily traveled north, and trajectories used in the frequency calculation are in the ESI.† While the model applied did not include particulate deposition or transport, results suggest that atmospheric pollutants emitted travelled east and north of the derailment site. The residential and commercial buildings visited by the authors were also located within USEPA's soot footprint map,<sup>24</sup> and the modified High Resolution Rapid Refresh dispersion model impact zone identified by other investigators (Table ESI-7†). A limitation here is that the HYSPLIT model does not have the spatial resolution to capture the variability across the various sampling sites in this study.
