# A study of dynamic nanoscale corrosion initiation events using HS-AFM†

Received 5th February 2018, Accepted 7th March 2018

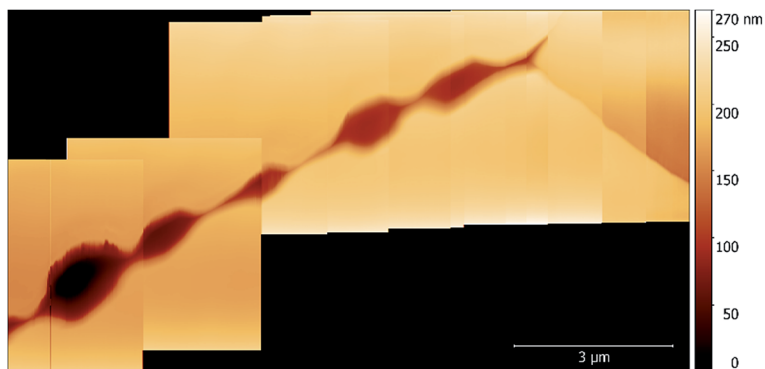
Fig. 6 A topographic map of a number of pits formed along a GB in sensitised AISI 304 stainless steel within 1% aqueous NaCl.

While imaging along GBs just ahead of the corrosion front, a number of small intergranular pits were identified, and in some areas these occurred in chains, as seen in Fig. 6. By monitoring GBs surrounding corrosion events, the formation of an intergranular pit was observed. Fig. 7a and b show before and after topographic maps of an intergranular pit forming at a GB during a galvanostatic scan. The feature formed between two subsequent HS-AFM frames. Given that the HS-AFM was collecting images at a rate of  $2\text{ s}^{-1}$ , the timeframe at which this reaction occurred can be deduced as  $\leq 0.5\text{ s}$ .

HS-AFM measurements revealed that intergranular pits form as chains along the GB (Fig. 6). This was due to preferential corrosion of the GB, as a result of
