COMMUNICATION

Cite this: *Environ. Sci.: Water Res. Technol.*, 2021, 7, 274

Drinking water contamination from the thermal degradation of plastics: implications for wildfire and structure fire response†

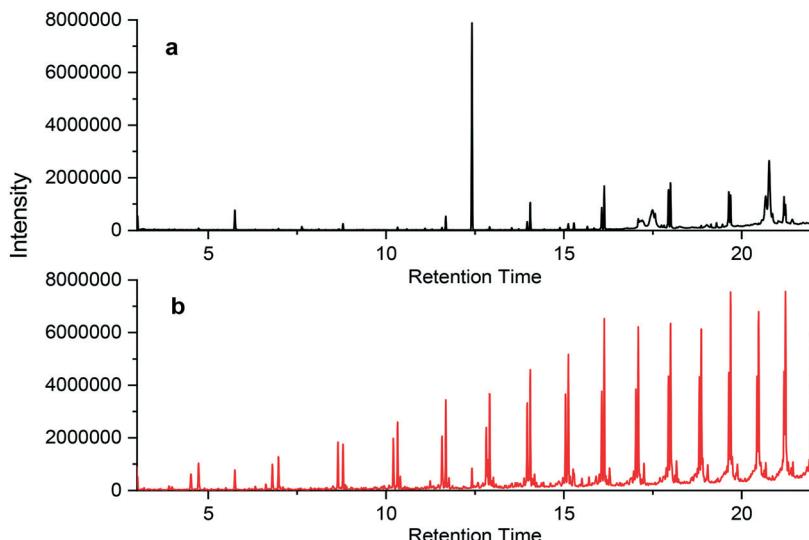
Fig. 4 Chromatographs of PEX-c-1a when (a) unburned and (b) burned at 400 °C, where samples were extracted in *n*-hexane. The internal standard is the peak at 5.8 minutes.

Leaching promoted by hexane extraction. As expected, a greater number of peaks were observed in the *n*-hexane extracts (32 to 134) compared to the water extracts (3 to 22) for all plastics (see example for PEX-c-1a in Fig. 4 and all other pipe types in Fig. S17–S26†). For the degraded PEX, HDPE, and PP pipes, between 100 to 134 unique compounds were leached into *n*-hexane, whereas for the degraded PVC and CPVC pipes between 30 to 41 compounds were leached (Fig. 4 and S17–S26†). While most compounds extracted from the new pipes were either straight chain or branched alkanes of varying lengths (Table S3†), thermal exposure led alkenes to represent the majority of compounds detected in the leachate (Table S5†). These aliphatic hydrocarbons are products of alkane hydrocarbon chain scission and are not typical drinking water contaminants. They have low aqueous solubility, which is why they were only detected in the hexane extracts and are generally less toxic than their cyclical or aromatic counterparts.^{56,57}

Generally, both the magnitude of the peak and the number of compounds increased after burning the materials. However, one notable exception occurred for the PEX-c pipes; one peak (retention time of 12.5 min) for the unburned pipe was significantly larger than that of any of the burned peaks (Fig. 4 and S21†). This peak likely represented the compound, di-*tert*-butylbenzene, which has been shown to be an ultraviolet light or radiolysis degradation product of the antioxidant Irgafos 168®.^{58,59} This compound was only observed in the leachate of the PEX-c materials, in which the crosslinking occurs using beta irradiation. This may explain why the magnitude of this degradation product was so large.⁶⁰ This peak decreased substantially in the burned plastic extract (Fig. 4 and S21†), indicating it may have been thermally decomposed.
