## CRITICAL REVIEW

## Ongoing legacy contamination from a military radar station in Iceland: a case study

Contamination in and around military radar stations in the Arctic has been an ongoing concern since first identified in the 1980s. This study reports on the environmental impact from a DEW line US military station that was operated on Heiðarfjall mountain in northeast Iceland from 1957 to 1970. This review is conducted as a part of work of the POPs Expert Group of the Arctic Monitoring and Assessment Program (AMAP) for an assessment report on local sources vs. long-range transport of Persistent Organic Pollutants (POPs) in the Arctic. The main resource for this summary is an evaluation of results from several reports on Heiðarfjall Langanes, one from an Icelandic Environmental Authority in 1993 and another from the Canadian Environmental Science Group (ESG) at the Royal Military College of Canada, which was commissioned in 2017 by the owners of the land that was used for the station. The results are compared to findings in scientific papers and reports for contamination at other military radar stations in Canada and Alaska. This review shows considerable contamination on Heið

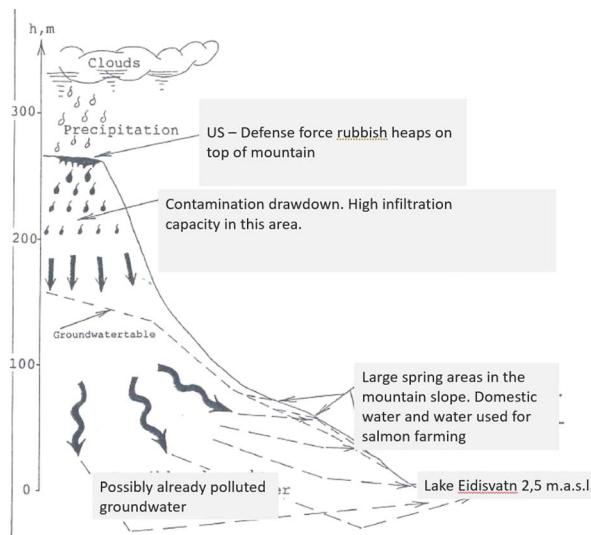
Fig. 2 Transport model of pollution spread at Heiðarfjall.<sup>42</sup>

The engineering consultant's conclusion was that groundwater pollution would mostly spread southwards towards the farm, the estuary lake Eiðisvatn and the sea as shown in Fig. 2. Calculations of the pollution infiltration flow from the top of the mountain indicate that it would take at least 30 years to reach the springs on the south side of the mountain flowing to Eiði

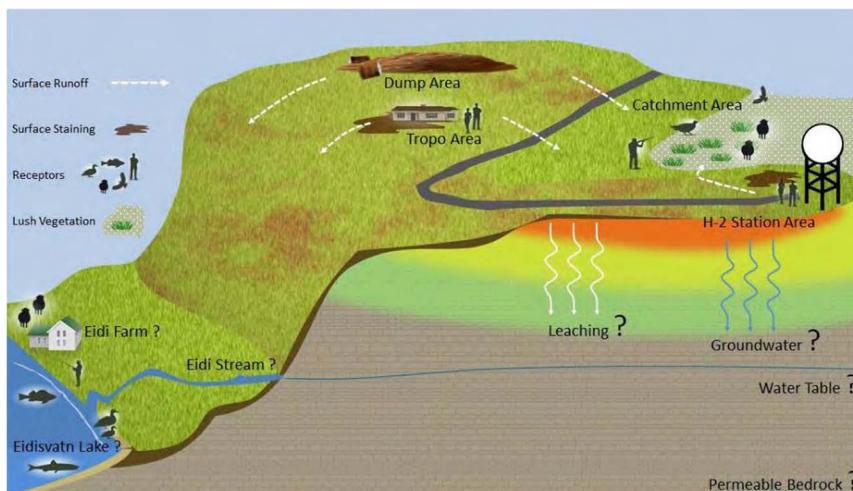
Fig. 3 Schematic picture of Heiðarfjall and the sites investigated by the ESG in 2017.<sup>10</sup> Water source for Eidi farm is at the Eidi stream.

The sites chosen for sampling by the ESG, see Fig. 3, were: (1) the Dump area (*ca.*  $18.000 \text{ m}^2$ ) where debris, both during operating and later during clean-up, had been buried; (2) the Tropo area, with a communication building (still standing), and where two tropospheric communication dishes once stood; (3) the Sewage Outfall area; (4) the POL (petroleum oil and lubricant) Tank area, where a large fuel storage tank used to be situated. Sites 3 and 4 were on the southern edge of the summit area, directly above the Eiði farm; (5) the Garage area; (6) the Barracks area; (7) the Powerhouse area, and (8) Radome area (sites 5, 6, 7, and 8 are all situated at the Station area); (9) the lower-lying Catchment area, where a concrete drainage pipe was observed leading to a small pond; and (10) the Eiði stream area. Fig. 4 shows a recent picture of the Station area.

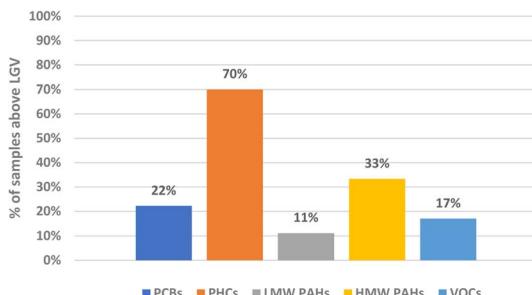
Fig. 5 Non-compliance of POPs with the LGW (lowest guideline value) in samples.<sup>10</sup>

POPs are non-compliant to the lowest guideline value, as shown in Fig. 5, from 11% for low molecular weight PAHs to

70% for PHCs. However, this is not representative as sampling is not evenly distributed and several sites are not tested for some POPs as shown in Table 1.

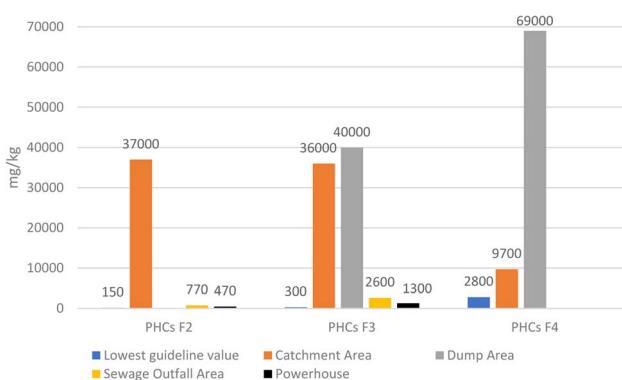
Fig. 6 PHCs ( $\text{mg kg}^{-1}$ ) detected above the lowest guideline value for F2, F3 and F4 (150, 300, and 2800, respectively) at four areas. The highest value in each area of the four is shown in the figure.

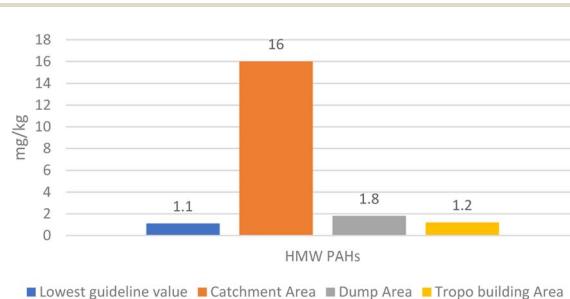
Fig. 7 HMW PAHs ( $\text{mg kg}^{-1}$ ) tested in five areas with the content exceeding the lowest guideline value ( $1.1\text{ mg kg}^{-1}$ ) in three areas. The highest values detected in the three areas are shown.

PAHs are released during incomplete combustion of petroleum products or from petroleum spill. They are persistent in the environment and several have multiple adverse health effects.<sup>27</sup> PAHs were summarized in two categories, low molecular weight PAHs (LMW PAHs) and high molecular weight PAHs (HMW PAHs), with the latter being more toxic and carcinogenic.<sup>51</sup> Fifteen PAHs were tested (5 LMW and 10 HMW) in nine samples from five areas (Dump, Tropo, Sewage outfall, Powerhouse and Catchment), see Table 1, and found to exceed the lowest guideline value at three areas: Catchment, Dump and Tropo areas. The highest values in both categories (LMW and HMW) were found at the Catchment area (Table 2). See Fig. 7 for results for HMW PAHs.

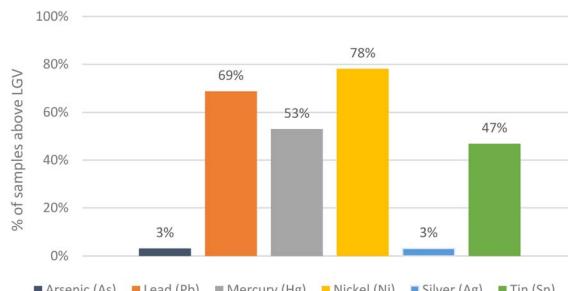
Fig. 8 Non-compliance with the lowest guideline value in samples of 6 primary trace elements, measured in 32 samples from the 10 areas chosen by the ESG for investigation at the H-2 area.<sup>10</sup>

aluminium, antimony, cobalt, copper, iron, manganese, vanadium, and zinc were frequently above the guideline values. None of the six primary inorganic elements were above the guideline values at the Eiði farm area. However, ten other inorganic elements (not shown here) exceeded the lowest guidelines at the Eiði farm area, especially vanadium and antimony which were 50 and 20-fold higher than the lowest guideline values. Others were aluminium, chromium, cobalt, copper, iron, manganese, sulphur, and zinc, ranging from 2 to 7-fold higher (Fig. 8).
