Cite this: *Environ. Sci.: Water Res. Technol.*, 2016, 2, 164

## Survey of green building water systems reveals elevated water age and water quality concerns†

William J. Rhoads,\* Amy Pruden and Marc A. Edwards

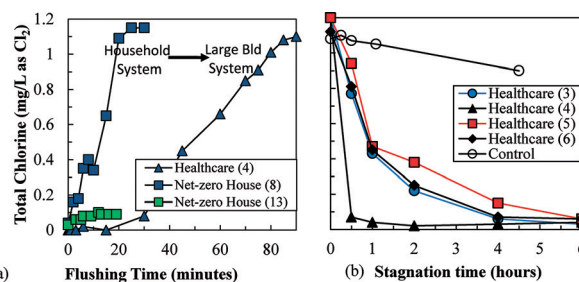
Note: Sampling locations indicated in parenthesis in the figure legends correspond to sample locations depicted in Figure 1.

**Fig. 2** Total chlorine residual concentrations (a) as a function of stagnation in one room at the healthcare suite (large building system above), a tap near the head of the building at the net-zero house (household system above), and during three showering events at net-zero house, and (b) as a function of stagnation in several rooms at FS#1 (control represents identical water placed in a glass container with no head space).

minutes of flushing was necessary to establish a chloramine residual similar to that present in the main distribution system (Fig. 2a). Taps at these locations are typically used for 15–30 seconds at a time; therefore, it is unlikely that a chloramine residual is ever present in portions of this plumbing system. Approximately 30 minutes of flushing was required at the net-zero energy house to establish a residual in the cold water system during the first site visit. In contrast, the conventional home had a residual of 0.71 mg L<sup>-1</sup> chlorine as Cl<sub>2</sub> in stagnant cold water. The water heaters at the net-zero house had <0.15 mg L<sup>-1</sup> chlorine as Cl<sub>2</sub> during a 20 minute flush due to the added storage volume and water age associated with the solar heater (Fig. 1c).

The healthcare suite also showed evidence of very rapid disinfectant residual decay. In all four exam rooms monitored, the first-order decay rate of chloramine in the plumbing was 20–144 times greater than in well-flushed (>80 minutes) water collected from the same tap and placed into a glass container with no headspace (*i.e.*, “control,” Fig. 2b). The highest rate of decay (sample location 4) was observed in
