Cite this: *Environ. Sci.: Water Res. Technol.*, 2021, 7, 274

DOI: 10.1039/d0ew00836b

## Drinking water contamination from the thermal degradation of plastics: implications for wildfire and structure fire response†

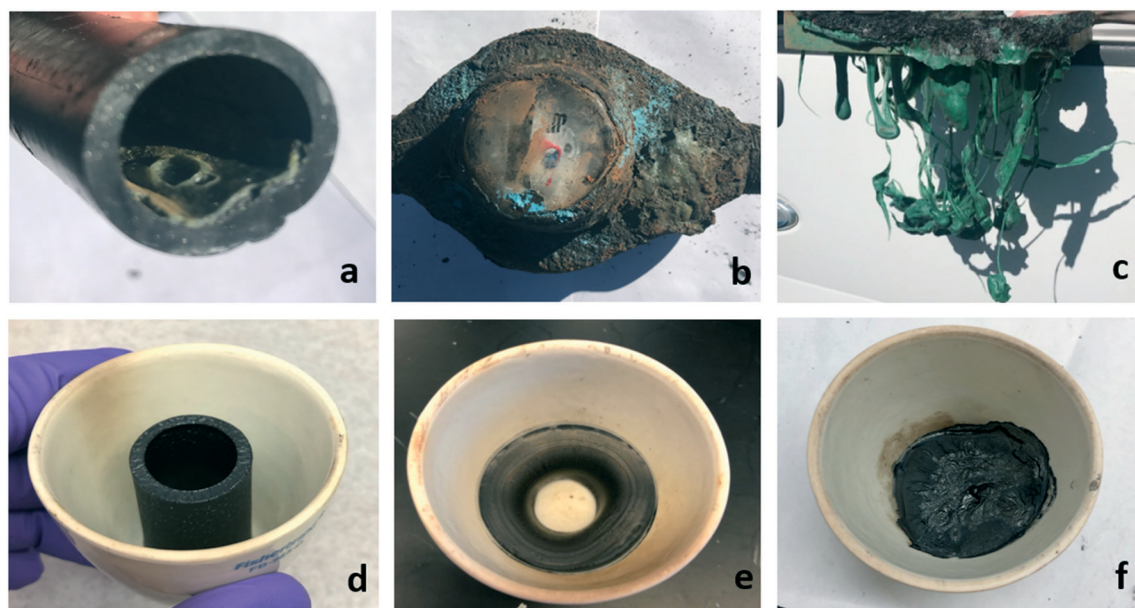
**Fig. 1** Images of fire-damaged water system components including (a) a HDPE plastic pipe, (b) a water meter, and (c) a water meter cover following the Camp Fire. Thermally degraded pipe samples in laboratory experiments include the (d) PEX-c pipe degraded at 300 °C, (e) HDPE pipe degraded at 300 °C, and (f) HDPE pipe degraded at 400 °C.

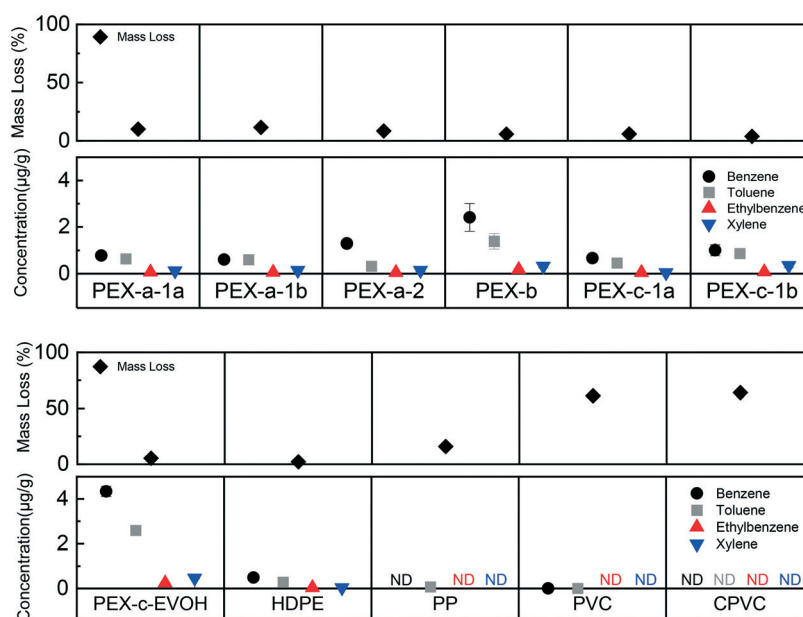
Fig. 2 Average amount of benzene, toluene, ethylbenzene, and xylene leaching observed after burning each material at 400 °C and extracting in water for 7 days. The error bars reflect the standard deviation of the measurements ( $n = 3$ ). If no error bars are visible, this indicates the error bars are smaller than the symbol size. ND indicates the compound was not detected above the MDL.

Results showed that plastic pipe thermal exposure can generate BTEX, which can then leach from cooled plastics into water. BTEX was not found from new and non-thermally degraded plastics in water, while 10 of 11 thermally degraded plastic pipes leached at least one BTEX component (Fig. 2). The chemical leaching differences between products is likely attributed to differences between plastic characteristics and experimental conditions. PE materials lost less mass due to isothermal heating (5 wt% to 10 wt%) compared to the PVC and CPVC samples (61 wt% and 64 wt%, respectively) (Fig. 2). A detectable, but significantly lower amount of benzene and toluene was observed for the PVC pipe, and no BTEX was found for the CPVC pipe (Fig. 2). Additionally, there was a general trend of compound concentration leaching across the plastics where benzene > toluene > ethylbenzene ≈ xylene (Fig. 2). This trend could be attributed to several factors including compound production, water solubility, air volatilization, polymer solubility parameters, and/or partitioning into the aqueous phase. Octanol-water coefficients and solubility values mirror the trend of concentrations observed (Table S4†), indicating that benzene would most readily partition into the aqueous phase.

The discovery that BTEX was generated by thermally degraded plastic pipes is supported by prior literature focused on air testing. Benzene and toluene tend to be formed during the first stage of decomposition for vinyl material thermal degradation.<sup>49</sup> Alkylated aromatics, such as ethylbenzene and xylene can be formed during a second degradation step due to chain scission and aromatization.<sup>49</sup> VOC release from HDPE into air during pyrolysis (lack of oxygen) or combustion (presence of oxygen) occurs due a similar scission and aromatization mechanism, and previous studies have observed all four BTEX compounds.<sup>50,51</sup> The results of this study suggest that BTEX may have been formed in the intact, but thermally degraded, plastics and subsequently leached into the water. The inverse relationship between BTEX in the aqueous phase and mass loss (Fig. 2) indicates that as structural integrity becomes compromised, as was the case for the vinyl materials (Fig. S2–S5†), the volatile compounds tend to partition into air. To the best of the authors' knowledge, there have been no prior PEX thermal degradation studies that have found BTEX compounds in the air. Primary degradation products of PEX have been reported to include linear hydrocarbons and cyclical siloxane compounds, although PEX pipe is created by crosslinking HDPE and medium density polyethylene resins.<sup>52</sup>

Little to no BTEX was found for the PP pipe, which has a similar structure to HDPE. The onset degradation temperature of the PP pipe (416 °C) was lower than that of the HDPE and PEX materials (Table 1), and unsurprisingly, the PP had more mass loss (~15 wt%) (Fig. 2) at the same temperature. In previous PP studies, benzene has been found in the air after pyrolysis between 300 °C to 600 °C.<sup>53,54</sup> No prior studies were found that examined BTEX release into water from thermally damaged PP materials.

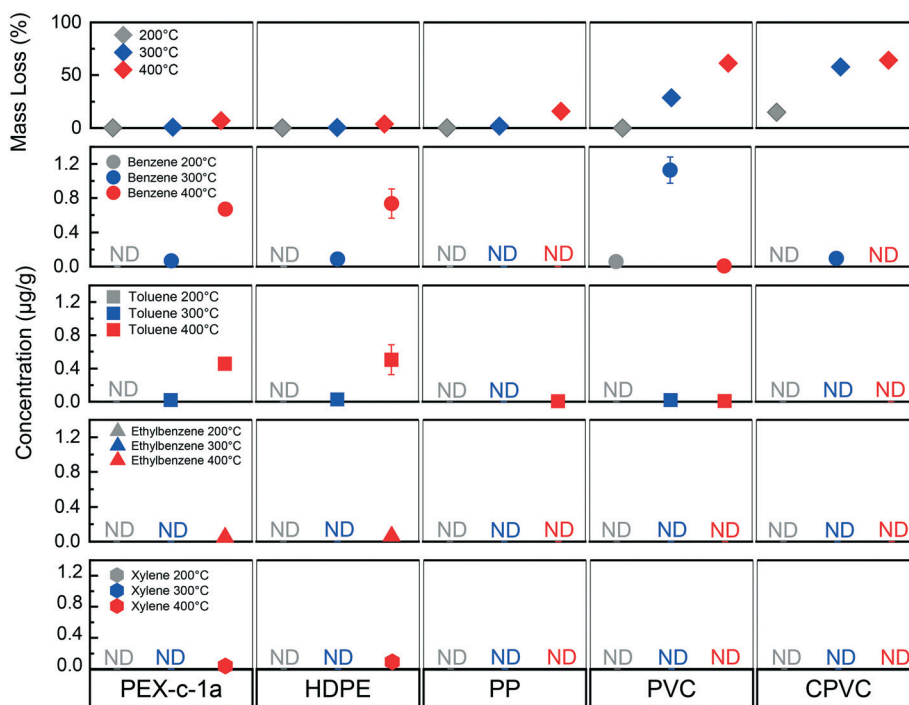
**Fig. 3** Mean BTEX concentration after extracting each burned material at 200 °C, 300 °C, and 400 °C in water. The error bars reflect the standard deviation of the measurements ( $n = 3$ ). If no error bars are visible, it indicates they were smaller than the symbol size. ND indicates the compound was not detected.

Different concentrations of BTEX were found in water after changing the isothermal heating temperature, such that two patterns emerged (Fig. 3). For the HDPE and PEX pipes, the amount of BTEX that leached into the water increased as the plastic degradation temperature increased from 200 °C to 400 °C (Fig. 3). Conversely, the greatest benzene concentration was found for the PVC pipe when exposed to 300 °C, with relatively less concentrations at 200 °C and 400 °C (Fig. 3). The CPVC pipe showed a similar pattern for benzene as the PVC pipe, however, at much lower concentrations (Fig. 3). This spike phenomenon for vinyl materials can potentially be explained by the lower amount of mass loss, where not all benzene produced during degradation volatilized out of the solid. The 300 °C exposure temperature was greater than the onset degradation temperature (Table 1) where dehydrochlorination would occur. However, the PVC pipe mass loss was only 23 wt% as opposed to 61 wt% at the 400 °C condition resulting in a more structurally intact plastic after degradation (Fig. S2†).

Despite structural similarities for the vinyl pipes, benzene was only detected in water exposed to the CPVC pipe at a fraction of the amount it was found in water exposed to the PVC material (Fig. 3). This difference may be explained by the additional chlorine atoms present on the CPVC polymer chains resulting in a greater number of chlorine substituted aromatic products when CPVC was thermally degraded.<sup>34</sup> A previous CPVC pyrolysis study found significantly more

Compared to vinyl pipes, greater BTEX concentrations were found as the degradation temperature increased for the HDPE and PEX materials (Fig. 3). The onset degradation temperature for both of these materials exceeds 430 °C (Table 1) which can explain why little to no BTEX leaching was observed at 200 °C and 300 °C. The increase in leaching between 300 °C and 400 °C can be attributed to the plastic pipes beginning to degrade and generating BTEX and other compounds. Elevated temperatures lead to the polymer chain undergoing chain scission resulting in the formation of alkenes.<sup>32</sup> As the pipe is exposed to greater temperatures, the amount of polymer chain scission that occurs also increases. The increase in scission results in more alkene fragments that may subsequently undergo aromatization. A similar pattern was observed in a study of HDPE combustion by others, in which the benzene concentration in the air increased as the combustion temperatures increased from 500 °C to 800 °C.<sup>51</sup> However, the increase in potential BTEX formation does not necessarily indicate that this trend of increased leaching as a function of temperature will

continue.<sup>32</sup> Both the partitioning of BTEX into the air and mass loss are also increasing with system temperature, indicating that there may be an optimal degradation temperature for observing the maximum BTEX formation much like what was observed with the PVC at 300 °C.

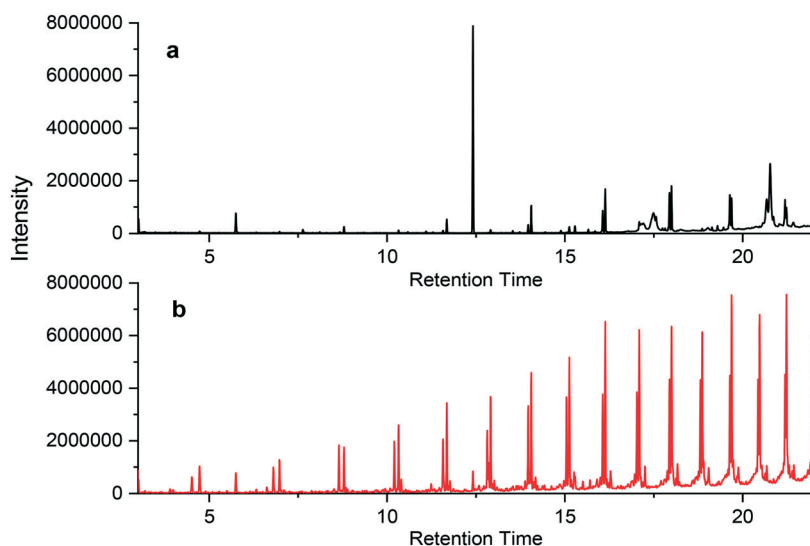
Fig. 4 Chromatographs of PEX-c-1a when (a) unburned and (b) burned at 400 °C, where samples were extracted in *n*-hexane. The internal standard is the peak at 5.8 minutes.

**Leaching promoted by hexane extraction.** As expected, a greater number of peaks were observed in the *n*-hexane extracts (32 to 134) compared to the water extracts (3 to 22) for all plastics (see example for PEX-c-1a in Fig. 4 and all other pipe types in Fig. S17–S26†). For the degraded PEX, HDPE, and PP pipes, between 100 to 134 unique compounds were leached into *n*-hexane, whereas for the degraded PVC and CPVC pipes between 30 to 41 compounds were leached (Fig. 4 and S17–S26†). While most compounds extracted from the new pipes were either straight chain or branched alkanes of varying lengths (Table S3†), thermal exposure led alkenes to represent the majority of compounds detected in the leachate (Table S5†). These aliphatic hydrocarbons are products of alkane hydrocarbon chain scission and are not typical drinking water contaminants. They have low aqueous solubility, which is why they were only detected in the hexane extracts and are generally less toxic than their cyclical or aromatic counterparts.<sup>56,57</sup>

Generally, both the magnitude of the peak and the number of compounds increased after burning the materials. However, one notable exception occurred for the PEX-c pipes; one peak (retention time of 12.5 min) for the unburned pipe was significantly larger than that of any of the burned peaks (Fig. 4 and S21†). This peak likely represented the compound, di-*tert*-butylbenzene, which has been shown to be an ultraviolet light or radiolysis degradation product of the antioxidant Irgafos 168®.<sup>58,59</sup> This compound was only observed in the leachate of the PEX-c materials, in which the crosslinking occurs using beta irradiation. This may explain why the magnitude of this degradation product was so large.<sup>60</sup> This peak decreased substantially in the burned plastic extract (Fig. 4 and S21†), indicating it may have been thermally decomposed.
