Cite this: *Environ. Sci.: Water Res. Technol.*, 2015, 1, 787

Decontaminating chemically contaminated residential premise plumbing systems by flushing†

K. S. Casteloes,^a R. H. Brazeau^b and A. J. Whelton^{*a}

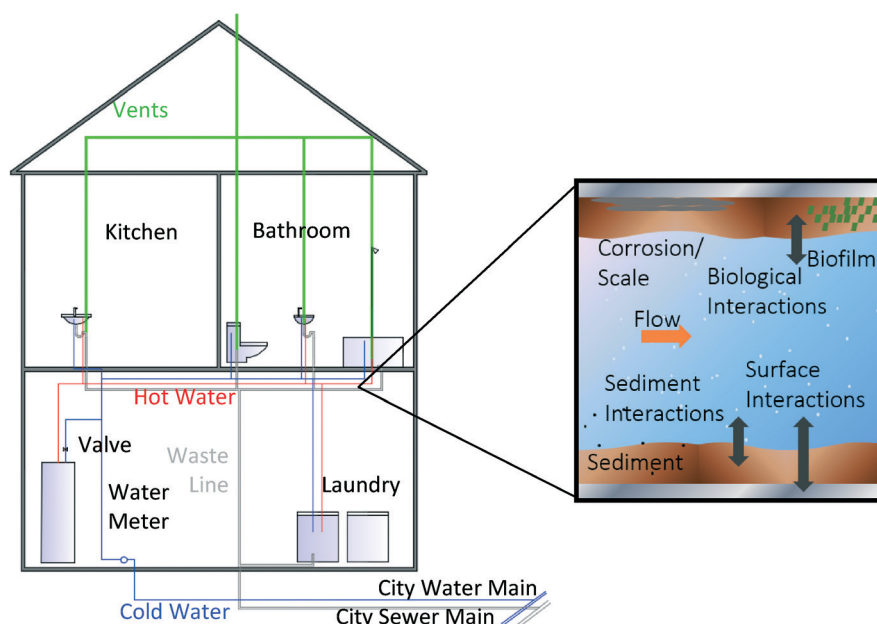
Fig. 1 Example premise plumbing layout for a residential home with a standard water heater that does not re-circulate.

biofilm, and contaminant properties. Fig. 1 shows a typical trunk and branch premise plumbing design for a two story residential home with traditional storage water heating. The average single family U.S. residence has about 280 feet (ft) [85.3 meters (m)] of plumbing pipe (140 ft, or 42.7 m, each for hot and cold water) and uses an average of 180 gallons per day (gpd) [681.3 liters per day (L per day)].¹⁰ Cold and hot water supply pipes generally range from 0.25 in [0.64 cm] to 0.75 in [1.9 cm] diameter in residences. Copper is the most common metal plumbing pipe used for cold and hot potable water supply, though a variety of plastic pipes are increasingly being installed (Table 1).¹¹

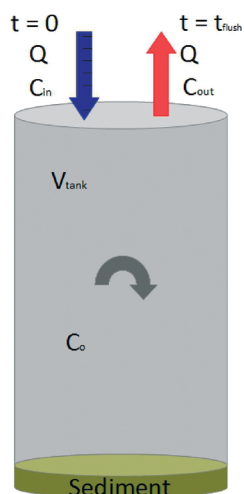
Fig. 2 Water heater control volume.

where C is the concentration leaving the system (equal to the concentration within the water heater), C_{in} is the concentration entering the water heater, C_0 is the initial concentration within the water heater, Q is the flow rate, V is the tank volume, M is mass, and t is time. A diagram of the water heater model is displayed in Fig. 2.

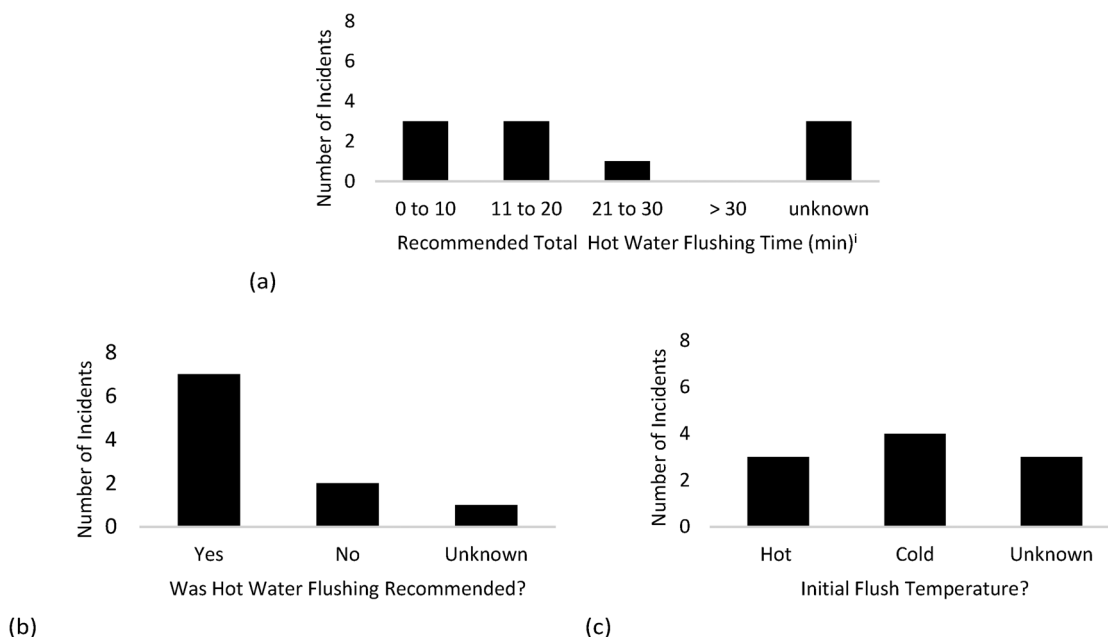
Fig. 3 Comparison of premise plumbing system flushing guidance for ten incidents. (a) Recommended hot water total flushing time, (b) number of incidents where residents were explicitly directed to flush hot water, (c) recommended water temperature for the initial flush. Incidents represent those events presented in Table 4. ⁱWest Virginia septic tank flushing procedure not included.

odor should be used as an end point, and if indoor ventilation precautions were issued and the specificity of those precautions (Fig. 3 and Table 4). Additionally, several premise plumbing flushing protocols did not seem to include the time needed to remove contaminated water from residential

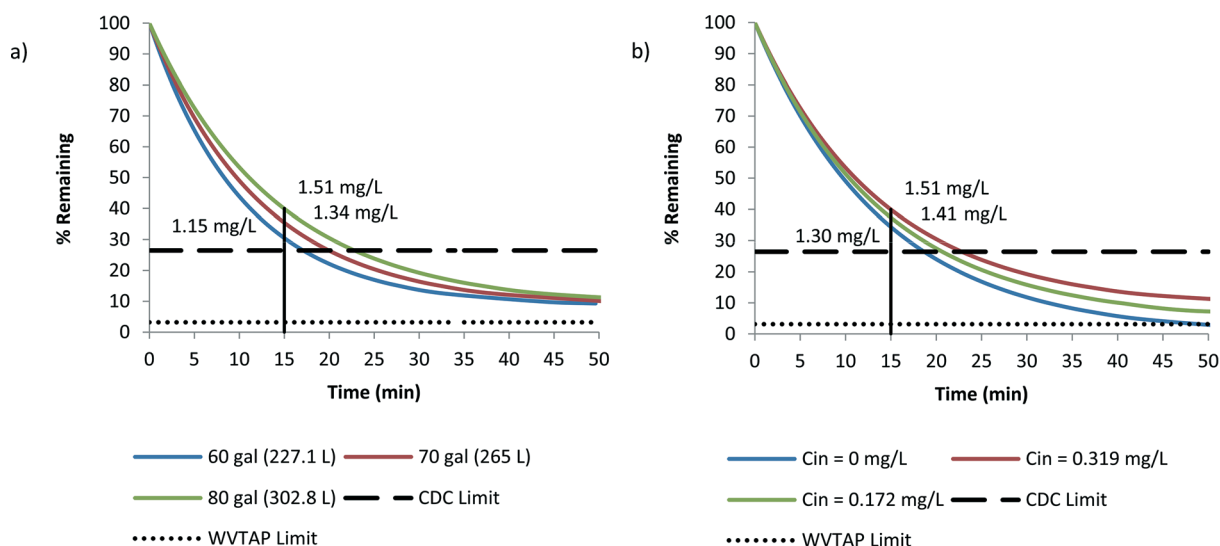
Fig. 4 West Virginia example: new two story single family home with water saving fixtures, initial 4-MCHM concentration of 3.773 mg L^{-1} . (a) with tank volume 60–80 gallons [227.1–302.8 liters] and influent concentration 0.319 mg L^{-1} , (b) with tank volume of 80 gallons [302.8 liters] and variation of influent concentration 0– 0.319 mg L^{-1} . CDC and WVTAP health based screening levels were 1 mg L^{-1} and 0.120 mg L^{-1} .

concentration, storage tank volume, and flow rate were responsible for these exceedances (Fig. 4).

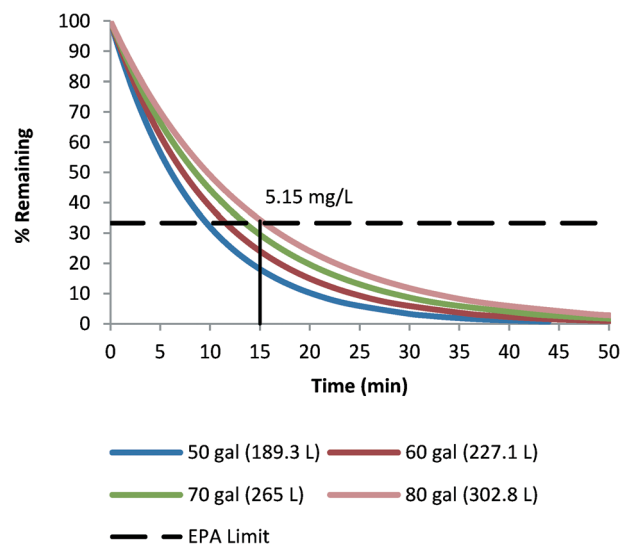
Fig. 5 Montana example: new two story single family home with water saving fixtures, initial benzene concentration of 15 µg L⁻¹, and EPA MCL of 5 µg L⁻¹.

In contrast to model results from the West Virginia incident, only 2 scenarios of 32 examined for the Montana crude oil contaminated water incident resulted in benzene exceeding the drinking water health limit (Fig. 5). These Montana scenarios (one for the two story single family home and one for the manufactured home) involved buildings with water saving fixtures and the largest size water heater. A limitation of the Montana modeling effort was that no post-flushing premise drinking water quality test results were found to validate the model.
