Cite this: *Environ. Sci.: Water Res. Technol.*, 2015, **1**, 787

Decontaminating chemically contaminated residential premise plumbing systems by flushing[†]

K. S. Casteloes,^a R. H. Brazeau^b and A. J. Whelton^{*a}

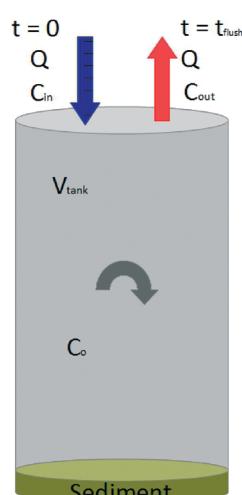
Fig. 2 Water heater control volume.

where C is the concentration leaving the system (equal to the concentration within the water heater), C_{in} is the concentration entering the water heater, C_0 is the initial concentration within the water heater, Q is the flow rate, V is the tank volume, M is mass, and t is time. A diagram of the water heater model is displayed in Fig. 2.

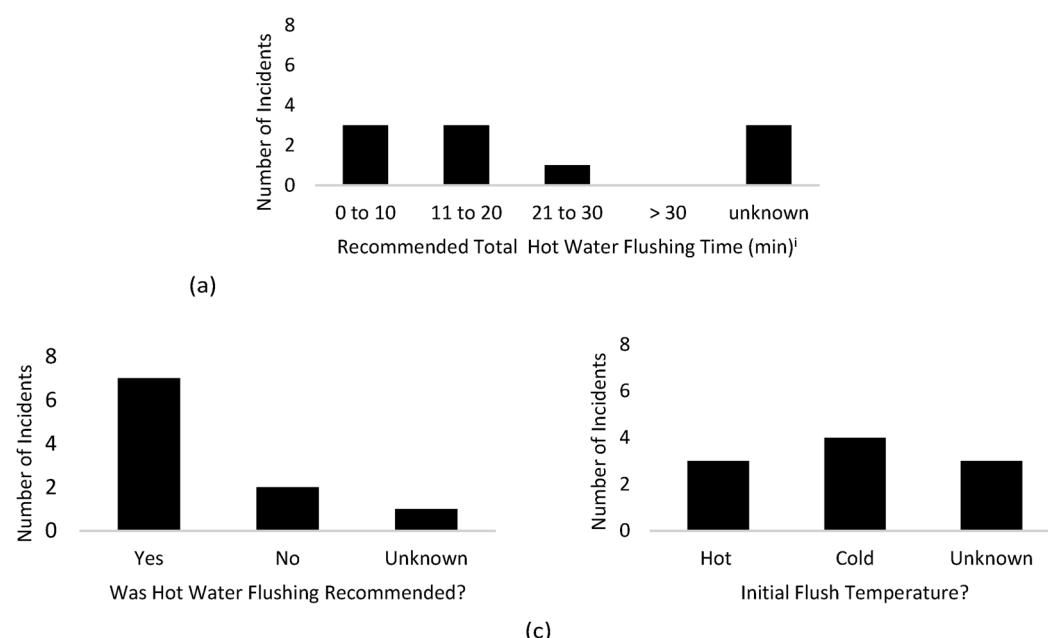
Fig. 3 Comparison of premise plumbing system flushing guidance for ten incidents. (a) Recommended hot water total flushing time, (b) number of incidents where residents were explicitly directed to flush hot water, (c) recommended water temperature for the initial flush. Incidents represent those events presented in Table 4. ⁱWest Virginia septic tank flushing procedure not included.

odor should be used as an end point, and if indoor ventilation precautions were issued and the specificity of those precautions (Fig. 3 and Table 4). Additionally, several premise plumbing flushing protocols did not seem to include the time needed to remove contaminated water from residential

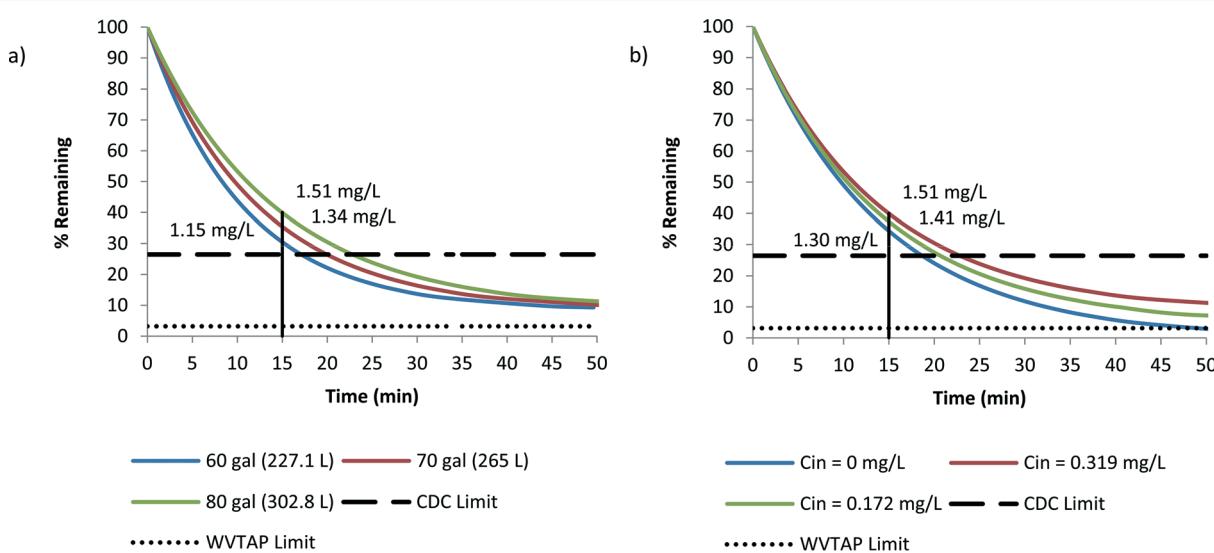
Fig. 4 West Virginia example: new two story single family home with water saving fixtures, initial 4-MCHM concentration of 3.773 mg L^{-1} . (a) with tank volume 60–80 gallons [227.1–302.8 liters] and influent concentration 0.319 mg L^{-1} , (b) with tank volume of 80 gallons [302.8 liters] and variation of influent concentration $0\text{--}0.319 \text{ mg L}^{-1}$. CDC and WVTAP health based screening levels were 1 mg L^{-1} and 0.120 mg L^{-1} .

concentration, storage tank volume, and flow rate were responsible for these exceedances (Fig. 4).
