Cite this: *Environ. Sci.: Water Res. Technol.*, 2015, 1, 787

Decontaminating chemically contaminated residential premise plumbing systems by flushing†

K. S. Casteloes,^a R. H. Brazeau^b and A. J. Whelton^{*a}

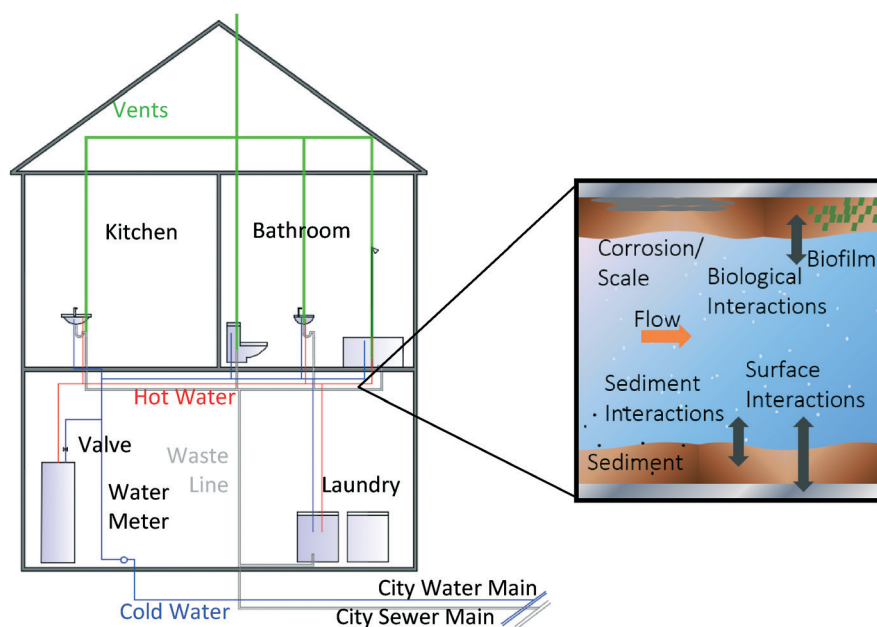
Fig. 1 Example premise plumbing layout for a residential home with a standard water heater that does not re-circulate.

biofilm, and contaminant properties. Fig. 1 shows a typical trunk and branch premise plumbing design for a two story residential home with traditional storage water heating. The average single family U.S. residence has about 280 feet (ft) [85.3 meters (m)] of plumbing pipe (140 ft, or 42.7 m, each for hot and cold water) and uses an average of 180 gallons per day (gpd) [681.3 liters per day (L per day)].¹⁰ Cold and hot water supply pipes generally range from 0.25 in [0.64 cm] to 0.75 in [1.9 cm] diameter in residences. Copper is the most common metal plumbing pipe used for cold and hot potable water supply, though a variety of plastic pipes are increasingly being installed (Table 1).¹¹

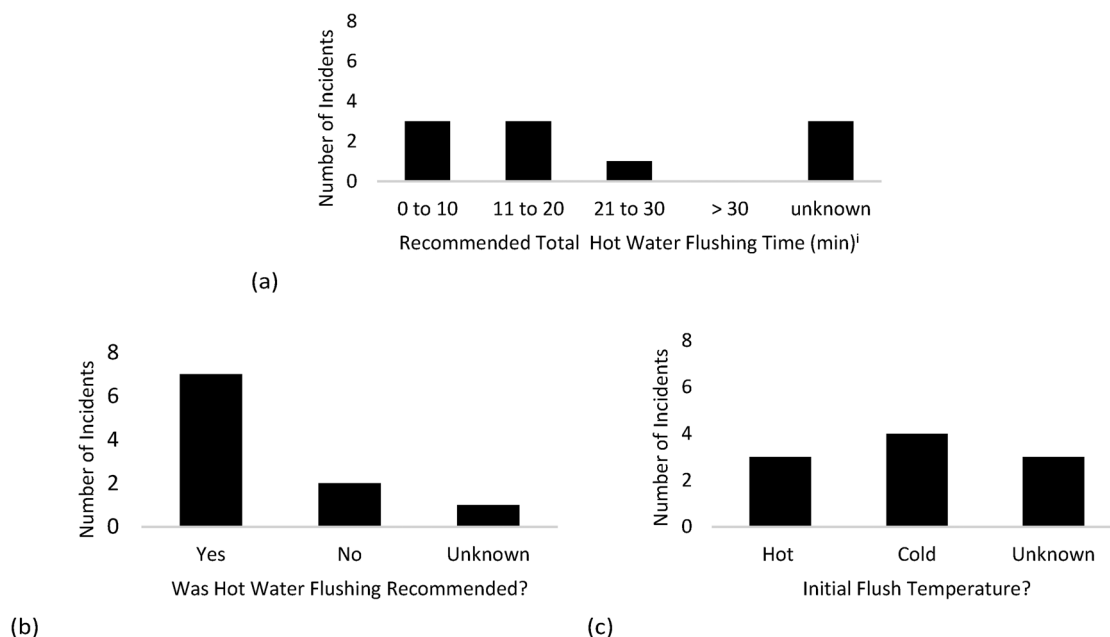
Fig. 3 Comparison of premise plumbing system flushing guidance for ten incidents. (a) Recommended hot water total flushing time, (b) number of incidents where residents were explicitly directed to flush hot water, (c) recommended water temperature for the initial flush. Incidents represent those events presented in Table 4. ⁱWest Virginia septic tank flushing procedure not included.

odor should be used as an end point, and if indoor ventilation precautions were issued and the specificity of those precautions (Fig. 3 and Table 4). Additionally, several premise plumbing flushing protocols did not seem to include the time needed to remove contaminated water from residential

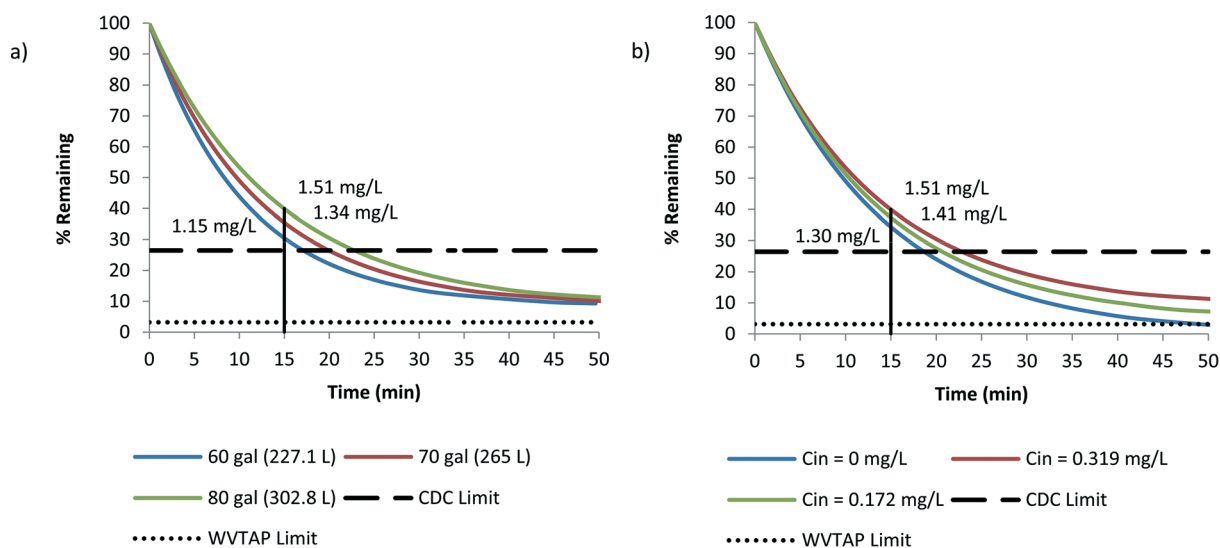
Fig. 4 West Virginia example: new two story single family home with water saving fixtures, initial 4-MCHM concentration of 3.773 mg L^{-1} . (a) with tank volume 60–80 gallons [227.1–302.8 liters] and influent concentration 0.319 mg L^{-1} , (b) with tank volume of 80 gallons [302.8 liters] and variation of influent concentration 0– 0.319 mg L^{-1} . CDC and WVTAP health based screening levels were 1 mg L^{-1} and 0.120 mg L^{-1} .

The water utility and State of West Virginia flushing guidelines were examined for the West Virginia incident. Because the total flushing durations of each protocol were the same, the impact of flushing on water heaters by both protocols can be discussed singularly. The model revealed several water heater flushing scenarios where the 4-MCHM concentration was not reduced below the CDC's health limit (Tables SI-2–SI-5†). Of the 120 scenarios modeled for the manufactured home, 14 did not reduce 4-MCHM concentrations below the CDC limit. For the two story single family home, 24 scenarios of 200 examined did not result in a 4-MCHM concentration below the CDC limit. The water heater influent

concentration, storage tank volume, and flow rate were responsible for these exceedances (Fig. 4).
