Cite this: *Environ. Sci.: Water Res. Technol.*, 2016, 2, 164

Survey of green building water systems reveals elevated water age and water quality concerns†

William J. Rhoads,* Amy Pruden and Marc A. Edwards

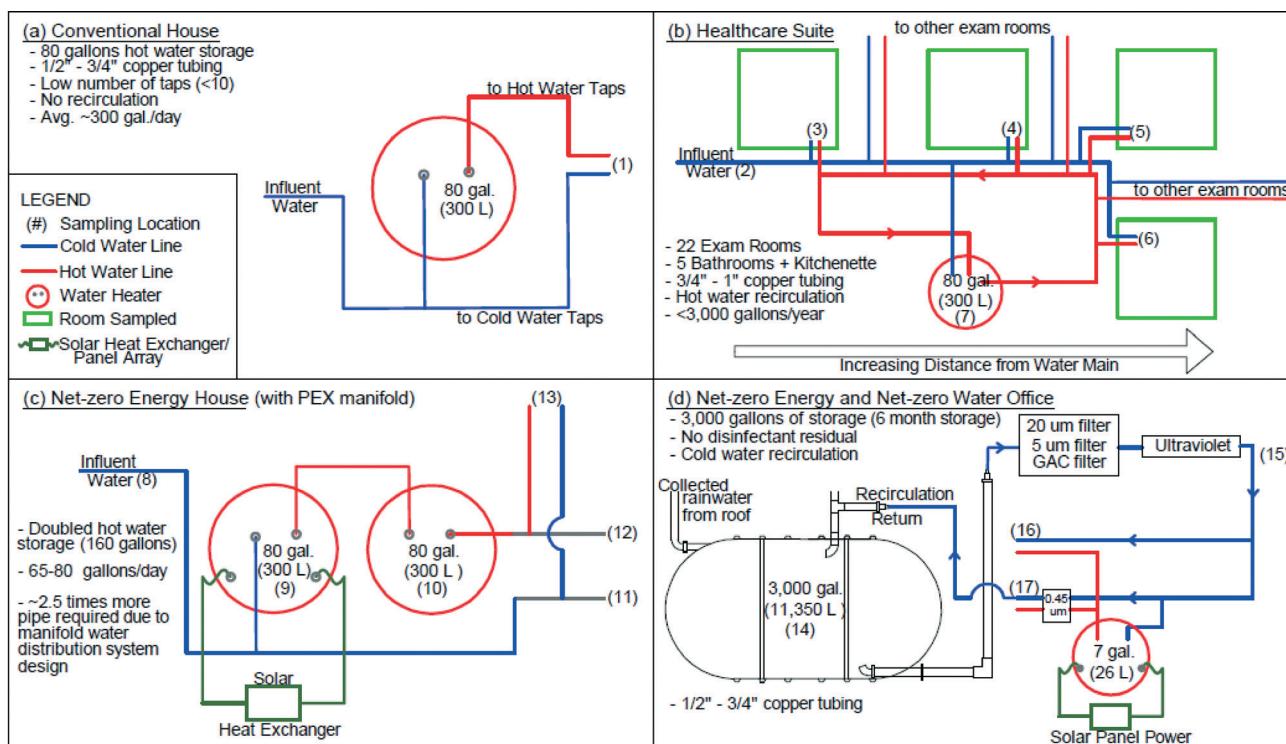
Fig. 1 Plumbing schematics and sampling locations for each field site.

Note: Numbers 1-17 in parentheses indicate sampling locations referred to in Table 2.

Four buildings with a cross-section of energy and water conservation strategies were surveyed and sampled to explore effects of green plumbing systems on water quality (Table 1). The buildings included a conventional house with no conservation features (Fig. 1a), a healthcare suite (Fig. 1b), a net-zero energy house (Fig. 1c), and a net-zero energy and net-zero water office building (Fig. 1d).

This study provided detailed documentation of the potable water systems in three innovative green buildings (Fig. 1). After reviewing the characteristics of each water system and closely examining trends in disinfectant residuals within the buildings, we provide an overview of microbial sampling from each building.

minutes of flushing was necessary to establish a chloramine residual similar to that present in the main distribution system (Fig. 2a). Taps at these locations are typically used for 15–30 seconds at a time; therefore, it is unlikely that a chloramine residual is ever present in portions of this plumbing system. Approximately 30 minutes of flushing was required at the net-zero energy house to establish a residual in the cold water system during the first site visit. In contrast, the conventional home had a residual of 0.71 mg L⁻¹ chlorine as Cl₂ in stagnant cold water. The water heaters at the net-zero house had <0.15 mg L⁻¹ chlorine as Cl₂ during a 20 minute flush due to the added storage volume and water age associated with the solar heater (Fig. 1c).
