Case study: the crude MCHM chemical spill investigation and recovery in West Virginia USA

Several recent chemical spills have caused large-scale drinking water contamination incidents in Canada and the USA. The study goal was to identify key decisions and actions critical to incident investigations using the 2014 crude MCHM chemical spill in West Virginia USA as a case study. Environmental testing records, scientific reports, government documents, and communication records were reviewed. Results showed that thorough characterization of the spilled liquid and impacted source water is critical to assessing potential public health risks, estimating chemical fate, and designing infrastructure decontamination procedures that can restore infrastructure use. Premise plumbing water testing was not carried-out by responders but testing conducted by other organizations identified the decontamination procedures issued by responders and drinking water screening levels were not adequate to protect public health. Rapid bench-scale tests should be considered to (1) examine water treatment breakdown products, (2) evaluate chemical sorption and leaching by infrastructure materials (*i.e.*, activat

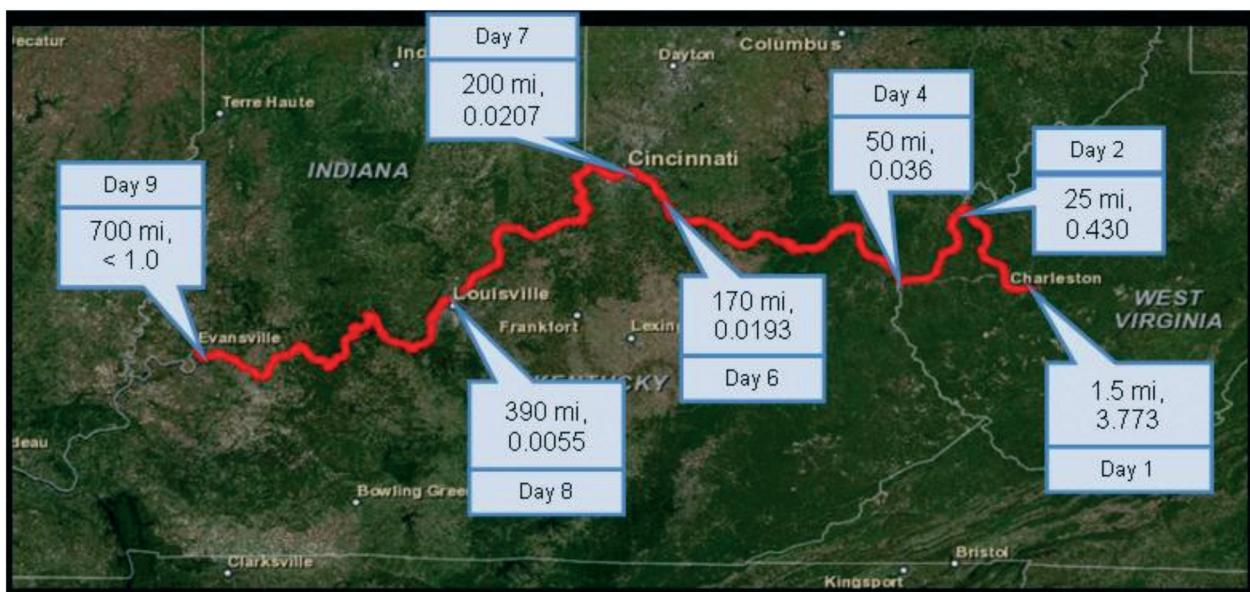
Fig. 1 Maximum known 4-MCHM concentration (ppm) in river water reported as distance downstream from the spill site starting January 9, 2015 as water flowed down the Elk River, into the Kanawha River, and Ohio River.

At the water intake. The day after the spill was discovered, RESP began analysing 4-MCHM concentrations in Elk River water at the KWWTP. 4-MCHM concentrations in river water decreased during the next several days (Fig. 1). On January 10, ATTY also conducted grab sampling near the KWWTP intake and found 0.57 ppm 4-MCHM,³⁴ a concentration much lower than the 3.3 ppm detected at the KWWTP that same day. This difference is likely due to the ATTY collecting grab samples at the surface of the Elk River whereas RESP water originated from lower in the water column where the intake structure was installed. This difference highlights the importance of consistent water sampling and how methodology can impact the data reported.

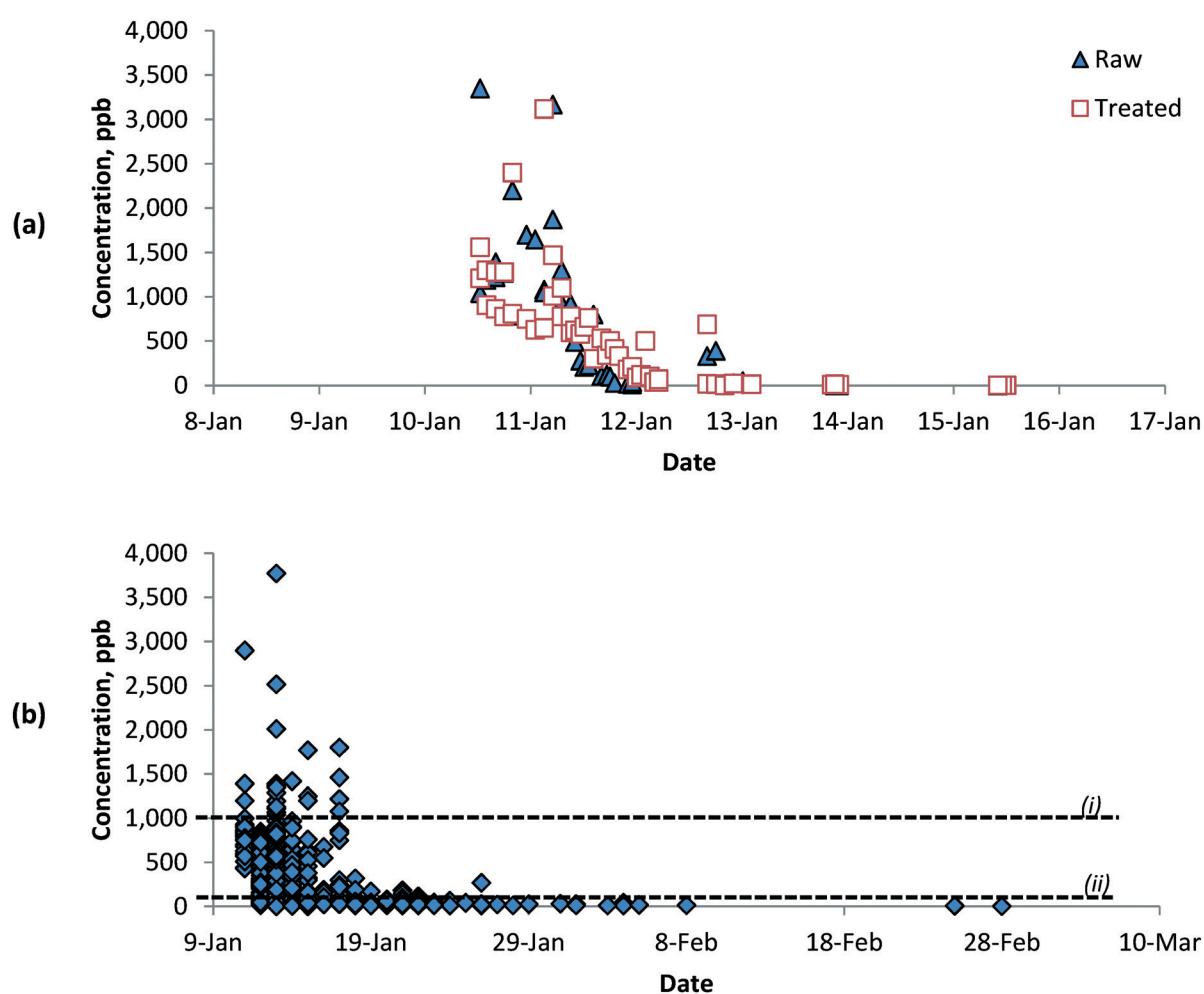
Fig. 2 4-MCHM concentration at the (a) Kanawha Valley water treatment plant and (b) water distribution system. The dotted lines represent the (i) CDC's 1 ppm health-based 4-MCHM screening level, and (ii) WVTAP's health-based 4-MCHM 0.120 ppm screening level. Reproduced from Whelton *et al.*¹⁹

Water treatment plant. The day after the spill, RESP began monitoring finished drinking water exiting the Charleston KWWTP for 4-MCHM (Fig. 2), and the highest 4-MCHM concentration detected in the finished water leaving the treatment plant was 3.35 ppm. After Freedom Industries, Inc. disclosed that stripped PPH was present in the tank liquid, archived water samples were re-analysed and 10 ppb PPH and 11 ppb DiPPH were detected. No additional testing for these compounds was conducted and the reasoning for this decision was not found.

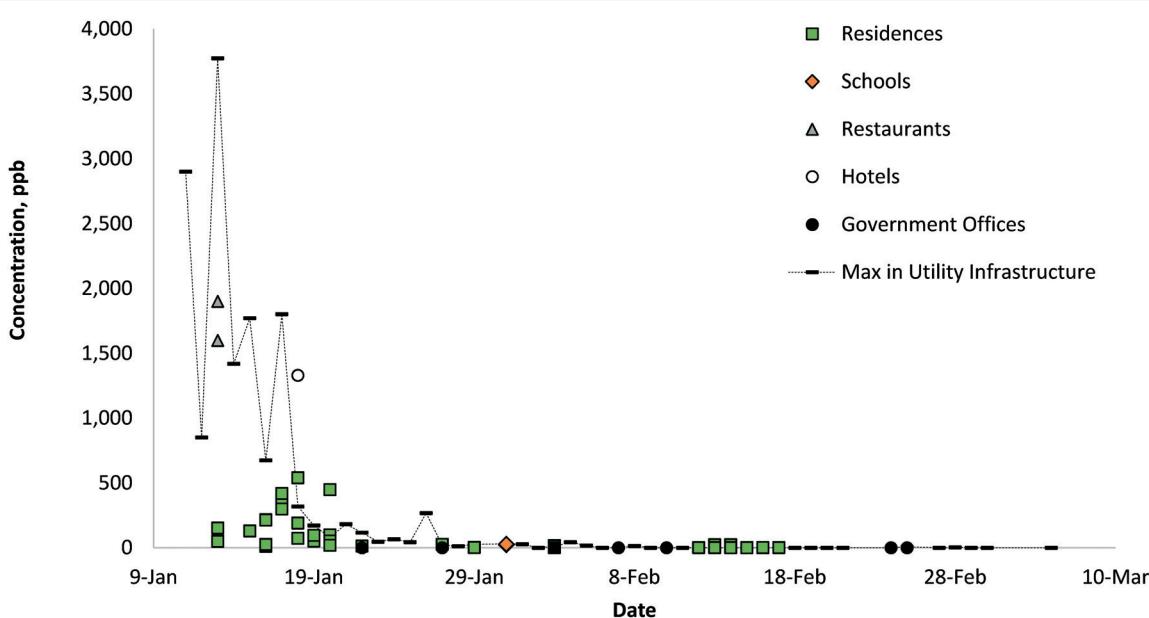
Fig. 3 4-MCHM concentrations in premise plumbing systems compared to the maximum concentration detected in the water utility infrastructure, January 9 through March 6, 2014. Non-detectable results not shown; building plumbing system flushing was authorized by WVAW on January 13 and the last zone was authorized for flushing on January 18; concentrations in USGS offices (January 22 through February 25) were reported as estimates due to matrix interference in analysed water samples; the 14 day and 28 day health based drinking water screening levels for 4-MCHM established by CDC and WVTAP were 1 ppm and 0.120 ppm, respectively.

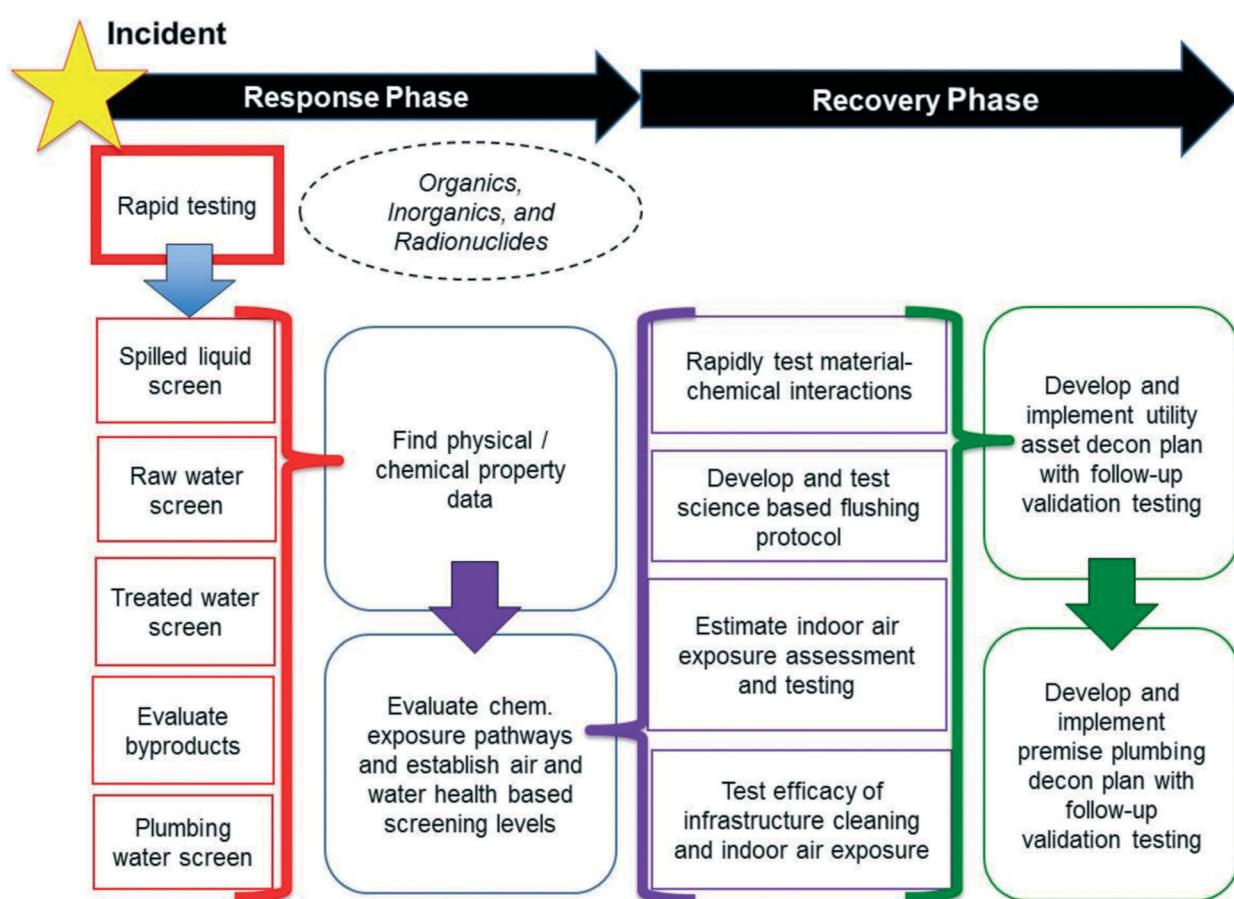
Fig. 5 Stepwise approach for investigating large-scale drinking water chemical contamination incidents.
