Cite this: *Environ. Sci.: Water Res. Technol.*, 2017, 3, 312

Case study: the crude MCHM chemical spill investigation and recovery in West Virginia USA

A. J. Whelton,^{*a} L. McMillan,^b C. L.-R. Novy,^b K. D. White^c and X. Huang^a

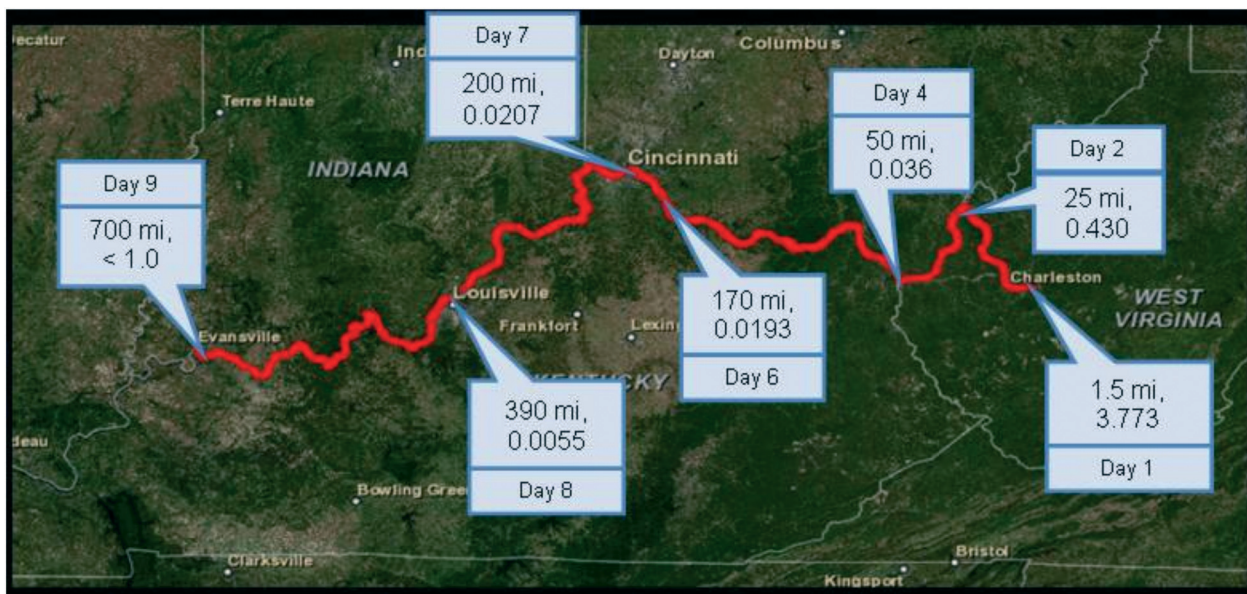
Fig. 1 Maximum known 4-MCHM concentration (ppm) in river water reported as distance downstream from the spill site starting January 9, 2015 as water flowed down the Elk River, into the Kanawha River, and Ohio River.

At the water intake. The day after the spill was discovered, RESP began analysing 4-MCHM concentrations in Elk River water at the KVVWTP. 4-MCHM concentrations in river water decreased during the next several days (Fig. 1). On January 10, ATTY also conducted grab sampling near the KVVWTP intake and found 0.57 ppm 4-MCHM,³⁴ a concentration much lower than the 3.3 ppm detected at the KVVWTP that same day. This difference is likely due to the ATTY collecting grab samples at the surface of the Elk River whereas RESP water originated from lower in the water column where the intake structure was installed. This difference highlights the importance of consistent water sampling and how methodology can impact the data reported.

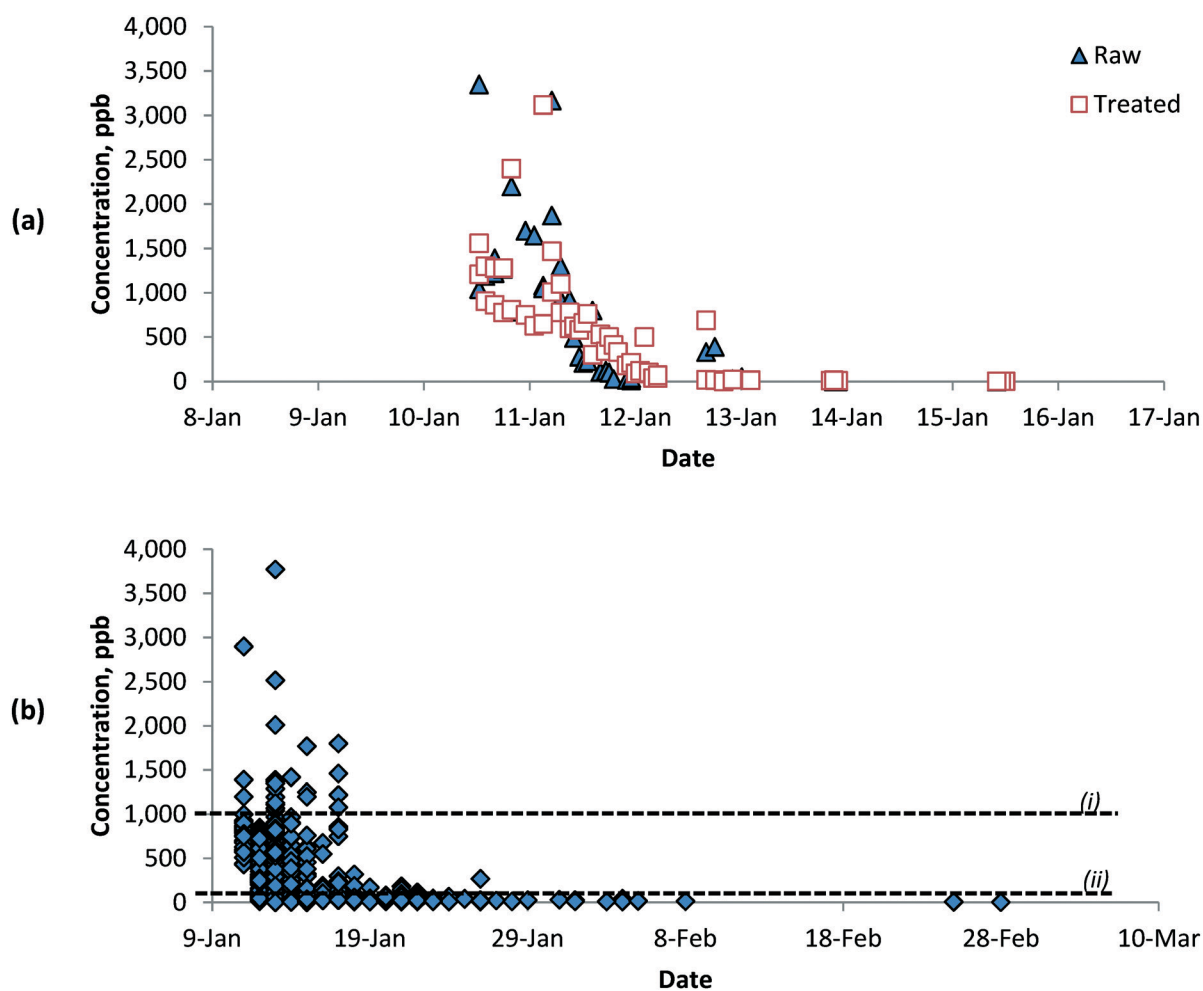
Fig. 2 4-MCHM concentration at the (a) Kanawha Valley water treatment plant and (b) water distribution system. The dotted lines represent the (i) CDC's 1 ppm health-based 4-MCHM screening level, and (ii) WVTAP's health-based 4-MCHM 0.120 ppm screening level. Reproduced from Whelton *et al.*¹⁹

Water treatment plant. The day after the spill, RESP began monitoring finished drinking water exiting the Charleston KVVWTP for 4-MCHM (Fig. 2), and the highest 4-MCHM concentration detected in the finished water leaving the treatment plant was 3.35 ppm. After Freedom Industries, Inc. disclosed that stripped PPH was present in the tank liquid, archived water samples were re-analysed and 10 ppb PPH and 11 ppb DiPPH were detected. No additional testing for these compounds was conducted and the reasoning for this decision was not found.

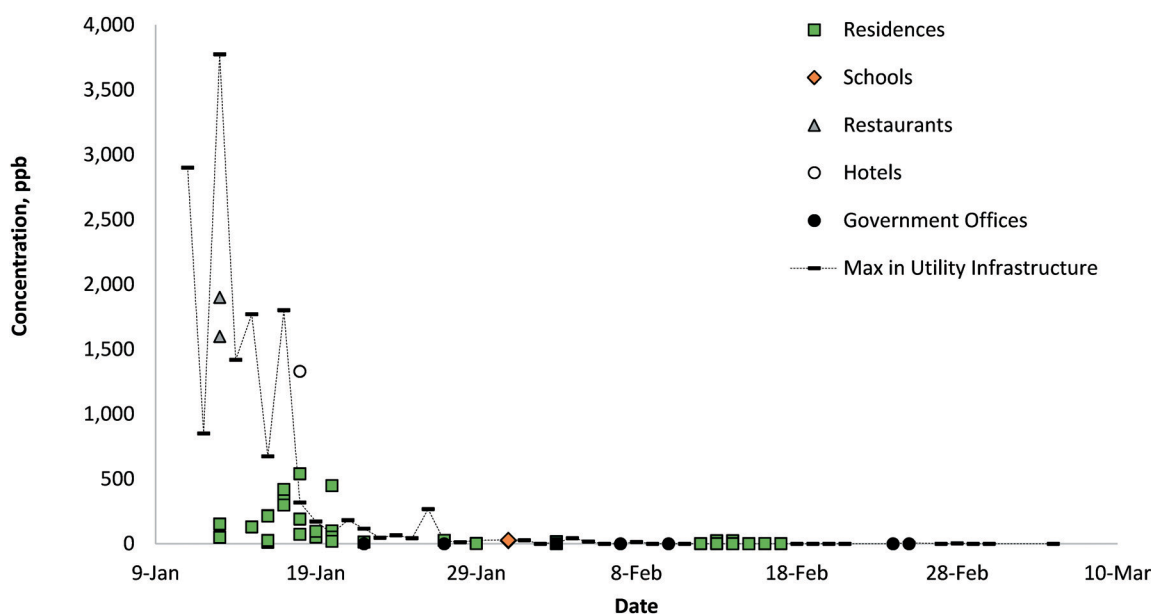
Fig. 3 4-MCHM concentrations in premise plumbing systems compared to the maximum concentration detected in the water utility infrastructure, January 9 through March 6, 2014. Non-detectable results not shown; building plumbing system flushing was authorized by WVAW on January 13 and the last zone was authorized for flushing on January 18; concentrations in USGS offices (January 22 through February 25) were reported as estimates due to matrix interference in analysed water samples; the 14 day and 28 day health based drinking water screening levels for 4-MCHM established by CDC and WVTAP were 1 ppm and 0.120 ppm, respectively.

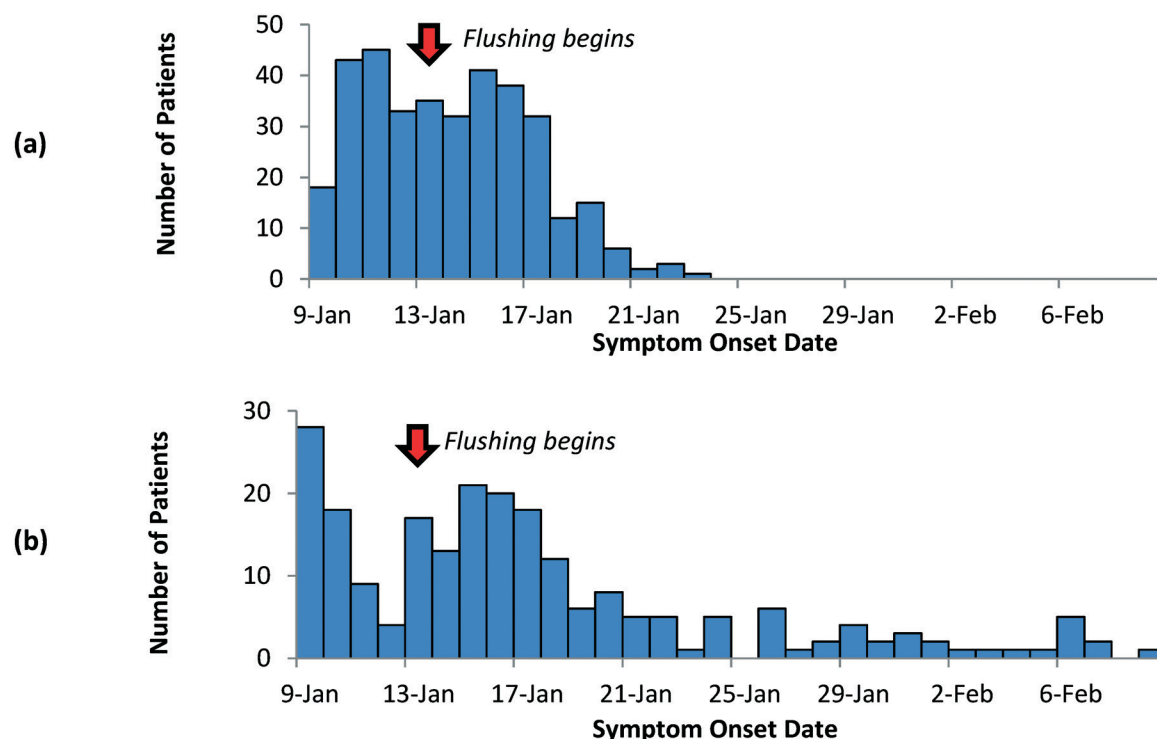
Fig. 4 (a) Visits to emergency departments reported by the U.S. Centers for Disease Control and West Virginia Bureau of Public Health (b) syndromic surveillance cases of clinically defined chemical exposure from January 9 through February 9, 2014. Records represent 10 emergency medical departments with 356 patients and 10 physician offices with 224 patients, respectively (source: open-access¹⁹).

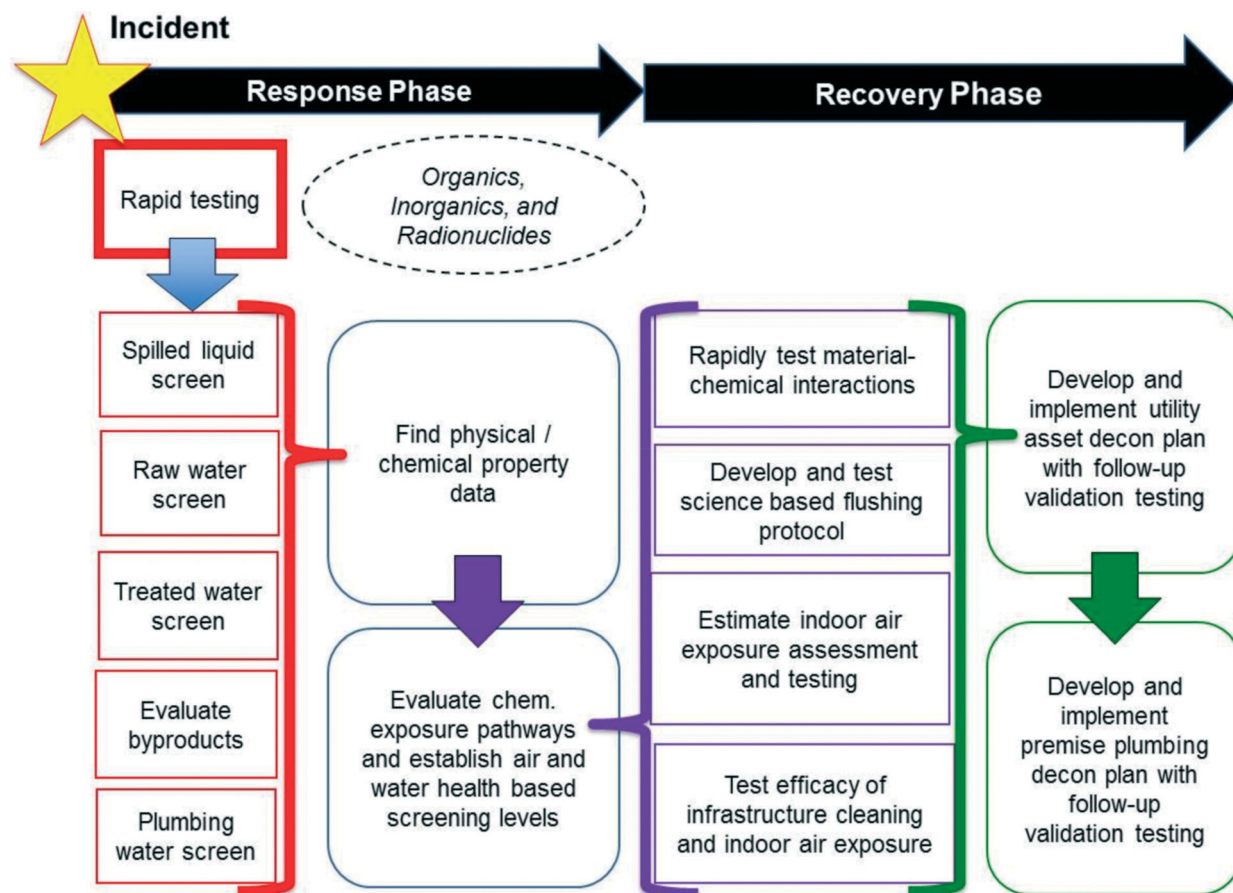
Fig. 5 Stepwise approach for investigating large-scale drinking water chemical contamination incidents.
