Case study: the crude MCHM chemical spill investigation and recovery in West Virginia USA

A. J. Whelton,^{*a} L. McMillan,^b C. L.-R. Novy,^b K. D. White^c and X. Huang^a

Several recent chemical spills have caused large-scale drinking water contamination incidents in Canada and the USA. The study goal was to identify key decisions and actions critical to incident investigations using the 2014 crude MCHM chemical spill in West Virginia USA as a case study. Environmental testing records, scientific reports, government documents, and communication records were reviewed. Results showed that thorough characterization of the spilled liquid and impacted source water is critical to assessing potential public health risks, estimating chemical fate, and designing infrastructure decontamination procedures that can restore infrastructure use. Premise plumbing water testing was not carried-out by responders but testing conducted by other organizations identified the decontamination procedures issued by responders and drinking water screening levels were not adequate to protect public health. Rapid bench-scale tests should be considered to (1) examine water treatment breakdown products, (2) ev

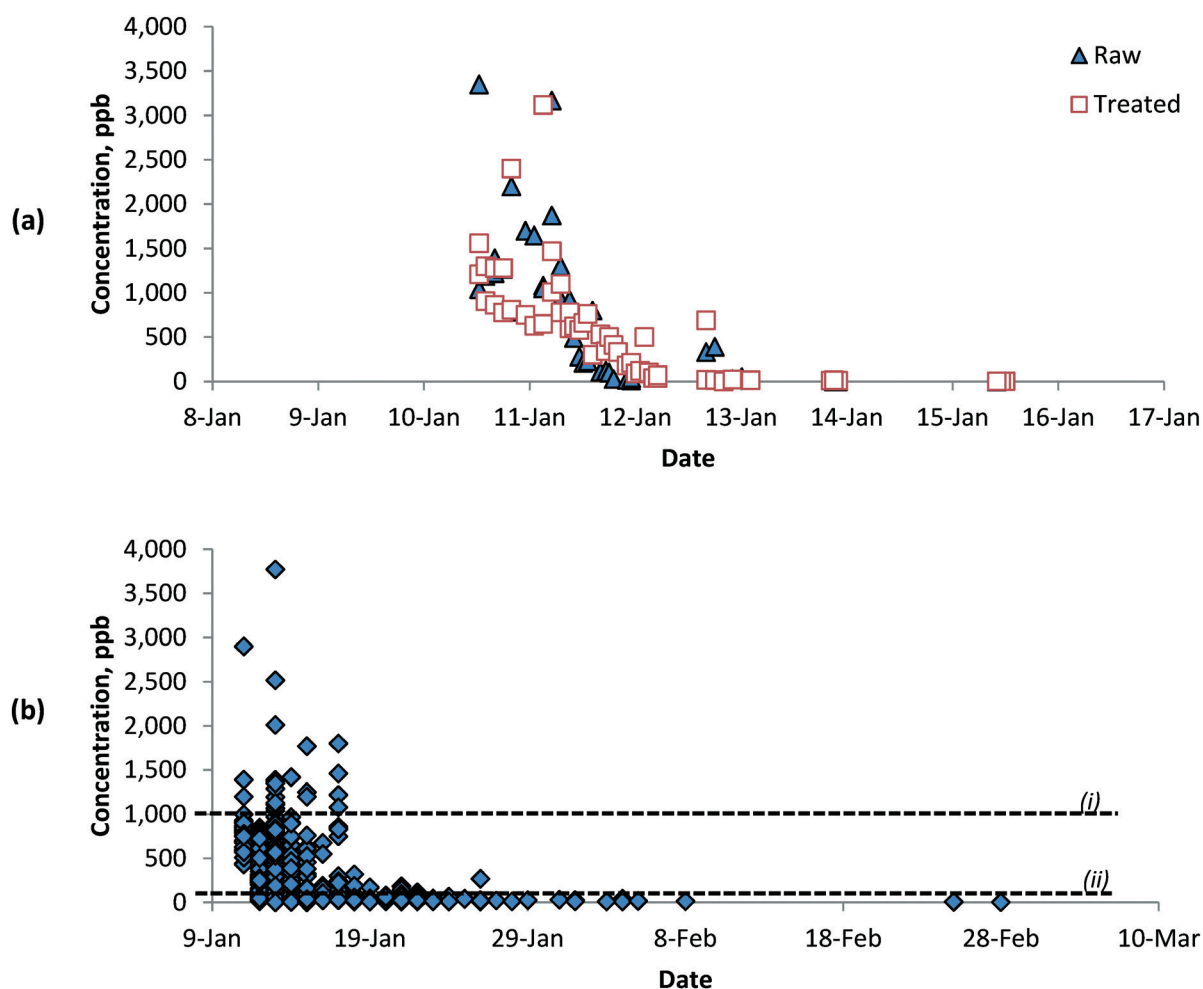
Fig. 2 4-MCHM concentration at the (a) Kanawha Valley water treatment plant and (b) water distribution system. The dotted lines represent the (i) CDC's 1 ppm health-based 4-MCHM screening level, and (ii) WVTAP's health-based 4-MCHM 0.120 ppm screening level. Reproduced from Whelton et al.¹⁹

Water treatment plant. The day after the spill, RESP began monitoring finished drinking water exiting the Charleston KVVWTP for 4-MCHM (Fig. 2), and the highest 4-MCHM concentration detected in the finished water leaving the treatment plant was 3.35 ppm. After Freedom Industries, Inc. disclosed that stripped PPH was present in the tank liquid, archived water samples were re-analysed and 10 ppb PPH and 11 ppb DiPPH were detected. No additional testing for these compounds was conducted and the reasoning for this decision was not found.

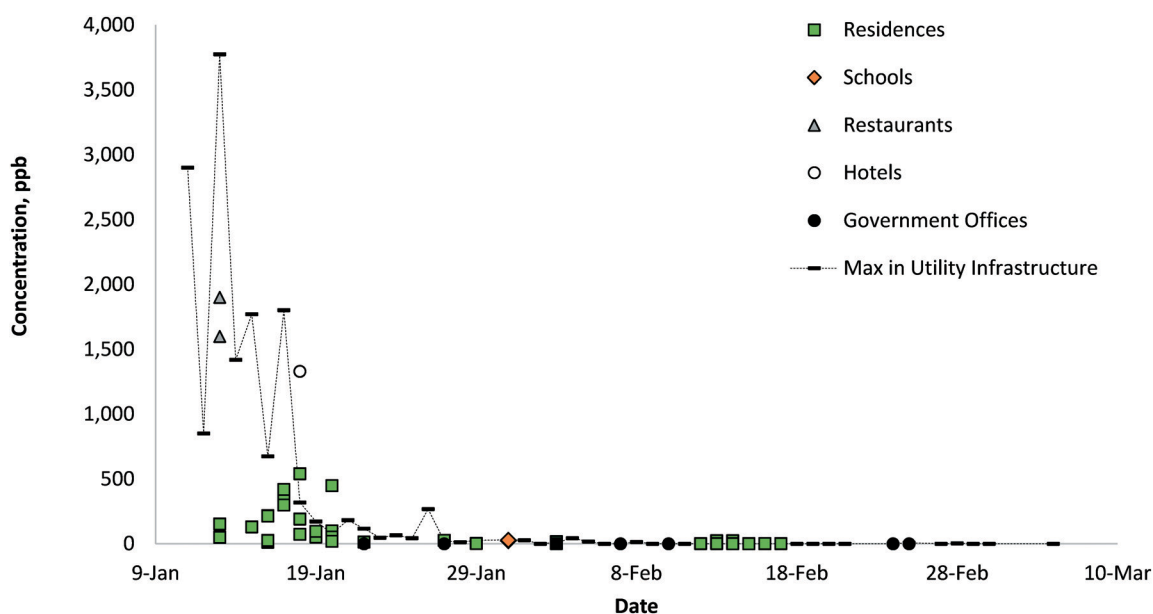
Fig. 3 4-MCHM concentrations in premise plumbing systems compared to the maximum concentration detected in the water utility infrastructure, January 9 through March 6, 2014. Non-detectable results not shown; building plumbing system flushing was authorized by WVAW on January 13 and the last zone was authorized for flushing on January 18; concentrations in USGS offices (January 22 through February 25) were reported as estimates due to matrix interference in analysed water samples; the 14 day and 28 day health based drinking water screening levels for 4-MCHM established by CDC and WVTAP were 1 ppm and 0.120 ppm, respectively.

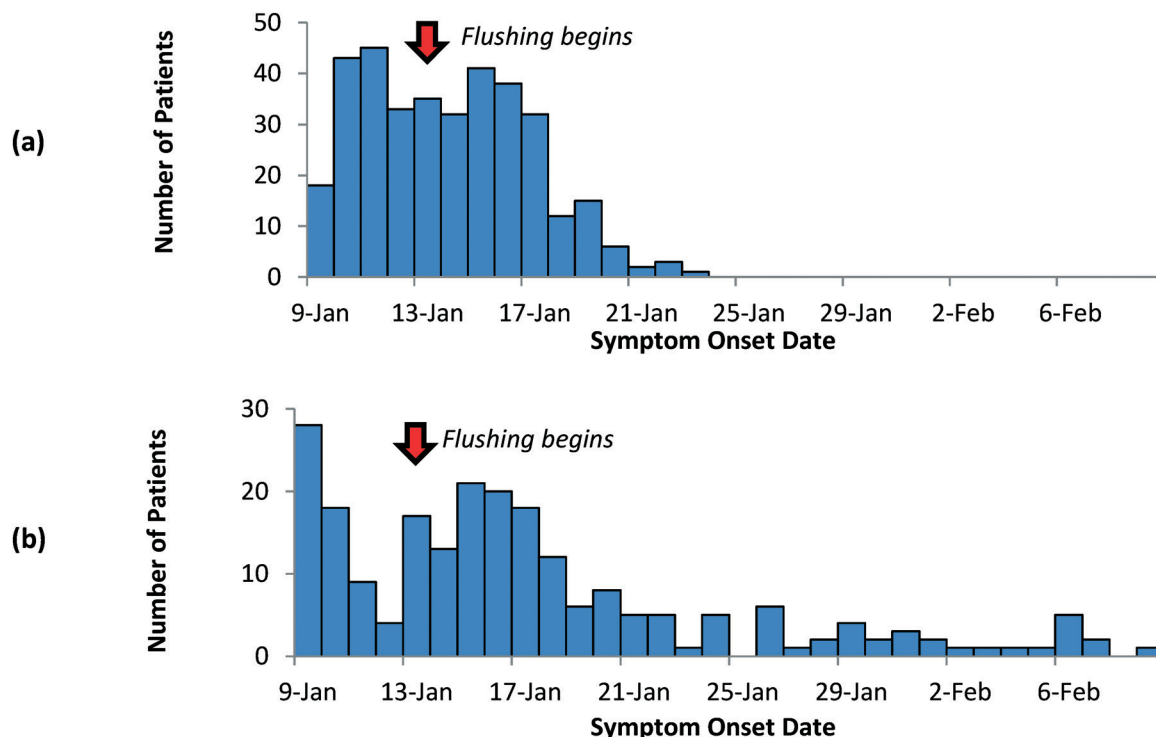
Fig. 4 (a) Visits to emergency departments reported by the U.S. Centers for Disease Control and West Virginia Bureau of Public Health (b) syndromic surveillance cases of clinically defined chemical exposure from January 9 through February 9, 2014. Records represent 10 emergency medical departments with 356 patients and 10 physician offices with 224 patients, respectively (source: open-access¹⁹).

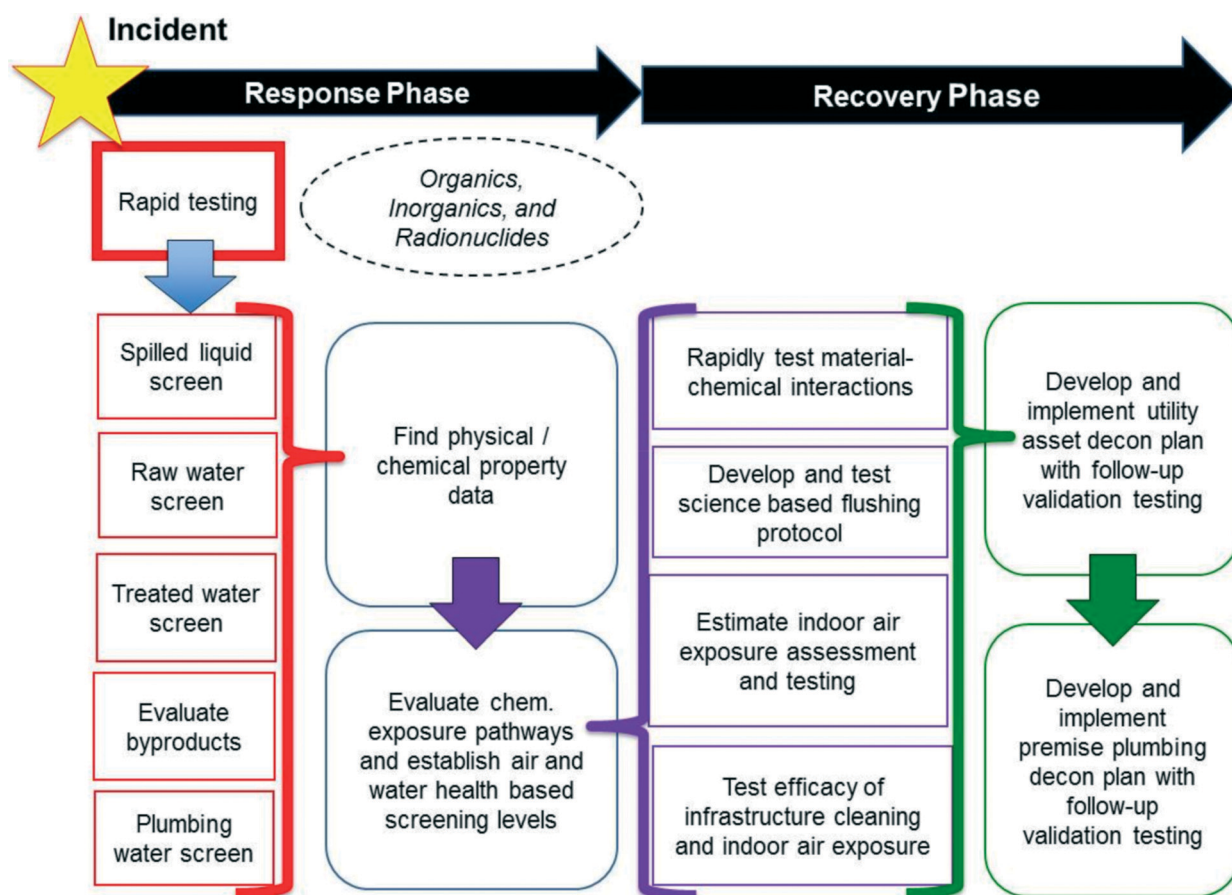
Fig. 5 Stepwise approach for investigating large-scale drinking water chemical contamination incidents.
