Cite this: *Environ. Sci.: Water Res. Technol.*, 2017, 3, 312

## Case study: the crude MCHM chemical spill investigation and recovery in West Virginia USA

Several recent chemical spills have caused large-scale drinking water contamination incidents in Canada and the USA. The study goal was to identify key decisions and actions critical to incident investigations using the 2014 crude MCHM chemical spill in West Virginia USA as a case study. Environmental testing records, scientific reports, government documents, and communication records were reviewed. Results showed that thorough characterization of the spilled liquid and impacted source water is critical to assessing potential public health risks, estimating chemical fate, and designing infrastructure decontamination procedures that can restore infrastructure use. Premise plumbing water testing was not carried-out by responders but testing conducted by other organizations identified the decontamination procedures issued by responders and drinking water screening levels were not adequate to protect public health. Rapid bench-scale tests should be considered to (1) examine water treatment breakdown products, (2) evaluate chemical

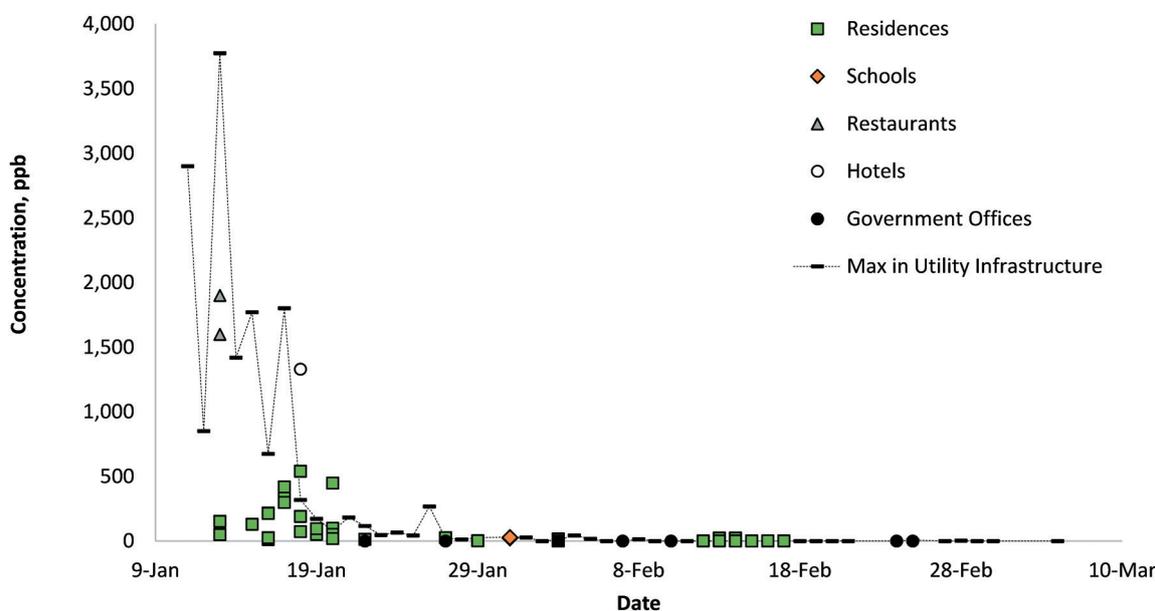
**Fig. 3** 4-MCHM concentrations in premise plumbing systems compared to the maximum concentration detected in the water utility infrastructure, January 9 through March 6, 2014. Non-detectable results not shown; building plumbing system flushing was authorized by WVAW on January 13 and the last zone was authorized for flushing on January 18; concentrations in USGS offices (January 22 through February 25) were reported as estimates due to matrix interference in analysed water samples; the 14 day and 28 day health based drinking water screening levels for 4-MCHM established by CDC and WVTAP were 1 ppm and 0.120 ppm, respectively.

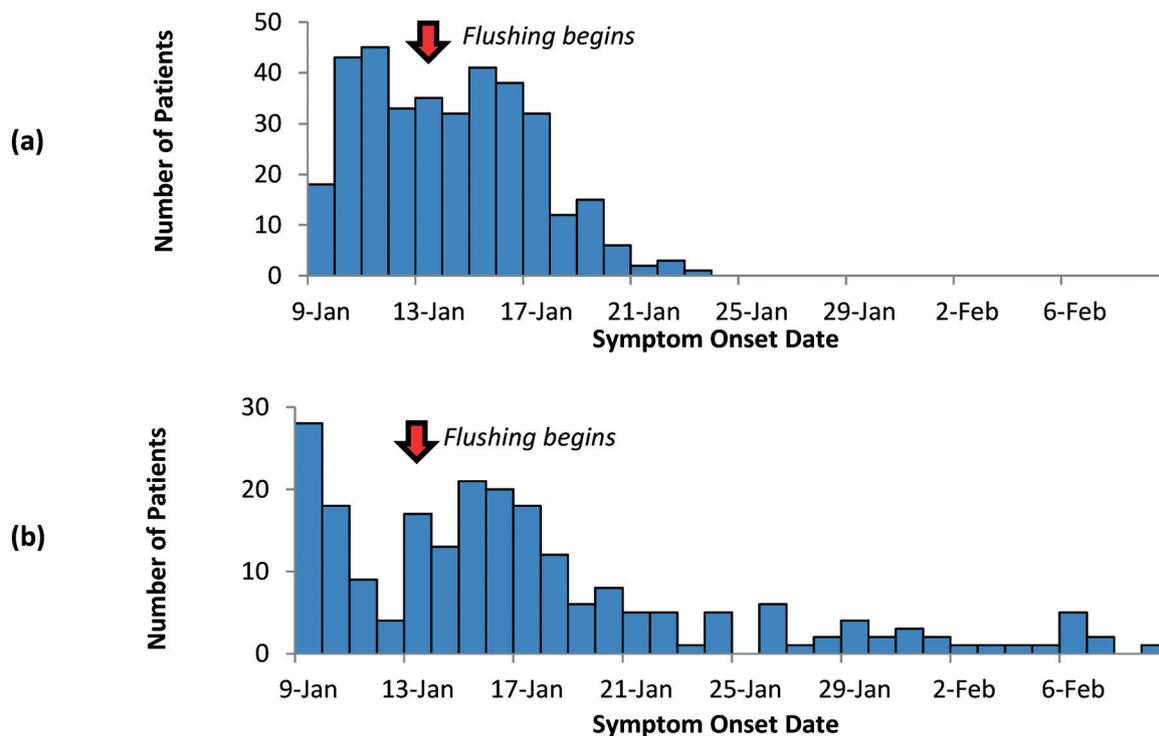
Fig. 4 (a) Visits to emergency departments reported by the U.S. Centers for Disease Control and West Virginia Bureau of Public Health (b) syndromic surveillance cases of clinically defined chemical exposure from January 9 through February 9, 2014. Records represent 10 emergency medical departments with 356 patients and 10 physician offices with 224 patients, respectively (source: open-access<sup>19</sup>).
