Cite this: *Environ. Sci.: Water Res. Technol.*, 2017, 3, 312

Case study: the crude MCHM chemical spill investigation and recovery in West Virginia USA

A. J. Whelton,^{*a} L. McMillan,^b C. L.-R. Novy,^b K. D. White^c and X. Huang^a

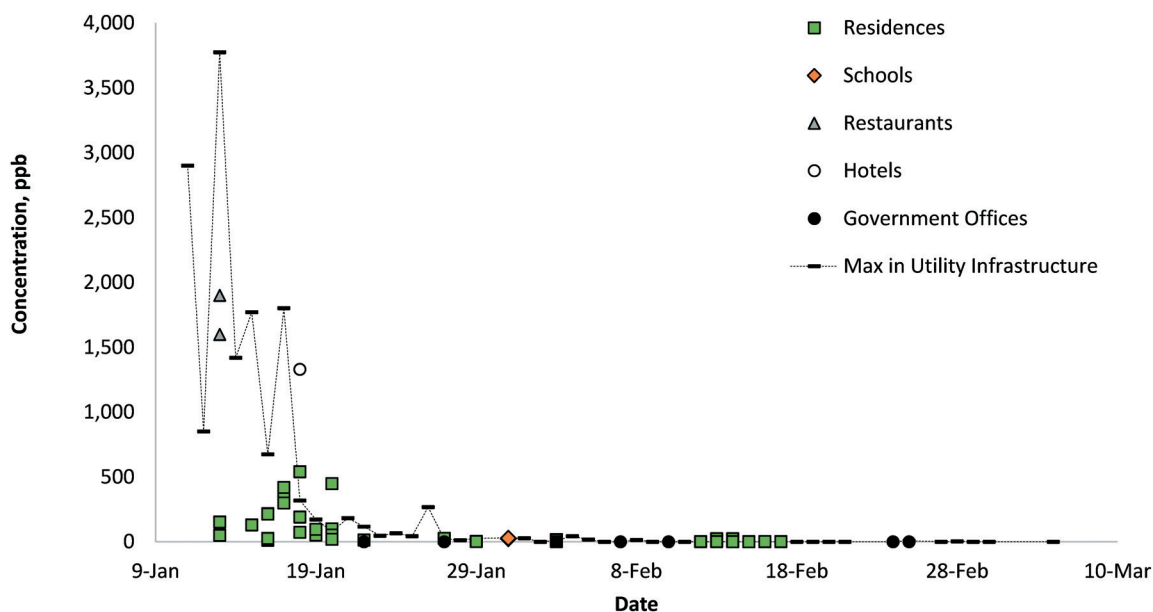
Fig. 3 4-MCHM concentrations in premise plumbing systems compared to the maximum concentration detected in the water utility infrastructure, January 9 through March 6, 2014. Non-detectable results not shown; building plumbing system flushing was authorized by WVAW on January 13 and the last zone was authorized for flushing on January 18; concentrations in USGS offices (January 22 through February 25) were reported as estimates due to matrix interference in analysed water samples; the 14 day and 28 day health based drinking water screening levels for 4-MCHM established by CDC and WVTAP were 1 ppm and 0.120 ppm, respectively.
