## Case study: the crude MCHM chemical spill investigation and recovery in West Virginia USA

Several recent chemical spills have caused large-scale drinking water contamination incidents in Canada and the USA. The study goal was to identify key decisions and actions critical to incident investigations using the 2014 crude MCHM chemical spill in West Virginia USA as a case study. Environmental testing records, scientific reports, government documents, and communication records were reviewed. Results showed that thorough characterization of the spilled liquid and impacted source water is critical to assessing potential public health risks, estimating chemical fate, and designing infrastructure decontamination procedures that can restore infrastructure use. Premise plumbing water testing was not carried-out by responders but testing conducted by other organizations identified the decontamination procedures issued by responders and drinking water screening levels were not adequate to protect public health. Rapid bench-scale tests should be considered to (1) examine water treatment breakdown products, (2) evaluate chemical sorption and leaching by infrastructure materials (*i.e.*, acti

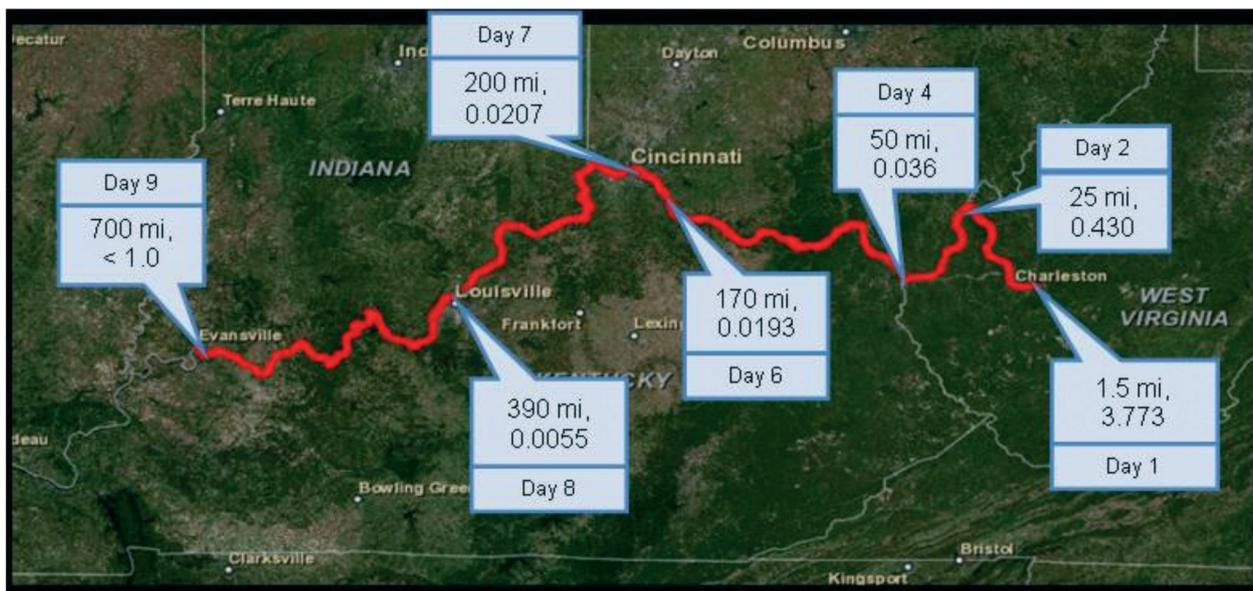
Fig. 1 Maximum known 4-MCHM concentration (ppm) in river water reported as distance downstream from the spill site starting January 9, 2015 as water flowed down the Elk River, into the Kanawha River, and Ohio River.

**At the water intake.** The day after the spill was discovered, RESP began analysing 4-MCHM concentrations in Elk River water at the KVVWTP. 4-MCHM concentrations in river water decreased during the next several days (Fig. 1). On January 10, ATTY also conducted grab sampling near the KVVWTP intake and found 0.57 ppm 4-MCHM,<sup>34</sup> a concentration much lower than the 3.3 ppm detected at the KVVWTP that same day. This difference is likely due to the ATTY collecting grab samples at the surface of the Elk River whereas RESP water originated from lower in the water column where the intake structure was installed. This difference highlights the importance of consistent water sampling and how methodology can impact the data reported.

Premise 4-MCHM concentrations decreased in the weeks following the do not use order (Fig. 1). One month after the spill, WVTAP conducted the last known in-home water testing effort in 11 residences and detected a maximum concentration of 6.1 ppb 4-MCHM. PPH concentrations in 11 homes were also measured by WVTAP one month after the spill and were not detected (0.5 ppb MDL).<sup>20</sup> Based on records reviewed, no other organization characterized premise water for PPH during the response. No record was found for any organization that characterized premise water for DiPPH.

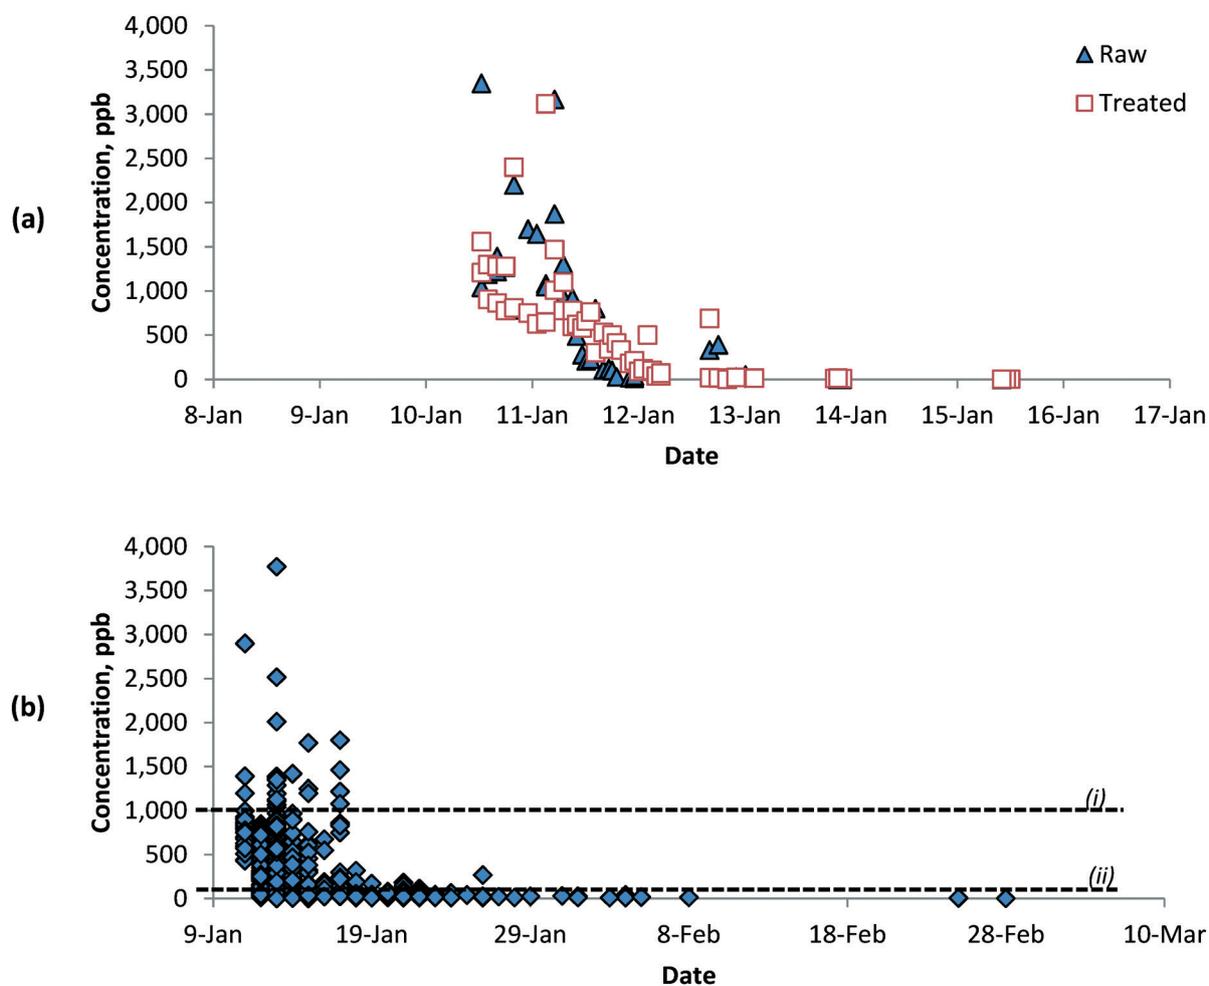
Fig. 2 4-MCHM concentration at the (a) Kanawha Valley water treatment plant and (b) water distribution system. The dotted lines represent the (i) CDC's 1 ppm health-based 4-MCHM screening level, and (ii) WVTAP's health-based 4-MCHM 0.120 ppm screening level. Reproduced from Whelton *et al.*<sup>19</sup>

**Water treatment plant.** The day after the spill, RESP began monitoring finished drinking water exiting the Charleston KVVWTP for 4-MCHM (Fig. 2), and the highest 4-MCHM concentration detected in the finished water leaving the treatment plant was 3.35 ppm. After Freedom Industries, Inc. disclosed that stripped PPH was present in the tank liquid, archived water samples were re-analysed and 10 ppb PPH and 11 ppb DiPPH were detected. No additional testing for these compounds was conducted and the reasoning for this decision was not found.

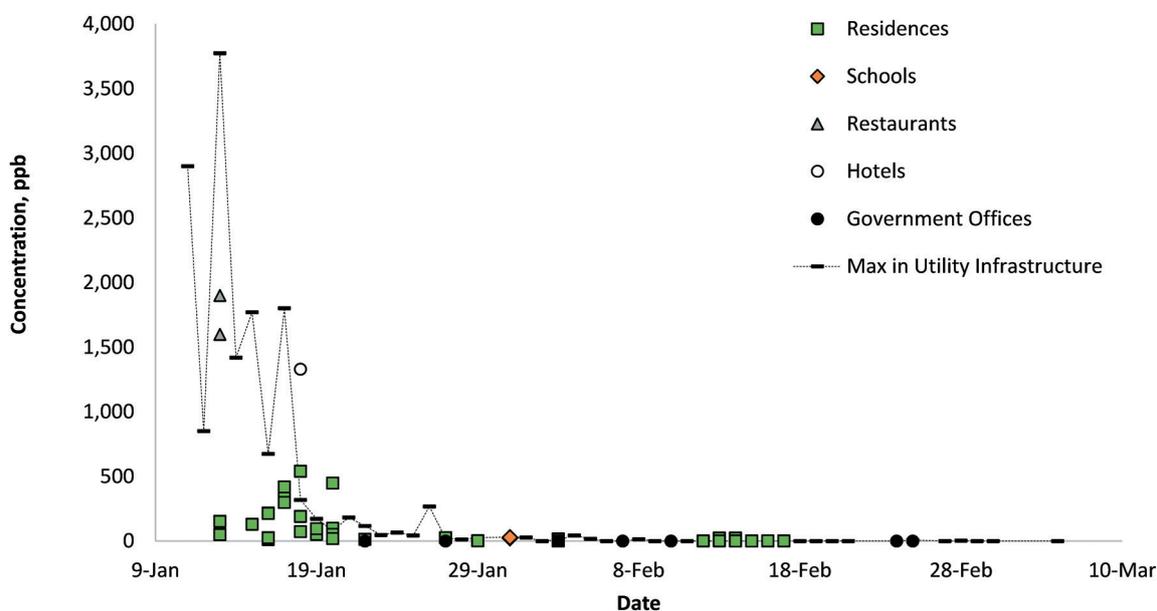
**Fig. 3** 4-MCHM concentrations in premise plumbing systems compared to the maximum concentration detected in the water utility infrastructure, January 9 through March 6, 2014. Non-detectable results not shown; building plumbing system flushing was authorized by WVAW on January 13 and the last zone was authorized for flushing on January 18; concentrations in USGS offices (January 22 through February 25) were reported as estimates due to matrix interference in analysed water samples; the 14 day and 28 day health based drinking water screening levels for 4-MCHM established by CDC and WVTAP were 1 ppm and 0.120 ppm, respectively.

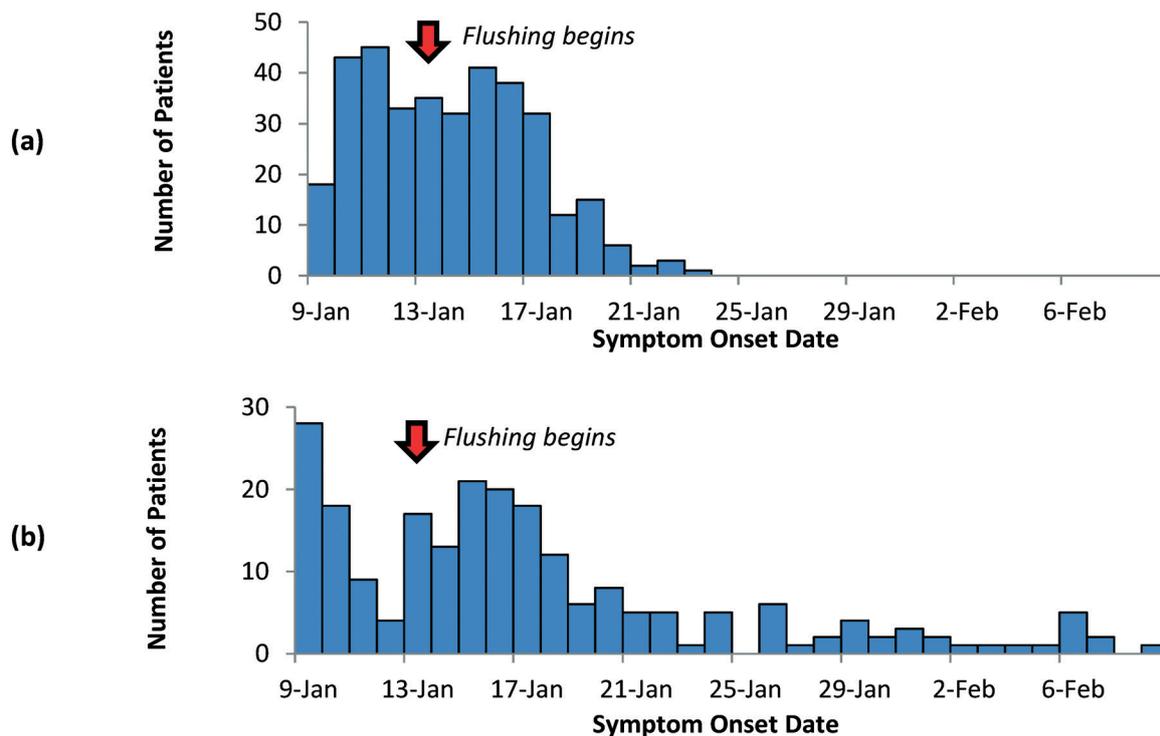
Fig. 4 (a) Visits to emergency departments reported by the U.S. Centers for Disease Control and West Virginia Bureau of Public Health (b) syndromic surveillance cases of clinically defined chemical exposure from January 9 through February 9, 2014. Records represent 10 emergency medical departments with 356 patients and 10 physician offices with 224 patients, respectively (source: open-access<sup>19</sup>).

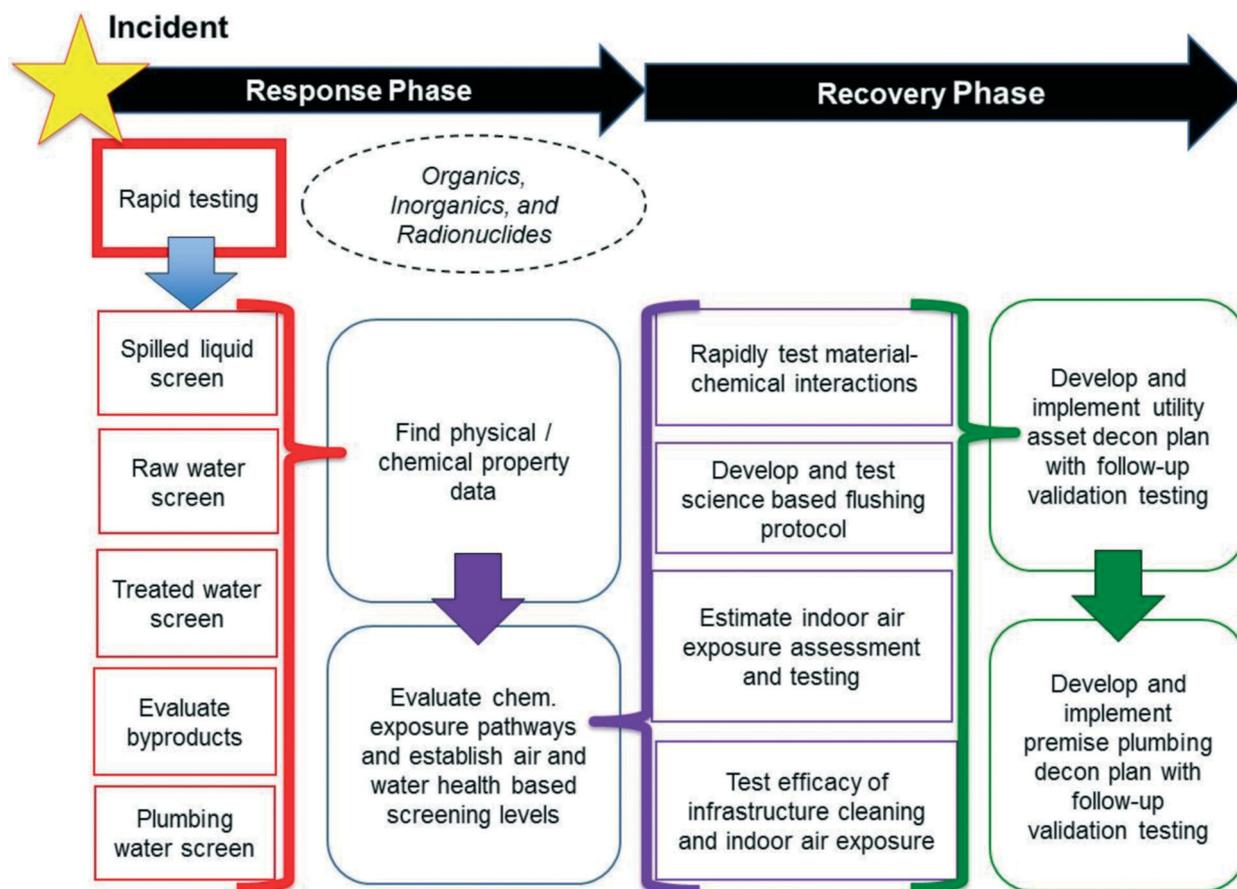
Fig. 5 Stepwise approach for investigating large-scale drinking water chemical contamination incidents.
