Effects of the degradation of methane sulfonic acid electrolyte on the collapse failure of Sn–Ag alloy solders for flip-chip interconnections

The present study investigates the degradation mechanism of a methanesulfonic acid (MSA) based electroplating bath used for the electrodeposition of Sn–Ag alloy solder bumps, and its effects on the microstructure of the solder and on the collapse failure of flip-chip solder bumps. To examine the degradation behavior of the electroplating bath, a degraded electrolyte is prepared by accelerated aging treatment. In the presence of dissolved oxygen and Ag⁺ ions in the electrolyte, the chemical oxidation of Sn²⁺ ions to Sn⁴⁺ ions and the precipitation of SnO₂ nanoparticles with a diameter below 100 nm are promoted by the reduction of Ag⁺. Under cathodic bias, colloidal SnO₂ particles are adsorbed on the surface of the Sn–Ag solder bumps *via* electrophoresis, and incorporated into the layer by the electrodeposition layer of Sn–Ag. The presence of oxide layer mainly composed of SnO₂ on the surface of the bumps significantly reduces the friction coefficient of the solder surface by hardening the electrodeposits and deteriorates the solderability of

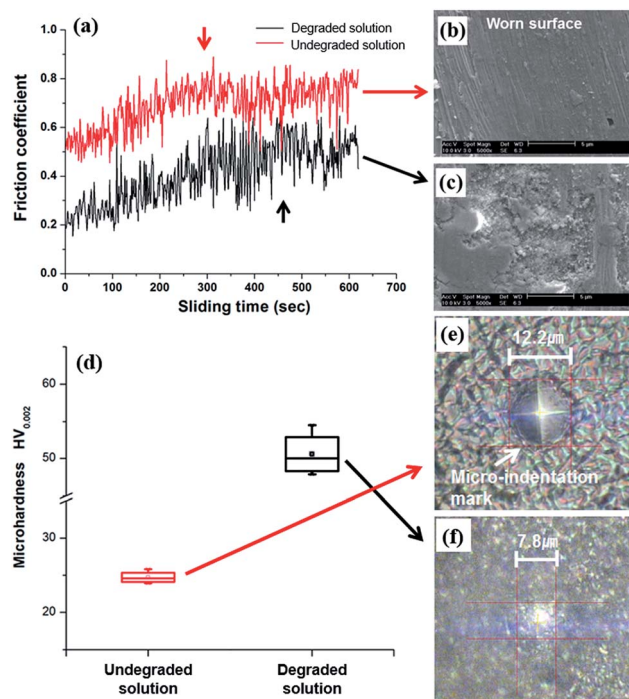
In addition to morphological changes, the mechanical properties of the solder bumps were also significantly affected by the degradation of the bath. Fig. 3 presents the results of the microscale friction, wear and hardness tests for the Sn–Ag alloy bumps prepared from solutions before and after degradation. As the bath was degraded, the coefficients of friction (COF) vs. sliding time curves show different tribological behavior (Fig. 3a). The frictional response of the sample formed from the undegraded bath showed an initial COF value of 0.5, and this value settled to 0.75 after 200 s. In contrast, the COF of the sample formed from the degraded bath was 0.2, and this value settled to 0.55 after 450 s. The tribological performance suggests that the degradation of the electrolyte can reduce the friction coefficient of the solder surface by hardening the electrodeposits. As shown in Fig. 3b and c, the wear scar on the surface of

Fig. 3 (a) Plot of friction coefficient vs. sliding time for two samples slid at a normal load of 20 mN. SEM images of the worn surface of the solders formed from (b) the undegraded bath and (c) degraded bath. (d) The Vickers microhardness values of the samples. Optical micrographs of Vickers indentation (40 mN) on the solders formed from (e) the undegraded bath and (f) degraded bath.

the Sn–Ag electrodeposits prepared from the degraded solution was broader and deeper (0.414 mm^3) than that of the electrodeposits prepared from the undegraded solution (0.084 mm^3). Moreover, as shown in Fig. 3d, the hardness of the sample formed from the degraded bath shows the greater hardness value of 50.6 by $\text{HV}_{0.002}$ (Fig. 3f) than the hardness value of the sample formed from the undegraded bath (24.7 by $\text{HV}_{0.002}$ (Fig. 3e)). These tribological behaviors and the hardening effects are consistent with previous reports^{26–28} that discussed the correlation between surface micro-hardness and the surface frictional property. Because the mechanical properties and the melting temperature of solder alloy are highly dependent on the microstructure and the composition of the solder alloy,^{29–31} these results suggest that the degradation of the bath has a negative influence on the fabrication of solder bumps. The formation of nanoparticles on the Sn–Ag solder bumps therefore may be one of the major causes of the collapse of the solder bumps during the solder reflow shown in Fig. 2f.

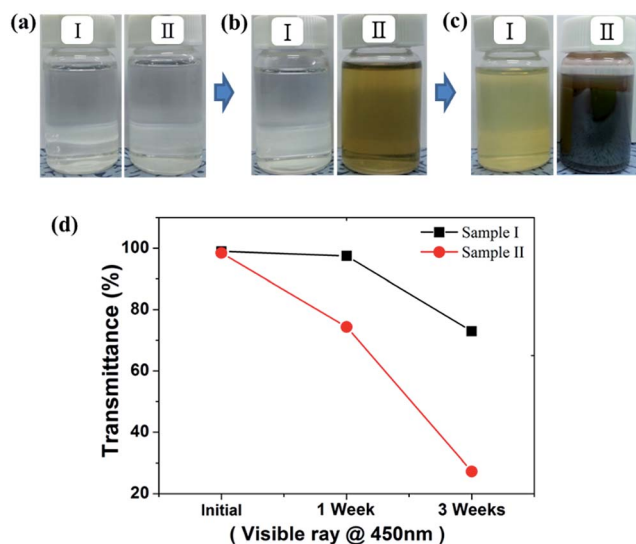
As shown in Fig. 6b and c, when Ag ions coexist in the Sn–MSA bath (solution II), the color changes are more obvious and much faster than in the Ag-free bath (solution I). While the color of solution I changed to a light yellow, the color of sample II changed to dark gray after three weeks, followed by the precipitation of a gray colored sludge. The transmittance of visible light at 450 nm through the degraded solution II decreased to below 30% after 3 weeks, whereas solution I retained ~60% of its transmittance (Fig. 6d).

Fig. 6 The color changes of (I) the Sn–MSA solution and (II) Sn–MSA with Ag cations (a) as prepared, (b) after a week and (c) after 3 weeks. (d) The transmittance of a visible ray at 450 nm wavelength for the solutions with time.
