Effects of the degradation of methane sulfonic acid electrolyte on the collapse failure of Sn–Ag alloy solders for flip-chip interconnections

Mi-Seok Park,^{ab} Do-Hwan Nam,^{ab} Ki-Min Jung,^a Kyung-Sik Hong^a and Hyuk-Sang Kwon^{*a}

The present study investigates the degradation mechanism of a methanesulfonic acid (MSA) based electroplating bath used for the electrodeposition of Sn–Ag alloy solder bumps, and its effects on the microstructure of the solder and on the collapse failure of flip-chip solder bumps. To examine the degradation behavior of the electroplating bath, a degraded electrolyte is prepared by accelerated aging treatment. In the presence of dissolved oxygen and Ag⁺ ions in the electrolyte, the chemical oxidation of Sn²⁺ ions to Sn⁴⁺ ions and the precipitation of SnO₂ nanoparticles with a diameter below 100 nm are promoted by the reduction of Ag⁺. Under cathodic bias, colloidal SnO₂ particles are adsorbed on the surface of the Sn–Ag solder bumps via electrophoresis, and incorporated into the layer by the electrodeposition layer of Sn–Ag. The presence of oxide layer mainly composed of SnO₂ on the surface of the bumps significantly reduces the friction coefficient

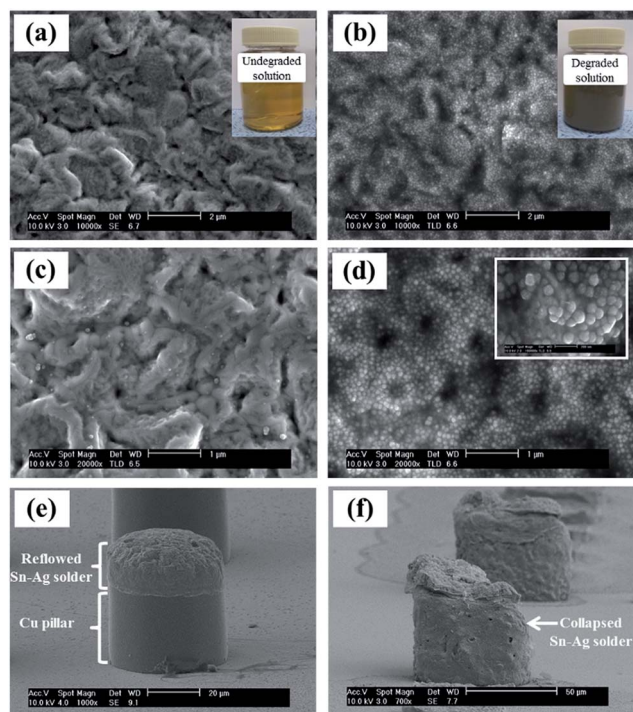
Fig. 2 The surface morphology of the Sn–Ag alloy bumps electrodeposited from ((a) and (c)) the undegraded bath and ((b) and (d)) the degraded solution. The insets of (a) and (b) are the photos of the undegraded and degraded solution, respectively. Thermal reflowed Sn–Ag solder bumps electrodeposited from (e) the undegraded bath and (f) the degraded solution.

Fig. 2 shows the surface morphologies of the Sn–2.3Ag alloy solder bumps electrodeposited from two different baths, which had been used in the mass-production electroplating process for one week, and three weeks, respectively. The inset images of Fig. 2a and b show the color changes of the solution with time. Typical electroplating baths that contain MSA, tin methanesulfonate, silver methanesulfonate, TS-SLG and catechol are transparent and colorless, but the color of the solution changed to light-yellow after using it for one week, and to muddy gray after using it for three weeks in mass production.

When the Sn–Ag alloy bumps were electrodeposited on Cu pillars from the lite-yellow solution (which had been used for one week), well reflowed Sn–Ag solders could be prepared, as shown in Fig. 2e. The overall morphology of the Sn–Ag alloy bumps electrodeposited from the gray solution (used for three weeks) looked similar to those from the one-week old solution. However, high-magnification SEM images (Fig. 2c and d) reveal

that a Sn–Ag alloy bump electrodeposited from the three-week old solution was fully covered with spherical particles which have diameters ranging between 50 nm and 100 nm, whereas there were no nanoparticles on the bump electrodeposited from the one-week old solution. In particular, the bumps from the three-week old solution completely collapsed and debris was scattered around the Cu pillar bumps after the thermal reflow process (Fig. 2f), which is totally different behavior from that observed in Fig. 2e. Therefore, the results clearly show that the degradation of the electrolyte not only affects the surface morphology of the Sn–Ag bumps, but also leads to the collapse failure of solder bumps during the solder reflow step.

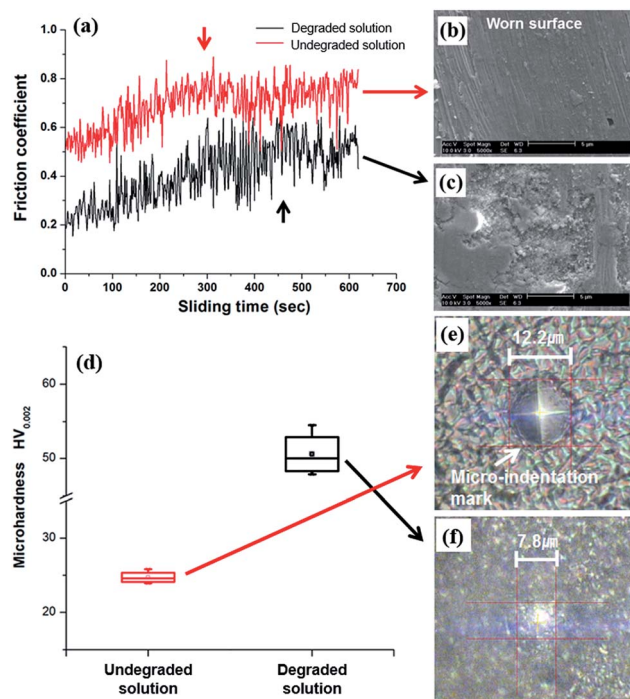
Fig. 3 (a) Plot of friction coefficient vs. sliding time for two samples slid at a normal load of 20 mN. SEM images of the worn surface of the solders formed from (b) the undegraded bath and (c) degraded bath. (d) The Vickers microhardness values of the samples. Optical micrographs of Vickers indentation (40 mN) on the solders formed from (e) the undegraded bath and (f) degraded bath.

In addition to morphological changes, the mechanical properties of the solder bumps were also significantly affected by the degradation of the bath. Fig. 3 presents the results of the microscale friction, wear and hardness tests for the Sn–Ag alloy bumps prepared from solutions before and after degradation. As the bath was degraded, the coefficients of friction (COF) vs. sliding time curves show different tribological behavior (Fig. 3a). The frictional response of the sample formed from the undegraded bath showed an initial COF value of 0.5, and this value settled to 0.75 after 200 s. In contrast, the COF of the sample formed from the degraded bath was 0.2, and this value settled to 0.55 after 450 s. The tribological performance suggests that the degradation of the electrolyte can reduce the friction coefficient of the solder surface by hardening the electrodeposits. As shown in Fig. 3b and c, the wear scar on the surface of

the Sn–Ag electrodeposits prepared from the degraded solution was broader and deeper (0.414 mm^3) than that of the electrodeposits prepared from the undegraded solution (0.084 mm^3). Moreover, as shown in Fig. 3d, the hardness of the sample formed from the degraded bath shows the greater hardness value of 50.6 by $\text{HV}_{0.002}$ (Fig. 3f) than the hardness value of the sample formed from the undegraded bath (24.7 by $\text{HV}_{0.002}$ (Fig. 3e)). These tribological behaviors and the hardening effects are consistent with previous reports^{26–28} that discussed the correlation between surface micro-hardness and the surface frictional property. Because the mechanical properties and the melting temperature of solder alloy are highly dependent on the microstructure and the composition of the solder alloy,^{29–31} these results suggest that the degradation of the bath has a negative influence on the fabrication of solder bumps. The formation of nanoparticles on the Sn–Ag solder bumps therefore may be one of the major causes of the collapse of the solder bumps during the solder reflow shown in Fig. 2f.

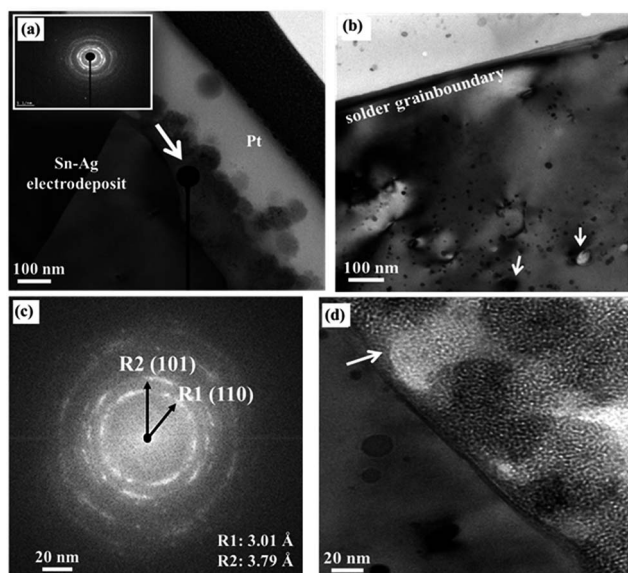
Fig. 4 (a and b) Cross-sectional TEM images and (c) SAED pattern of Sn-Ag alloy solder formed by the degraded electroplating bath showing the deposition of SnO_2 nanoparticles on the surface of the Sn-Ag electrodeposit. (d) The native oxide layer with the meniscus curved shape formed at the interface between SnO_2 nanoparticles and Sn-Ag alloy solder.

To analyze the nanoparticles formed on the surface of the bumps, the Sn–Ag alloy electrodeposits prepared from the degraded solution were further examined using TEM. The cross-sectional TEM image confirms the presence of the nanoparticles on the surface of the Sn–Ag alloy solder (Fig. 4a), in accordance with the SEM observation (Fig. 2d). In addition, a number of nanoparticles were also observed embedded in the subsurface layer as well as on the top surface of the solder bump (Fig. 4b). As shown in Fig. 4c, the SAED pattern for these

nanoparticles shows the clear ring patterns of a polycrystalline structure, which are attributed to the (110), (101) and (211) planes of SnO_2 . One notable feature in the HRTEM observation is that a native oxide layer was observed at the interface between the SnO_2 particles and the surface of the Sn-Ag electrodeposits (Fig. 4c). The meniscus shape of the native oxide implies that the SnO_2 particles were probably not acquired during the post electrodeposition process, but rather formed on the surface of the solder layer during the electrodeposition process.

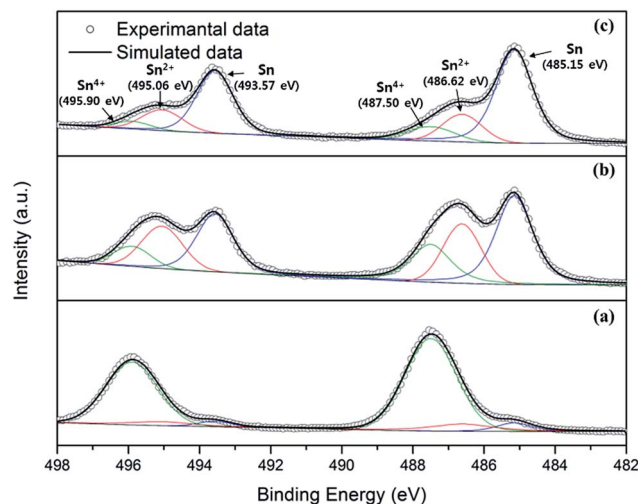
Fig. 5 Sn 3d XPS spectra of the electrodeposited film covered with spherical particles obtained from the degraded bath: (a) w/o ion etching, (b) with ion etching for 300 s and (c) with ion etching for 540 s.

To reveal their exact chemical compositions, XPS analysis was performed on the electrodeposited solder formed by the degraded solution. As shown in Fig. 5, the XPS spectra show the single peak curves of the surface (without ion etching) and double peak curves of the subsurface (after ion etching for 300 s and more). This indicates that Sn^{4+} was the dominant species on the top surface, but the subsurface was composed of Sn, Sn^{2+} and Sn^{4+} . Since the Sn^{2+} and Sn^{4+} spectra are still substantial at the deep subsurface exposed by ion beam etching for 540 s, it can be deduced that the deep subsurface and the top surface of the solder formed from the degraded bath were substantially composed of stannous and stannic oxide. According to a previous report,^{32,33} an oxidation layer with a thickness of less than a few tens of nanometers formed on the Sn-based solder surface can significantly affect its solderability due to the non-wetting behavior between the solder bump and solder on the pad substrate. In this respect, the existence of a thick oxide layer mainly composed of SnO_2 nanoparticles (tens of nm) is expected to degrade the solder wetting property¹⁸ and lead to failures, such as the collapse of the solder bumps during the solder reflow.

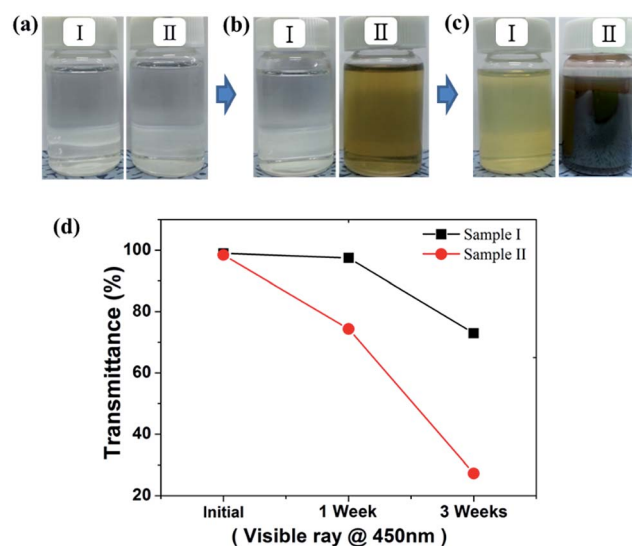
Fig. 6 The color changes of (I) the Sn-MSA solution and (II) Sn-MSA with Ag cations (a) as prepared, (b) after a week and (c) after 3 weeks. (d) The transmittance of a visible ray at 450 nm wavelength for the solutions with time.

As shown in Fig. 6b and c, when Ag ions coexist in the Sn-MSA bath (solution II), the color changes are more obvious and much faster than in the Ag-free bath (solution I). While the color of solution I changed to a light yellow, the color of sample II changed to dark gray after three weeks, followed by the precipitation of a gray colored sludge. The transmittance of visible light at 450 nm through the degraded solution II decreased to below 30% after 3 weeks, whereas solution I retained ~60% of its transmittance (Fig. 6d).

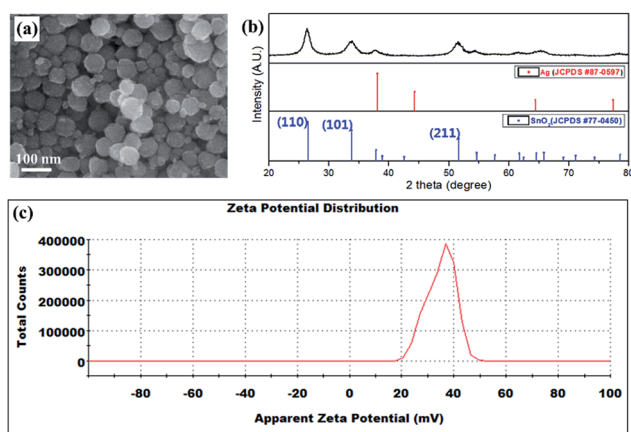
Fig. 7 (a) SEM image and (b) XRD pattern for the precipitated SnO₂ particles extracted from sample II shown in Fig. 6(c). (c) A surface zeta potential graph of SnO₂ particles precipitated from the degraded bath (pH 1.8).

To analyze the species that precipitated after degradation, sludge particles were obtained by centrifugal separation. As shown in Fig. 7, the morphology and size of the particles were similar to the SnO₂ nanoparticles deposited on the surface of the Sn–Ag bumps (Fig. 2d). In addition, all of the peaks in the diffraction pattern of the sludge particles matched that of crystalline SnO₂ (JCPDS no. 77-0450). Therefore, it can be assumed that the SnO₂ nanoparticles observed on the surface of the Sn–Ag bumps are formed in the solution through spontaneous chemical reactions, not during the electrodeposition.

Fig. 7c shows that the zeta potential of the precipitated SnO₂ particles in the degraded bath is about 35.1 mV. The result indicates that the surfaces of the SnO₂ particles are positively charged in the degraded bath (pH 1.8), which is consistent with a previous study that SnO₂ particles have positive zeta potentials in the pH range below 4.3, and
