# Effects of the degradation of methane sulfonic acid electrolyte on the collapse failure of Sn–Ag alloy solders for flip-chip interconnections

The present study investigates the degradation mechanism of a methanesulfonic acid (MSA) based electroplating bath used for the electrodeposition of Sn–Ag alloy solder bumps, and its effects on the microstructure of the solder and on the collapse failure of flip-chip solder bumps. To examine the degradation behavior of the electroplating bath, a degraded electrolyte is prepared by accelerated aging treatment. In the presence of dissolved oxygen and  $\text{Ag}^+$  ions in the electrolyte, the chemical oxidation of  $\text{Sn}^{2+}$  ions to  $\text{Sn}^{4+}$  ions and the precipitation of  $\text{SnO}_2$  nanoparticles with a diameter below 100 nm are promoted by the reduction of  $\text{Ag}^+$ . Under cathodic bias, colloidal  $\text{SnO}_2$  particles are adsorbed on the surface of the Sn–Ag solder bumps via electrophoresis, and incorporated into the layer by the electrodeposition layer of Sn–Ag. The presence of oxide layer mainly composed of  $\text{SnO}_2$  on the surface of the bumps significantly reduces the friction coefficient of t

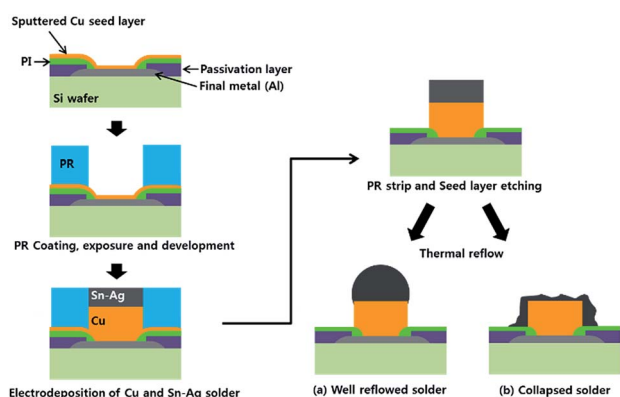
Fig. 1 Schematic illustration of the Cu pillar bump fabrication process; (a) well reflowed solder bump and (b) collapsed solder bump during thermal reflow.

To fabricate Sn–2.3Ag (wt%) alloy solder capped copper pillar bumps, a photo resist (PR) pattern with *via* hole arrays was fabricated using a conventional industrial photolithography process and mass production tools.<sup>1</sup> The electrodeposition of the Sn–Ag alloy was carried out on the Cu stud substrate at a current density of  $-20 \text{ mA cm}^{-2}$  for 600 s in a bath containing  $2.0 \text{ mol L}^{-1}$  MSA ( $\text{CH}_3\text{SO}_3\text{H}$ , Sigma-Aldrich),  $0.192 \text{ mol L}^{-1}$  tin methanesulfonate ( $(\text{CH}_3\text{SO}_3)_2\text{Sn}$ , Sigma-Aldrich) and  $0.008 \text{ mol L}^{-1}$  silver methanesulfonate ( $(\text{CH}_3\text{SO}_3)\text{Ag}$ , Sigma-Aldrich). In addition to the basic MSA bath,  $120 \text{ mL L}^{-1}$  TS-SLG and  $0.005 \text{ mol L}^{-1}$  catechol ( $\text{C}_6\text{H}_6\text{O}_2$ ) were added as an Ag complexing agent and anti-oxidant, respectively. The electrodeposition of the Sn–Ag alloy solder was conducted using a two-electrode cell: a Sn plate was used as the anode and a silicon wafer covered with Cu seed and PR *via* hole patterns (illustrated in Fig. 1) was used as the cathode. All the electrodepositions were conducted at room temperature, 296 K.

After the electrodeposition of the Sn–Ag alloy on the Cu pillar, standard PR stripping and etching of the Cu seed layer were performed.<sup>1</sup> The whole fabrication process for the solder capped Cu pillar bump is schematically illustrated in Fig. 1.
