# Effects of the degradation of methane sulfonic acid electrolyte on the collapse failure of Sn–Ag alloy solders for flip-chip interconnections

The present study investigates the degradation mechanism of a methanesulfonic acid (MSA) based electroplating bath used for the electrodeposition of Sn–Ag alloy solder bumps, and its effects on the microstructure of the solder and on the collapse failure of flip-chip solder bumps. To examine the degradation behavior of the electroplating bath, a degraded electrolyte is prepared by accelerated aging treatment. In the presence of dissolved oxygen and  $\text{Ag}^+$  ions in the electrolyte, the chemical oxidation of  $\text{Sn}^{2+}$  ions to  $\text{Sn}^{4+}$  ions and the precipitation of  $\text{SnO}_2$  nanoparticles with a diameter below 100 nm are promoted by the reduction of  $\text{Ag}^+$ . Under cathodic bias, colloidal  $\text{SnO}_2$  particles are adsorbed on the surface of the Sn–Ag solder bumps *via* electrophoresis, and incorporated into the layer by the electrodeposition layer of Sn–Ag. The presence of oxide layer mainly composed of  $\text{SnO}_2$  on the surface of the bumps significantly reduces the friction coefficient of

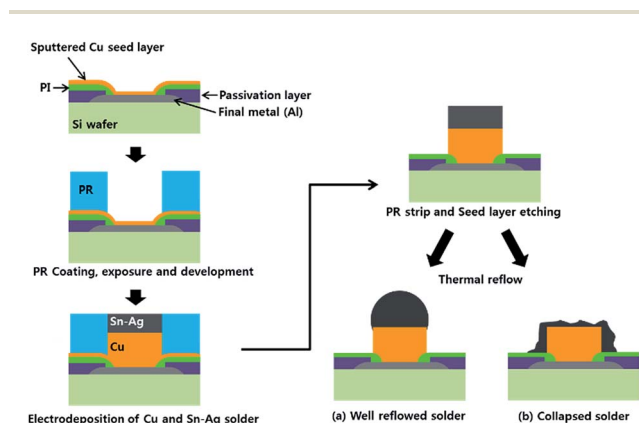
Fig. 1 Schematic illustration of the Cu pillar bump fabrication process; (a) well reflowed solder bump and (b) collapsed solder bump during thermal reflow.

To fabricate Sn–2.3Ag (wt%) alloy solder capped copper pillar bumps, a photo resist (PR) pattern with *via* hole arrays was fabricated using a conventional industrial photolithography process and mass production tools.<sup>1</sup> The electrodeposition of the Sn–Ag alloy was carried out on the Cu stud substrate at a current density of  $-20 \text{ mA cm}^{-2}$  for 600 s in a bath containing  $2.0 \text{ mol L}^{-1}$  MSA ( $\text{CH}_3\text{SO}_3\text{H}$ , Sigma-Aldrich),  $0.192 \text{ mol L}^{-1}$  tin methanesulfonate ( $(\text{CH}_3\text{SO}_3)_2\text{Sn}$ , Sigma-Aldrich) and  $0.008 \text{ mol L}^{-1}$  silver methanesulfonate ( $(\text{CH}_3\text{SO}_3)\text{Ag}$ , Sigma-Aldrich). In addition to the basic MSA bath,  $120 \text{ mL L}^{-1}$  TS-SLG and  $0.005 \text{ mol L}^{-1}$  catechol ( $\text{C}_6\text{H}_6\text{O}_2$ ) were added as an Ag complexing agent and anti-oxidant, respectively. The electrodeposition of the Sn–Ag alloy solder was conducted using a two-electrode cell: a Sn plate was used as the anode and a silicon wafer covered with Cu seed and PR *via* hole patterns (illustrated in Fig. 1) was used as the cathode. All the electrodepositions were conducted at room temperature, 296 K.

After the electrodeposition of the Sn–Ag alloy on the Cu pillar, standard PR stripping and etching of the Cu seed layer were performed.<sup>1</sup> The whole fabrication process for the solder capped Cu pillar bump is schematically illustrated in Fig. 1.

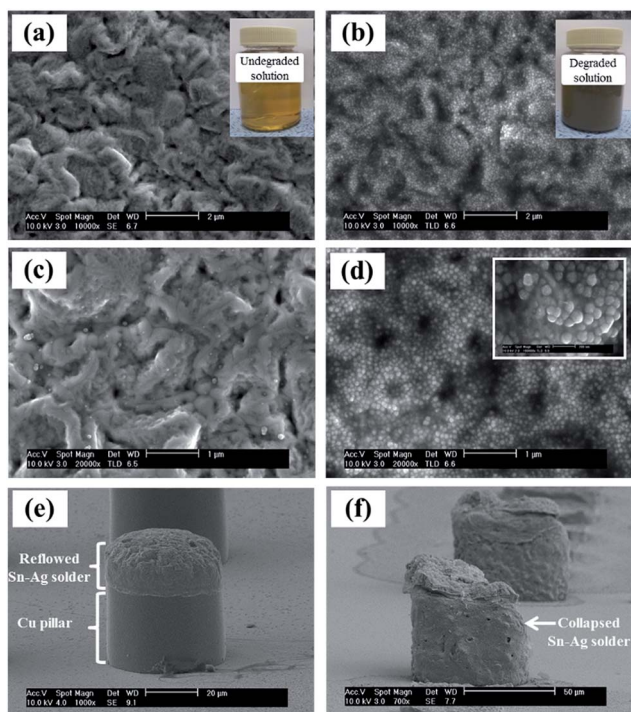
Fig. 2 shows the surface morphologies of the Sn–2.3Ag alloy solder bumps electrodeposited from two different baths, which had been used in the mass-production electroplating process for one week, and three weeks, respectively. The inset images of Fig. 2a and b show the color changes of the solution with time. Typical electroplating baths that contain MSA, tin methanesulfonate, silver methanesulfonate, TS-SLG and catechol are transparent and colorless, but the color of the solution changed to light-yellow after using it for one week, and to muddy gray after using it for three weeks in mass production.

When the Sn–Ag alloy bumps were electrodeposited on Cu pillars from the lite-yellow solution (which had been used for one week), well reflowed Sn–Ag solders could be prepared, as shown in Fig. 2e. The overall morphology of the Sn–Ag alloy bumps electrodeposited from the gray solution (used for three weeks) looked similar to those from the one-week old solution. However, high-magnification SEM images (Fig. 2c and d) reveal

**Fig. 2** The surface morphology of the Sn–Ag alloy bumps electro-deposited from ((a) and (c)) the undegraded bath and ((b) and (d)) the degraded solution. The insets of (a) and (b) are the photos of the undegraded and degraded solution, respectively. Thermal reflowed Sn–Ag solder bumps electro-deposited from (e) the undegraded bath and (f) the degraded solution.

that a Sn–Ag alloy bump electro-deposited from the three-week old solution was fully covered with spherical particles which have diameters ranging between 50 nm and 100 nm, whereas there were no nanoparticles on the bump electro-deposited from the one-week old solution. In particular, the bumps from the three-week old solution completely collapsed and debris was scattered around the Cu pillar bumps after the thermal reflow process (Fig. 2f), which is totally different behavior from that observed in Fig. 2e. Therefore, the results clearly show that the degradation of the electrolyte not only affects the surface morphology of the Sn–Ag bumps, but also leads to the collapse failure of solder bumps during the solder reflow step.

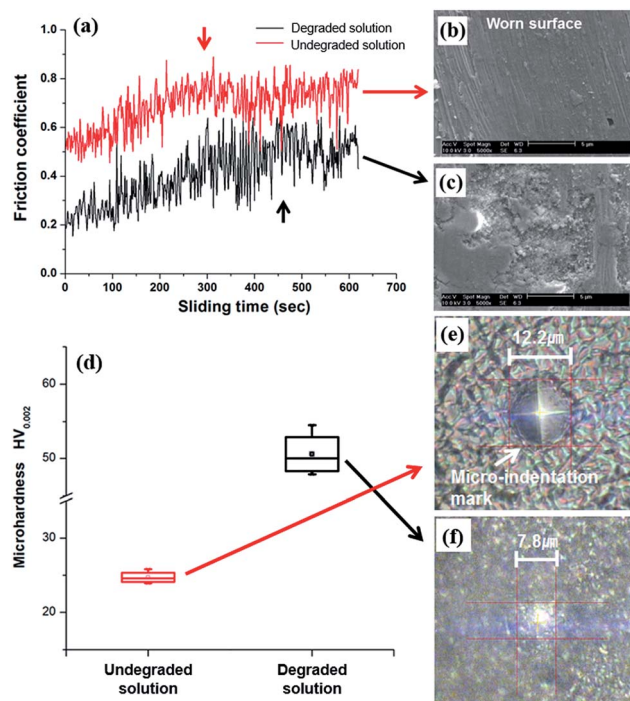
In addition to morphological changes, the mechanical properties of the solder bumps were also significantly affected by the degradation of the bath. Fig. 3 presents the results of the microscale friction, wear and hardness tests for the Sn–Ag alloy bumps prepared from solutions before and after degradation. As the bath was degraded, the coefficients of friction (COF) vs. sliding time curves show different tribological behavior (Fig. 3a). The frictional response of the sample formed from the undegraded bath showed an initial COF value of 0.5, and this value settled to 0.75 after 200 s. In contrast, the COF of the sample formed from the degraded bath was 0.2, and this value settled to 0.55 after 450 s. The tribological performance suggests that the degradation of the electrolyte can reduce the friction coefficient of the solder surface by hardening the electrodeposits. As shown in Fig. 3b and c, the wear scar on the surface of

**Fig. 3** (a) Plot of friction coefficient vs. sliding time for two samples slid at a normal load of 20 mN. SEM images of the worn surface of the solders formed from (b) the undegraded bath and (c) degraded bath. (d) The Vickers microhardness values of the samples. Optical micrographs of Vickers indentation (40 mN) on the solders formed from (e) the undegraded bath and (f) degraded bath.

the Sn–Ag electrodeposits prepared from the degraded solution was broader and deeper ( $0.414 \text{ mm}^3$ ) than that of the electrodeposits prepared from the undegraded solution ( $0.084 \text{ mm}^3$ ). Moreover, as shown in Fig. 3d, the hardness of the sample formed from the degraded bath shows the greater hardness value of 50.6 by  $\text{HV}_{0.002}$  (Fig. 3f) than the hardness value of the sample formed from the undegraded bath (24.7 by  $\text{HV}_{0.002}$  (Fig. 3e)). These tribological behaviors and the hardening effects are consistent with previous reports<sup>26–28</sup> that discussed the correlation between surface micro-hardness and the surface frictional property. Because the mechanical properties and the melting temperature of solder alloy are highly dependent on the microstructure and the composition of the solder alloy,<sup>29–31</sup> these results suggest that the degradation of the bath has a negative influence on the fabrication of solder bumps. The formation of nanoparticles on the Sn–Ag solder bumps therefore may be one of the major causes of the collapse of the solder bumps during the solder reflow shown in Fig. 2f.

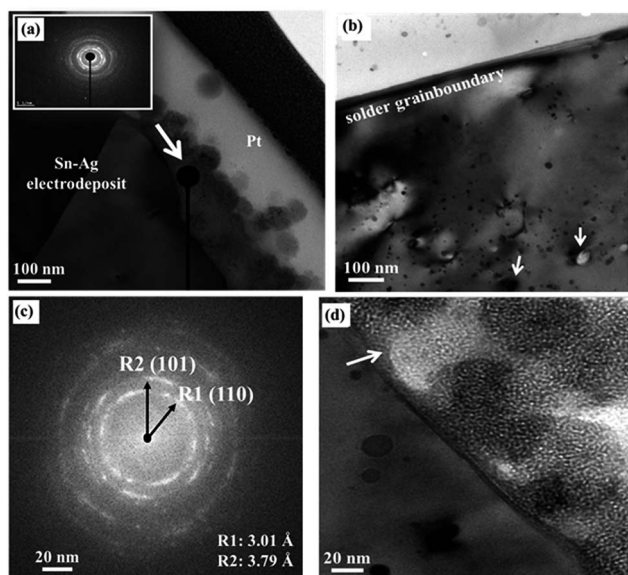
To analyze the nanoparticles formed on the surface of the bumps, the Sn–Ag alloy electrodeposits prepared from the degraded solution were further examined using TEM. The cross-sectional TEM image confirms the presence of the nanoparticles on the surface of the Sn–Ag alloy solder (Fig. 4a), in accordance with the SEM observation (Fig. 2d). In addition, a number of nanoparticles were also observed embedded in the subsurface layer as well as on the top surface of the solder bump (Fig. 4b). As shown in Fig. 4c, the SAED pattern for these

Fig. 4 (a and b) Cross-sectional TEM images and (c) SAED pattern of Sn–Ag alloy solder formed by the degraded electroplating bath showing the deposition of  $\text{SnO}_2$  nanoparticles on the surface of the Sn–Ag electrodeposit. (d) The native oxide layer with the meniscus curved shape formed at the interface between  $\text{SnO}_2$  nanoparticles and Sn–Ag alloy solder.

nanoparticles shows the clear ring patterns of a polycrystalline structure, which are attributed to the (110), (101) and (211) planes of  $\text{SnO}_2$ . One notable feature in the HRTEM observation is that a native oxide layer was observed at the interface between the  $\text{SnO}_2$  particles and the surface of the Sn–Ag electrodeposits (Fig. 4c). The meniscus shape of the native oxide implies that the  $\text{SnO}_2$  particles were probably not acquired during the post electrodeposition process, but rather formed on the surface of the solder layer during the electrodeposition process.

During the electrodeposition of the Sn–Ag alloy, the application of an electric field induces a coulombic force on the SnO<sub>2</sub> particles, and thus positively charged SnO<sub>2</sub> particles approach the negatively charged working electrode. This phenomenon is the well-known phenomenon of electrophoresis.<sup>37</sup> Therefore, it can be assumed that the electrophoretic deposition of SnO<sub>2</sub> nanoparticles occurs simultaneously with the electrodeposition of Sn–Ag alloy, which results in the incorporation of nanoparticles into the subsurface layer as well as the deposition on the top surface of the solder bump (Fig. 4b).

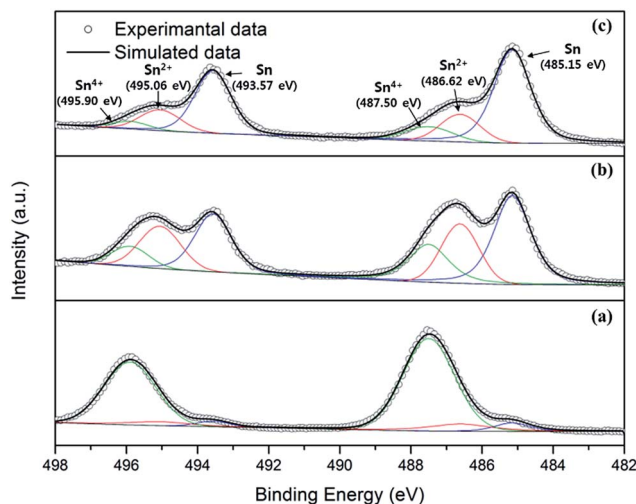
To reveal their exact chemical compositions, XPS analysis was performed on the electrodeposited solder formed by the degraded solution. As shown in Fig. 5, the XPS spectra show the single peak curves of the surface (without ion etching) and double peak curves of the subsurface (after ion etching for 300 s and more). This indicates that  $\text{Sn}^{4+}$  was the dominant species on the top surface, but the subsurface was composed of Sn,  $\text{Sn}^{2+}$  and  $\text{Sn}^{4+}$ . Since the  $\text{Sn}^{2+}$  and  $\text{Sn}^{4+}$  spectra are still substantial at the deep subsurface exposed by ion beam etching for 540 s, it can be deduced that the deep subsurface and the top surface of the solder formed from the degraded bath were substantially composed of stannous and stannic oxide. According to a previous report,<sup>32,33</sup> an oxidation layer with a thickness of less than a few tens of nanometers formed on the Sn-based solder surface can significantly affect its solderability due to the non-wetting behavior between the solder bump and solder on the pad substrate. In this respect, the existence of a thick oxide layer mainly composed of  $\text{SnO}_2$  nanoparticles (tens of nm) is expected to degrade the solder wetting property<sup>18</sup> and lead to failures, such as the collapse of the solder bumps during the solder reflow.

Fig. 5 Sn 3d XPS spectra of the electrodeposited film covered with spherical particles obtained from the degraded bath: (a) w/o ion etching, (b) with ion etching for 300 s and (c) with ion etching for 540 s.

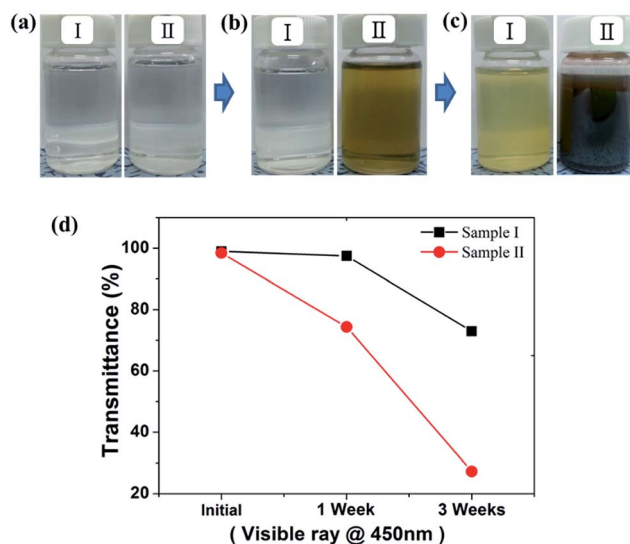
As shown in Fig. 6b and c, when Ag ions coexist in the Sn–MSA bath (solution II), the color changes are more obvious and much faster than in the Ag-free bath (solution I). While the color of solution I changed to a light yellow, the color of sample II changed to dark gray after three weeks, followed by the precipitation of a gray colored sludge. The transmittance of visible light at 450 nm through the degraded solution II decreased to below 30% after 3 weeks, whereas solution I retained ~60% of its transmittance (Fig. 6d).

Fig. 6 The color changes of (I) the Sn–MSA solution and (II) Sn–MSA with Ag cations (a) as prepared, (b) after a week and (c) after 3 weeks. (d) The transmittance of a visible ray at 450 nm wavelength for the solutions with time.

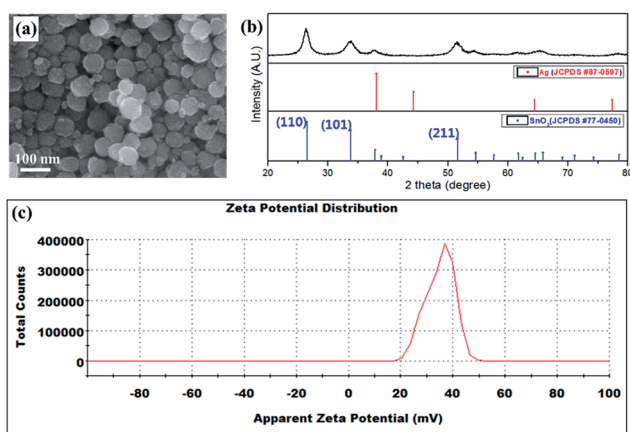
To analyze the species that precipitated after degradation, sludge particles were obtained by centrifugal separation. As shown in Fig. 7, the morphology and size of the particles were similar to the SnO<sub>2</sub> nanoparticles deposited on the surface of the Sn–Ag bumps (Fig. 2d). In addition, all of the peaks in the diffraction pattern of the sludge particles matched that of crystalline SnO<sub>2</sub> (JCPDS no. 77-0450). Therefore, it can be assumed that the SnO<sub>2</sub> nanoparticles observed on the surface of the Sn–Ag bumps are formed in the solution through spontaneous chemical reactions, not during the electrodeposition.

Fig. 7c shows that the zeta potential of the precipitated SnO<sub>2</sub> particles in the degraded bath is about 35.1 mV. The result indicates that the surfaces of the SnO<sub>2</sub> particles are positively charged in the degraded bath (pH 1.8), which is consistent with a previous study that SnO<sub>2</sub> particles have positive zeta potentials in the pH range below 4.3, and

Fig. 7 (a) SEM image and (b) XRD pattern for the precipitated SnO<sub>2</sub> particles extracted from sample II shown in Fig. 6(c). (c) A surface zeta potential graph of SnO<sub>2</sub> particles precipitated from the degraded bath (pH 1.8).
