# Effects of the degradation of methane sulfonic acid electrolyte on the collapse failure of Sn–Ag alloy solders for flip-chip interconnections

The present study investigates the degradation mechanism of a methanesulfonic acid (MSA) based electroplating bath used for the electrodeposition of Sn–Ag alloy solder bumps, and its effects on the microstructure of the solder and on the collapse failure of flip-chip solder bumps. To examine the degradation behavior of the electroplating bath, a degraded electrolyte is prepared by accelerated aging treatment. In the presence of dissolved oxygen and  $\text{Ag}^+$  ions in the electrolyte, the chemical oxidation of  $\text{Sn}^{2+}$  ions to  $\text{Sn}^{4+}$  ions and the precipitation of  $\text{SnO}_2$  nanoparticles with a diameter below 100 nm are promoted by the reduction of  $\text{Ag}^+$ . Under cathodic bias, colloidal  $\text{SnO}_2$  particles are adsorbed on the surface of the Sn–Ag solder bumps *via* electrophoresis, and incorporated into the layer by the electrodeposition layer of Sn–Ag. The presence of oxide layer mainly composed of  $\text{SnO}_2$  on the surface of the bumps significantly reduces the friction coefficient of

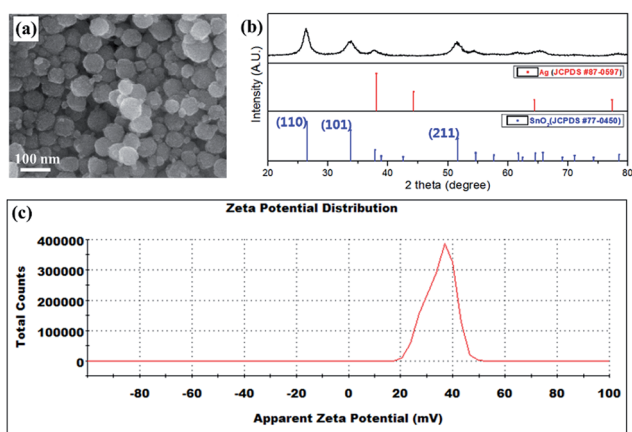
Fig. 7 (a) SEM image and (b) XRD pattern for the precipitated SnO<sub>2</sub> particles extracted from sample II shown in Fig. 6(c). (c) A surface zeta potential graph of SnO<sub>2</sub> particles precipitated from the degraded bath (pH 1.8).

To analyze the species that precipitated after degradation, sludge particles were obtained by centrifugal separation. As shown in Fig. 7, the morphology and size of the particles were similar to the SnO<sub>2</sub> nanoparticles deposited on the surface of the Sn–Ag bumps (Fig. 2d). In addition, all of the peaks in the diffraction pattern of the sludge particles matched that of crystalline SnO<sub>2</sub> (JCPDS no. 77-0450). Therefore, it can be assumed that the SnO<sub>2</sub> nanoparticles observed on the surface of the Sn–Ag bumps are formed in the solution through spontaneous chemical reactions, not during the electrodeposition.

Fig. 7c shows that the zeta potential of the precipitated SnO<sub>2</sub> particles in the degraded bath is about 35.1 mV. The result indicates that the surfaces of the SnO<sub>2</sub> particles are positively charged in the degraded bath (pH 1.8), which is consistent with a previous study that SnO<sub>2</sub> particles have positive zeta potentials in the pH range below 4.3, and
