Cite this: *RSC Adv.*, 2018, 8, 33414

# Investigation of a commercial lithium-ion battery under overcharge/over-discharge failure conditions

DOI: 10.1039/c8ra05564e

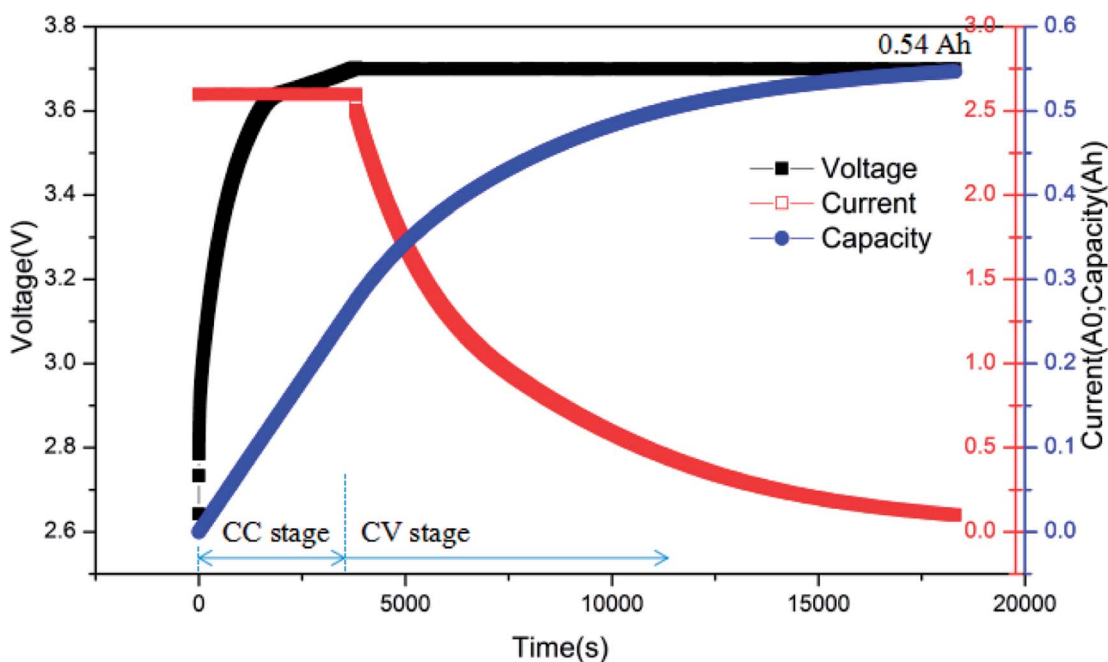
Fig. 8 The charging curves of the battery after over-discharge.

Fig. 8 presents the charging curves of battery after over-discharge, where the battery was charged by the CC-CV (constant current-constant voltage) method. The battery was charged at 2C rate first and then transferred to CV (3.7 V) until the current declined to 0.01C. From Fig. 10, it can be seen that the battery had a capacity of barely 0.54 A h when the charging was completed. In other words, it only had 41.5% SOC, which was much less than 80% SOC, the failure threshold for LIB.<sup>22</sup> Therefore, the battery failed after the over-discharge process.

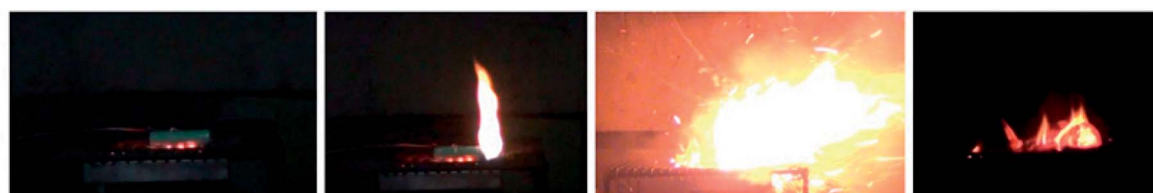
Fig. 10 The burning process of the batteries during the tests: (a) battery failure due to overcharge; (b) battery failure due to over-discharge.

Fig. 10 shows several typical moments during the burning process of LIB affected by a 2 kW power electric heater. The batteries were the ones experiencing failure induced by 2C overcharge/over-discharge. The batteries were placed upon the supporting mesh. The heater was under the batteries with a distance of 1 cm. According to the results, the burning process of the failed LIB consisted of a few stages, which will be discussed in detail:

The burning process of the failed battery due to overcharge comprised (1) the heating stage, (2) ignition, (3) rupture and explosion and (4) abatement. During the heating stage, the battery remained stable and only a part of the packing melted. With the continuous rise in temperature, the safety valve opened accompanied by a clear sound. Hereafter, some

combustible gases were released, and these gases were ignited at 235 s. The flame lasted until the rupture and explosion behaviors at 251 s. When the explosion happened, the safety valve was blown away; the jellyroll was then brought out and exposed to air. This phenomenon was different from the results of the normal batteries reported in previous studies,<sup>23–26</sup> where this stage was replaced by ejection and stable combustion. The explosion revealed that the fire behaviors of the failed battery due to overcharge were much more violent than those of normal batteries. On the one hand, this resulted from the redundant energy stored in the overcharged battery. Also, 137% SOC resulted in highly delithiated electroactive materials, which were unstable.<sup>27</sup> The damaged structures inside the battery caused by overcharge might contribute to the result. Hence, the fire behaviors of the LIB worsened. The explosion was of a short duration and then, the flame abated gradually.

The burning process of the failed battery due to over-discharge consisted of (1) the heating stage, (2) ignition, (3) the interval, (4) stable combustion and (5) abatement. Compared to the fire behaviors of the LIB described above, much moderate fire behavior was observed for the failure of the LIB due to over-discharge, and more time was required for ignition; the battery did not ignite until 401 s. The flame lasted for a long time and then abated. Then, it entered an interval where large quantities of smoke were released. Some electrolytes leaked from the opening of the battery and then ignited. With the depletion of the electrolytes, it entered the stable combustion stage at 568 s where the flame remained still. Due to the continuous release of combustible gases, this stage lasted for a long time: 127 s. After that, the flame abated and extinguished in the end.

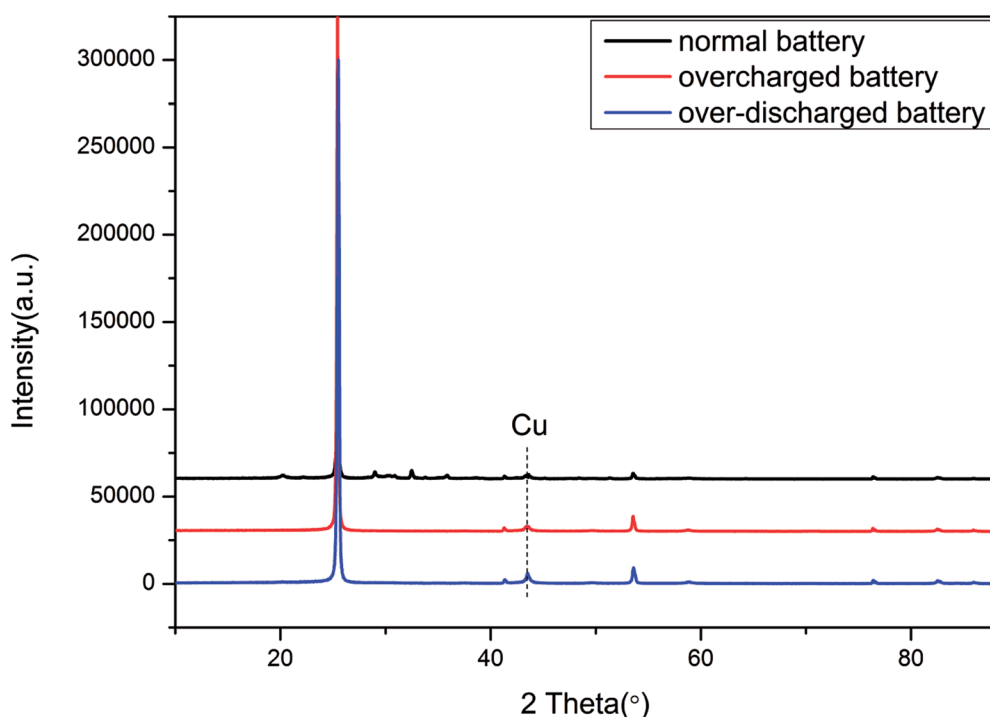
Fig. 13 Synchrotron XRD data of the anode materials.

Besides, the XRD (X-ray Diffraction) results of the anode materials are depicted in Fig. 13. The emerging peak of Cu in the curve of the over-discharged battery supported the previous assumption that the copper foil dissolved and then deposited onto the electrode in the over-discharged battery. Furthermore, Table 2 displays the element distribution details for the anode materials by XPS (X-ray Photoelectron Spectroscopy). For a normal battery, its anode comprised C and Li, whereas Cu appeared in the over-discharged battery, and the content of Li declined clearly due to serious loss of lithium ions by over-discharge. As for the overcharged battery, the excessive deposition of lithium ions could be found in the anode; meanwhile, the metals Ni, Mn and Co transferred from the cathode and emerged in the anode. The results of SEM, XRD and XPS were identical to the description of the overcharge/over-discharge mechanism in Section 3.1, and some similar reports could be found in previous studies.<sup>7,9,10</sup>
