Cite this: *RSC Adv.*, 2019, 9, 4035

Characteristics of water quality and bacterial communities in three water supply pipelines†

Dongpo Liu,^{id} ^{ab} Juntao Jin,^{*ac} Sichen Liang^{ad} and Jinsong Zhang^{ab}

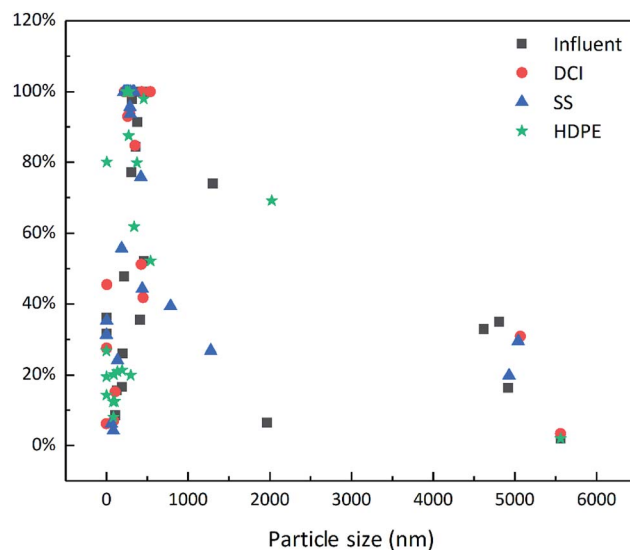
Fig. 2 shows the particle size distribution of the influent and effluents within 25 days. The particle size range (abscissa) of the particulates can be obtained from the particle size frequency distribution map, while the frequency (ordinate) of the particle size of each particulate within the particle size range can be quantified by the content of each particle size fraction present in the water. From Fig. 2, it was found that the solid content of the influent was lower, and the content of small particle sizes was more significant, with particles mainly concentrated in the 0 to 200 nm fraction, while the content of particles in the 400 to 600 nm fraction was relatively small. The large particle sizes in the effluent in the DCI and the SS pipes increased, mainly being concentrated in the 200 to 600 nm fraction, and their distribution at 400 nm was more concentrated. This is consistent with the particle-size distribution of the actual water sample (ESI 2†). The particle size of solids in the HDPE pipe samples showed no obvious change compared to the influent. Simoes *et al.* reported that biofilm growth in DWDS contributes to the accumulation of inorganic particles.³¹ Slaats *et al.* reported that when the pH increases, calcium carbonate can precipitate on

Fig. 2 Frequency distribution of particle size in the influent and effluents.

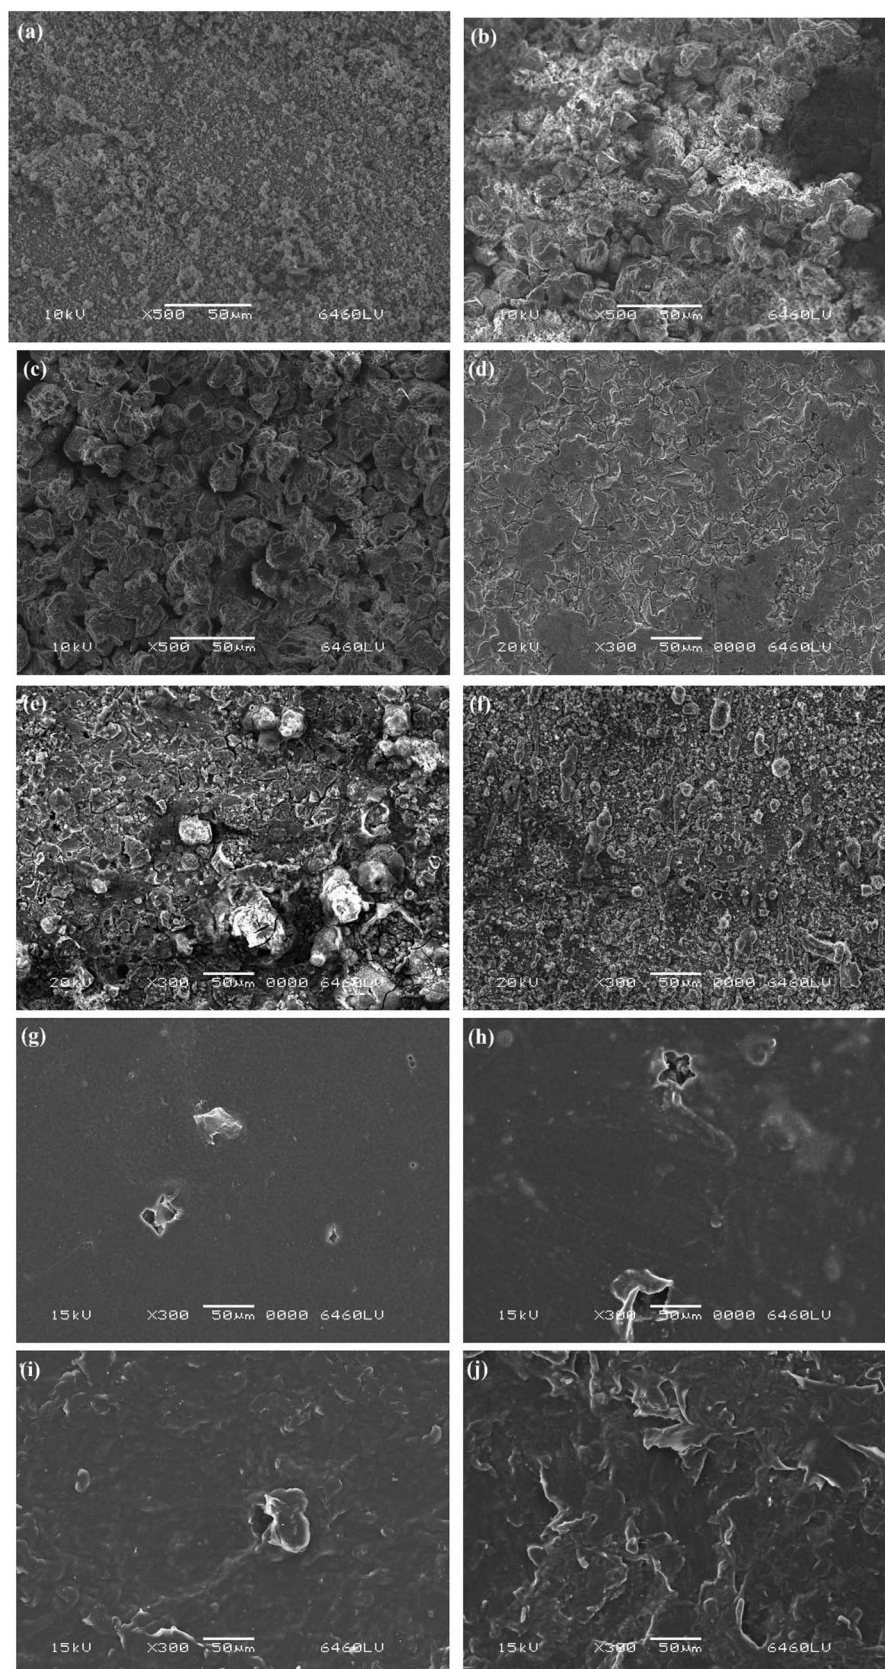
3.2.1 Micromorphology. Representative SEM images of the tubing inner walls during the different running stages are shown in Fig. 3, where it can be seen that the different tubing materials showed significant differences during operation, and even various different microstructural features could be seen in the same tubing samples.

Fig. 3 SEM image of the pipeline inner wall in the three different stages.

As shown in Fig. 3, the microstructure of the DCI pipe inner wall was loose and porous in the form of fine sand before running (Fig. 3(a)); then, relatively dense small grains appeared on the 14th day (Fig. 3(b)), and these became more prominent on the 25th day (Fig. 3(c)). Bonds *et al.* reported that the cement-mortar lining of DCI has cracks that can close and thereby the lining becomes tight after a period of exposure to water, but also the cement will eventually undergo autogenous healing, a phenomenon long recognised by the concrete industry and which occurs due to the formation of calcium carbonate and the continuing hydration of cement grains in the lining.⁴⁴

The SS pipe inner wall had a loose porous texture before running (Fig. 3(d)); then, obvious corrosion scales on the inner wall structure could be seen on the 14th day (Fig. 3(e)), and later the corrosion tubercles became smaller, and the inner walls were denser on the 25th day (Fig. 3(f)). These SEM images of SS are similar with the previous report.^{75,76} However, the corrosion of the SS pipe may not be that easy, as Zhang *et al.* reported that some loose floccus seen on the surface of their sample could represent the metabolites of bacteria.⁴⁰

Before running (Fig. 3(g)), and on the 14th day (Fig. 3(h)), the HDPE pipe inner walls were smooth, with obvious point-like small holes seen before running; the perforations therein increased, and the damage to the inner wall was clearly intensified on the 14th day, and then inner walls had become rough and compact by the 25th day (Fig. 3(i) and (j)). Leban *et al.* reported that the corrosion products were deposited especially around the perforation, with the shape of the perforations found on the pipe being of irregular shape with sharp angles.⁷⁵ These SEM images of HDPE are similar with the fouled membranes deposits and bacterial cells in the reports of Ayache *et al.*⁷⁷ and Rozej *et al.*⁶⁸, which imply that it is likely to be a change caused by biofilm formation or particle attachment.

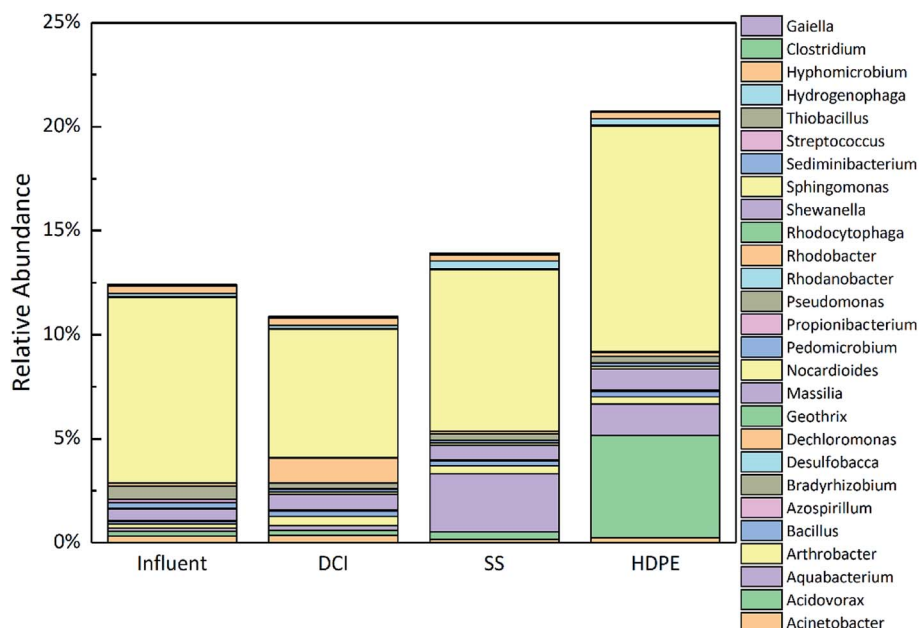
The relative abundance of the various corrosive-related bacteria in the influent and different pipeline effluents are shown in Fig. 4. *Sphingomonas* was dominant in both the influent and effluent of the three tubing material samples (8.9209%, 6.1609%, 7.7781%, and 10.8632%, respectively), followed by *Pseudomonas* (0.6265%) and *Massilia* (0.5473%) in the influent, *Rhodobacter* (1.2033%) and *Massilia* (0.7555%) in the DCI tube effluent, *Aquabacterium* (2.8047%) and *Massilia* (0.6892%) in the SS tube effluent and *Acidovorax* (4.9221%) and *Aquabacterium* (1.5092%) in the HDPE tube effluent. It could thus be seen that the different tubing materials affected the different corrosive bacterial communities.^{28,45,82,84,87,95,96}

Fig. 4 Relative community abundance of corrosion microorganisms at the genus level.

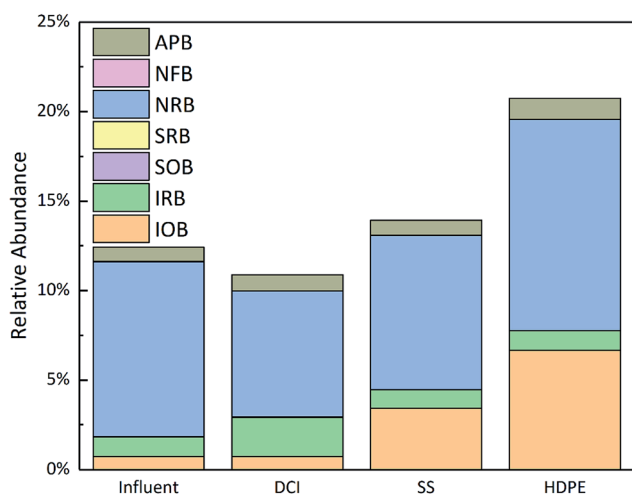
In Fig. 5, the bacterial community was counted according to the different functional types. It was found that NRB was always the most corrosive bacteria in the water from the influent to the effluent. Compared with the pipeline microbial community found in previous research, the relative abundance of the microbial community in this study was relatively low, mainly due to the initial use of new pipelines, and as stable microbial community structures had not yet formed inside the pipeline. Previous researchs has found that *Acidovorax* (IOB), *Aquabacterium* (IOB), *Sediminibacterium* (IOB) and *Desulfobacca* (SRB) promote corrosion, while *Thiobacillus* (SOB), *Geothrix* (IRB), *Pseudomonas* (IRB) *Bacillus* (IRB), etc. suppress corrosion.^{24,97–99} Therefore, it can be found from the overall microbial community structure that the microbial community that inhibits corrosion in the pipeline gives the main benefit, whereby the deterioration of the water quality of the pipeline is reduced and the corrosion of the inner wall of the pipeline is reduced.

Fig. 5 Relative abundance of different corrosive functional bacteria at the genus level.
