Cite this: *RSC Adv.*, 2019, 9, 4035

Characteristics of water quality and bacterial communities in three water supply pipelines†

Dongpo Liu,^{id} ^{ab} Juntao Jin,^{*ac} Sichen Liang^{ad} and Jinsong Zhang^{ab}

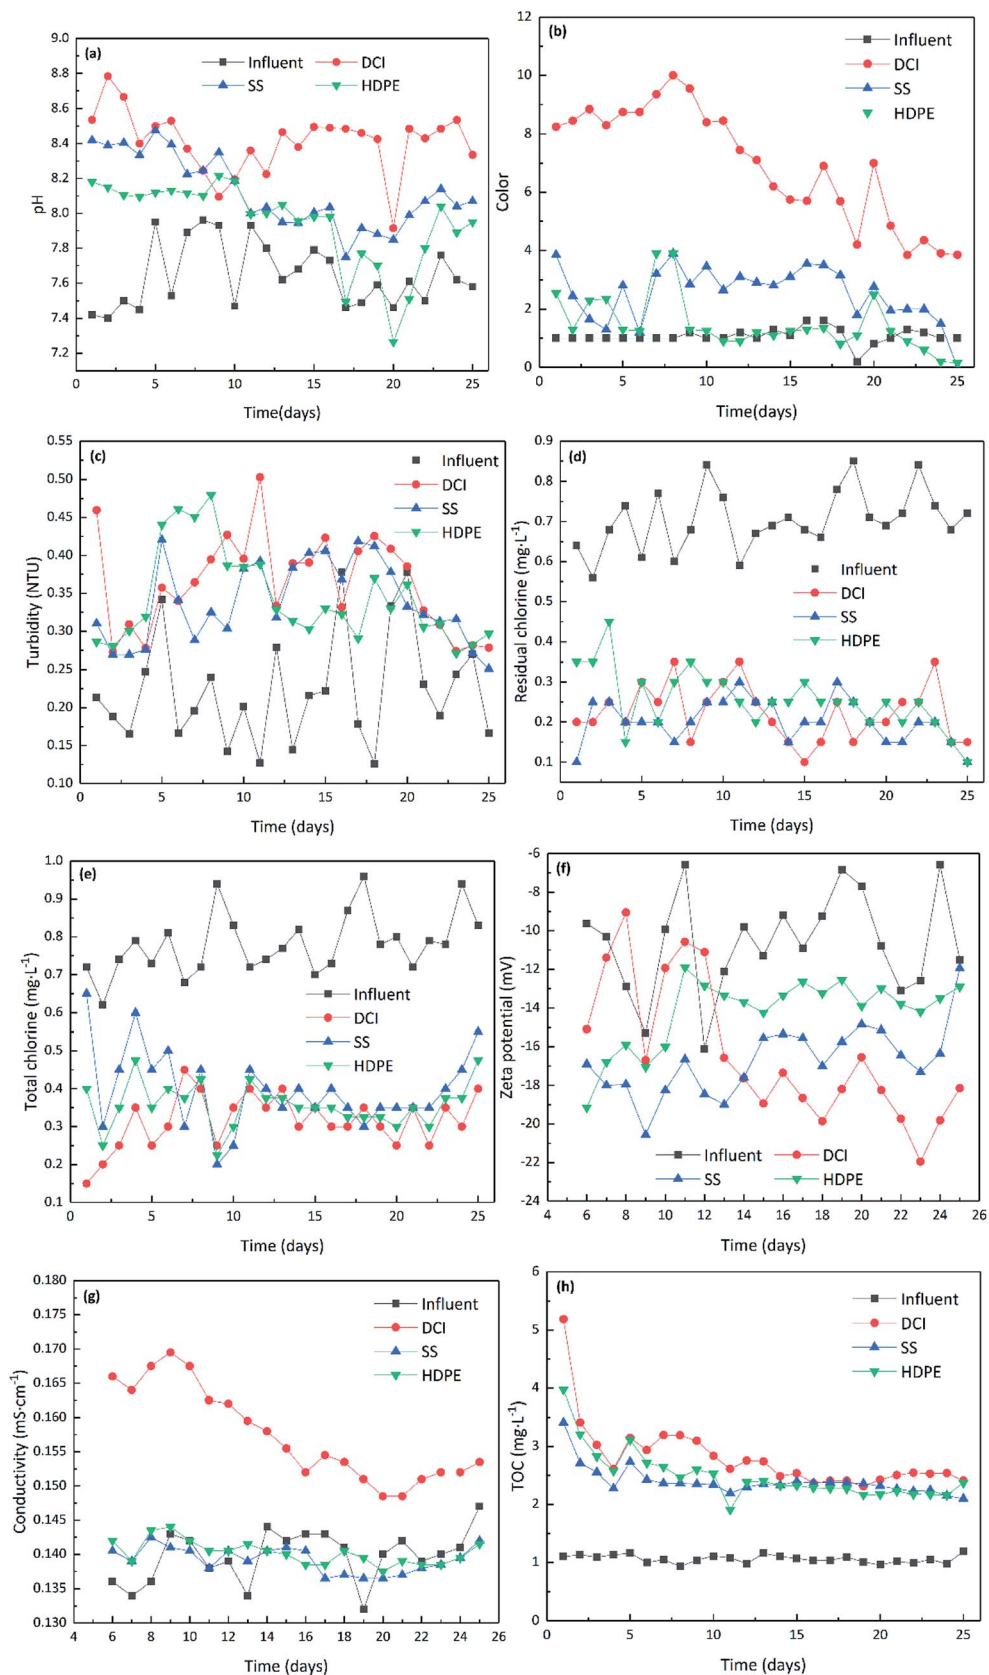
Water quality variations of the influent and effluents are shown in Fig. 1 and S2.† Fig. 1 (line chart) shows the changes in water quality index with the increase in running time within 25 days; moreover, Fig. S2† (box-plot) shows the overall situation of the water quality index over these 25 days.

Fig. 1 Variation of water quality in AR systems.

3.1.1 pH. Due to the different materials, there were significant differences in the effluent pH of the three tubings. As shown in Fig. 1(a) and S2(a),† the effluent pH values of the three tubings were always significantly higher than those of the influent, with that of the DCI pipe being the most significant. As shown in Fig. 1(a), when the pH of the influent was between 7.5 and 8.0, the pH of the effluents increased during operation, with the pH of the DCI pipe effluent always higher than 8.0, up to a highest pH of 8.8, while the pH of the SS and HDPE tubes was always less than 8.5. In the later stages of operation, the pH of the SS effluent was maintained at about 8.0, and the pH of HDPE was different from that of the influent. The laboratory simulation results are basically consistent with the actual water sample analysis results (ESI 2†). Although the lining of the DCI can protect the iron from corrosion, the dissolution of alkaline substances in the lining cause the pH to rise.^{28,41,42} Slaats *et al.* found that the corrosion of the inner walls of cement-containing pipes involves the leaching of hydroxides, causing pH changes and resulting in scaling in the water mains and domestic installations.⁴³ Bonds *et al.* reported that cement linings prevent tuberculation by creating a high pH at the pipe wall; moreover leachates from the uncoated cement lining can cause an undesirable rise in the pH of the water, particularly under low flow conditions in small-diameter pipes.⁴⁴ Due to the long HRT of this test (24 h), the dissolution of the DCI pipe resulted in a significant increase in pH.⁴³

As shown in Fig. 1(b) and S2(b),† during operation, the colour increase of the DCI pipe was significant, always higher

than that of the SS and HDPE pipes, such that the colour reached 10, and the colour of effluent in the SS and HDPE pipes also increased; however, the colour was maintained at within 4, and there was not much difference between the late effluent and the influent. Previous studies have found that the colour of the DCI pipe can significantly increase, mainly due to the dissolution of ferric ions contained in the iron-aluminum tetracalcium ($4\text{CaO}\cdot\text{Al}_2\text{O}_3\cdot\text{Fe}_2\text{O}_3$) in the cement mortar lining.^{41,42} Li *et al.* reported that the elevated pH is accompanied by high alkalinity, whereby CO_3^{2-} in bulk water might react with the iron release to generate poorly settling substances, such as siderite (FeCO_3), resulting in a rise in turbidity and colour.⁸

It can be seen from Fig. 1(c) and S2(c)† that, during operation, the turbidity of the effluent from the three tubings increased significantly. Among these, the HDPE pipe increased significantly in the first 10 days, and the effluent turbidity of the DCI pipe was unstable. Only the SS pipe remained at 0.35 NTU, and the turbidity of water from the latter three tubings was less than 0.3 NTU. During operation, the effluent turbidity of the three tubings were generally higher than the influent. The main reason for the turbidity characteristics of this kind of change may be due to the water being renewed every day, whereby the residual chlorine quickly kills the surviving microorganisms, making it difficult for the microorganisms to produce more extracellular secretions that can increase turbidity in the environment,⁴⁵ and the lining of the DCI pipe provides a haven for a small number of microorganisms. Also, the turbidity in the DCI pipe is more significant than that in the water from the SS and HDPE pipes. Simoes *et al.* reported that biofilm growth in DWDS contributes to the accumulation of inorganic particles, whereby any inorganic particle passing nearby (*e.g.* corrosion products, clays, sand) may be incorporated in the biofilms, in the distribution network, which are responsible for discoloured water and are a persistent cause of customer dissatisfaction.³¹

As shown in Fig. 1(d) and S2(d),† the trends in the consumption of residual chlorine in the three tubing sample

The zeta potentials were negative during the operation of the three tubing types in this research. Fig. 1(f) and S2(f)† show the zeta potential change. The zeta potential of the DCI pipe was gradually reduced from the initial –15.1 mV to –18 mV. The zeta potential of the SS pipe was relatively stable and was maintained at around –15 mV. The initial zeta potential of the HDPE pipe reached –19.1 mV, and this gradually increased and was maintained at –13 mV in the later stage. Previous studies have shown that under alkaline conditions, the zeta potential of the system is lower than that under acidic conditions, and the

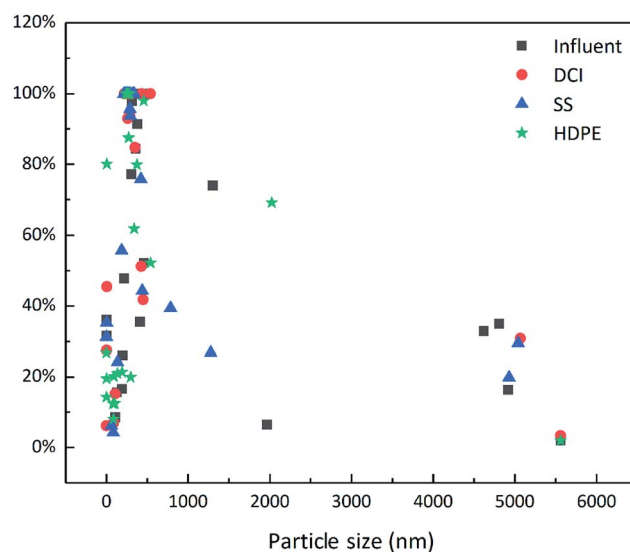
Fig. 2 shows the particle size distribution of the influent and effluents within 25 days. The particle size range (abscissa) of the particulates can be obtained from the particle size frequency distribution map, while the frequency (ordinate) of the particle size of each particulate within the particle size range can be quantified by the content of each particle size fraction present in the water. From Fig. 2, it was found that the soid content of the influent was lower, and the content of small particle sizes was more significant, with particles mainly concentrated in the 0 to 200 nm fraction, while the content of particles in the 400 to 600 nm fraction was relatively small. The large particle sizes in the effluent in the DCI and the SS pipes increased, mainly being concentrated in the 200 to 600 nm fraction, and their distribution at 400 nm was more concentrated. This is consistent with the particle-size distribution of the actual water sample (ESI 2†). The particle size of solids in the HDPE pipe samples showed no obvious change compared to the influent. Simoes *et al.* reported that biofilm growth in DWDS contributes to the accumulation of inorganic particles.³¹ Slaats *et al.* reported that when the pH increases, calcium carbonate can precipitate on

Fig. 2 Frequency distribution of particle size in the influent and effluents.

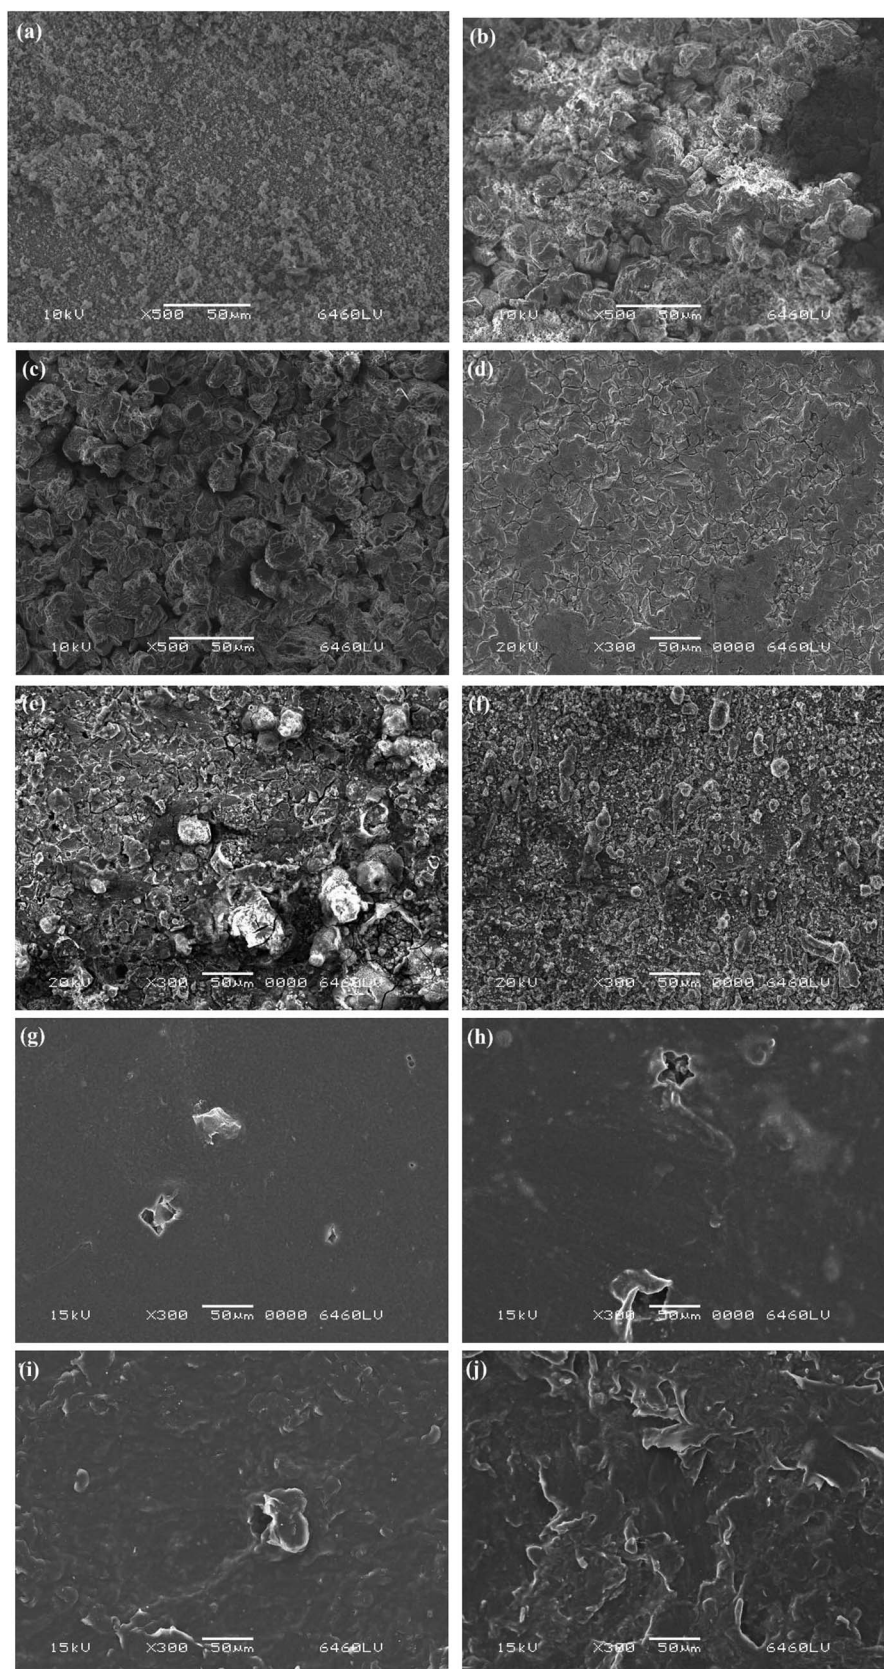
3.2.1 Micromorphology. Representative SEM images of the tubing inner walls during the different running stages are shown in Fig. 3, where it can be seen that the different tubing materials showed significant differences during operation, and even various different microstructural features could be seen in the same tubing samples.

Fig. 3 SEM image of the pipeline inner wall in the three different stages.

As shown in Fig. 3, the microstructure of the DCI pipe inner wall was loose and porous in the form of fine sand before running (Fig. 3(a)); then, relatively dense small grains appeared on the 14th day (Fig. 3(b)), and these became more prominent on the 25th day (Fig. 3(c)). Bonds *et al.* reported that the cement-mortar lining of DCI has cracks that can close and thereby the lining becomes tight after a period of exposure to water, but also the cement will eventually undergo autogenous healing, a phenomenon long recognised by the concrete industry and which occurs due to the formation of calcium carbonate and the continuing hydration of cement grains in the lining.⁴⁴

The SS pipe inner wall had a loose porous texture before running (Fig. 3(d)); then, obvious corrosion scales on the inner wall structure could be seen on the 14th day (Fig. 3(e)), and later the corrosion tubercles became smaller, and the inner walls were denser on the 25th day (Fig. 3(f)). These SEM images of SS are similar with the previous report.^{75,76} However, the corrosion of the SS pipe may not be that easy, as Zhang *et al.* reported that some loose floccus seen on the surface of their sample could represent the metabolites of bacteria.⁴⁰

Before running (Fig. 3(g)), and on the 14th day (Fig. 3(h)), the HDPE pipe inner walls were smooth, with obvious point-like small holes seen before running; the perforations therein increased, and the damage to the inner wall was clearly intensified on the 14th day, and then inner walls had become rough and compact by the 25th day (Fig. 3(i) and (j)). Leban *et al.* reported that the corrosion products were deposited especially around the perforation, with the shape of the perforations found on the pipe being of irregular shape with sharp angles.⁷⁵ These SEM images of HDPE are similar with the fouled membranes deposits and bacterial cells in the reports of Ayache *et al.*⁷⁷ and Rozej *et al.*⁶⁸, which imply that it is likely to be a change caused by biofilm formation or particle attachment.
