Cite this: *RSC Adv.*, 2019, 9, 4035

Characteristics of water quality and bacterial communities in three water supply pipelines†

Dongpo Liu,^{id} ^{ab} Juntao Jin,^{*ac} Sichen Liang^{ad} and Jinsong Zhang^{ab}

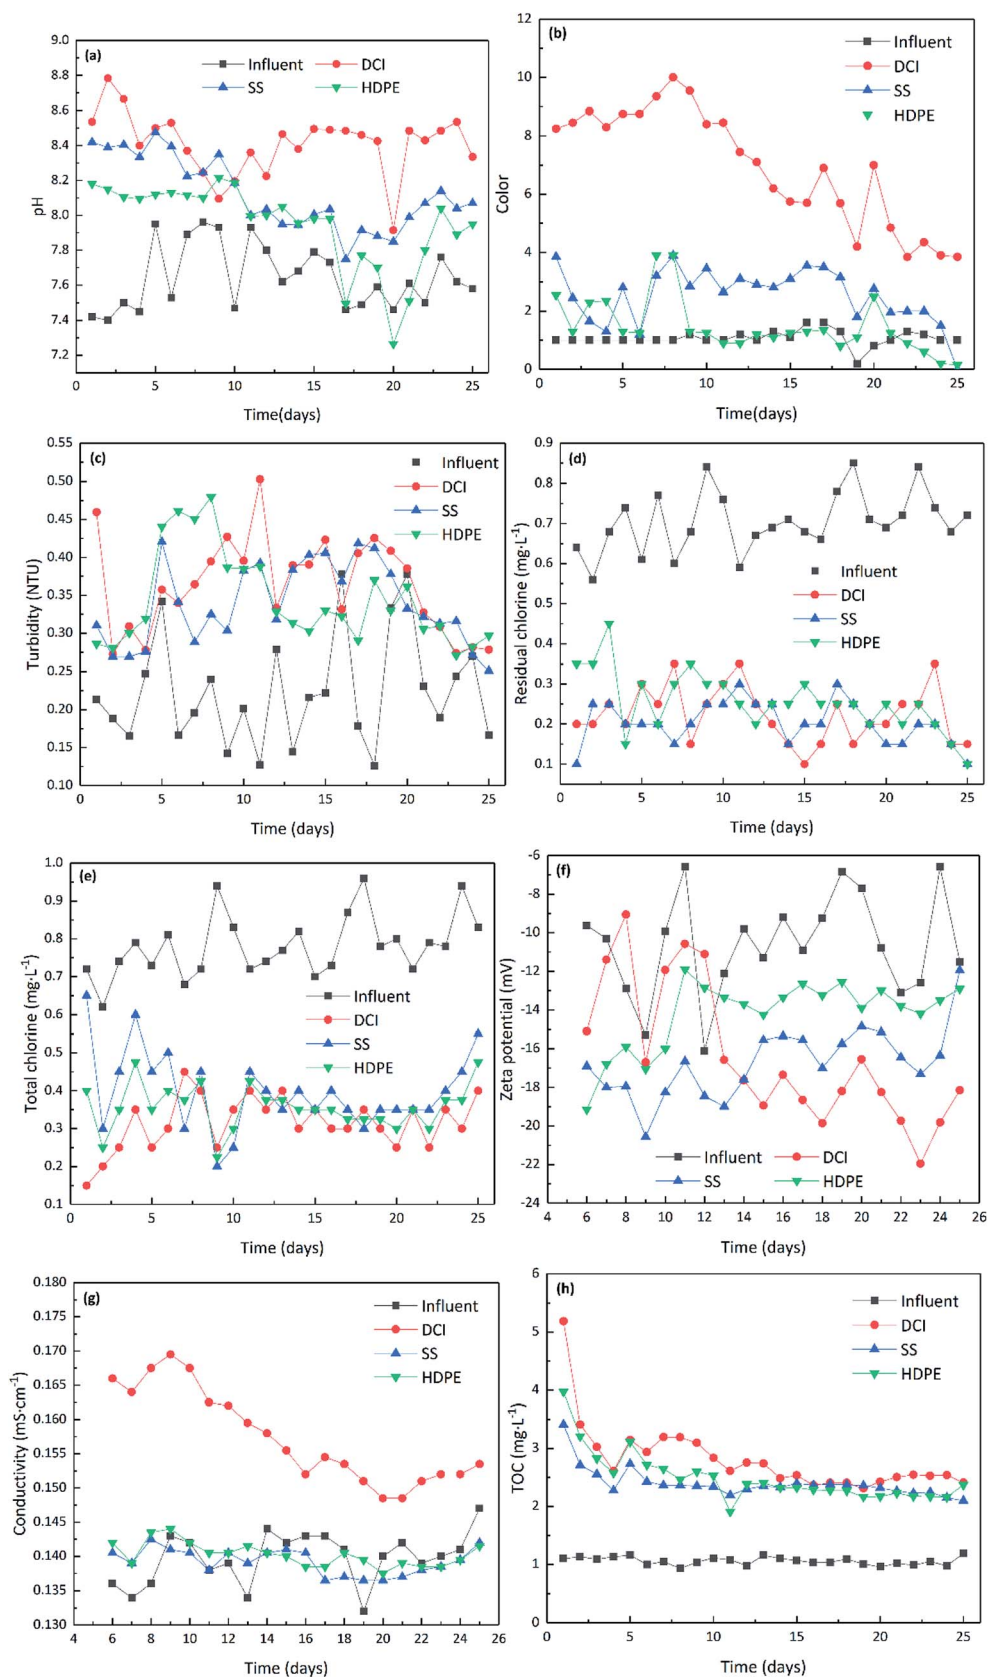
Water quality variations of the influent and effluents are shown in Fig. 1 and S2.† Fig. 1 (line chart) shows the changes in water quality index with the increase in running time within 25 days; moreover, Fig. S2† (box-plot) shows the overall situation of the water quality index over these 25 days.

Fig. 1 Variation of water quality in AR systems.

3.1.1 pH. Due to the different materials, there were significant differences in the effluent pH of the three tubings. As shown in Fig. 1(a) and S2(a),† the effluent pH values of the three tubings were always significantly higher than those of the influent, with that of the DCI pipe being the most significant. As shown in Fig. 1(a), when the pH of the influent was between 7.5 and 8.0, the pH of the effluents increased during operation, with the pH of the DCI pipe effluent always higher than 8.0, up to a highest pH of 8.8, while the pH of the SS and HDPE tubes was always less than 8.5. In the later stages of operation, the pH of the SS effluent was maintained at about 8.0, and the pH of HDPE was different from that of the influent. The laboratory simulation results are basically consistent with the actual water sample analysis results (ESI 2†). Although the lining of the DCI can protect the iron from corrosion, the dissolution of alkaline substances in the lining cause the pH to rise.^{28,41,42} Slaats *et al.* found that the corrosion of the inner walls of cement-containing pipes involves the leaching of hydroxides, causing pH changes and resulting in scaling in the water mains and domestic installations.⁴³ Bonds *et al.* reported that cement linings prevent tuberculation by creating a high pH at the pipe wall; moreover leachates from the uncoated cement lining can cause an undesirable rise in the pH of the water, particularly under low flow conditions in small-diameter pipes.⁴⁴ Due to the long HRT of this test (24 h), the dissolution of the DCI pipe resulted in a significant increase in pH.⁴³

As shown in Fig. 1(b) and S2(b),† during operation, the colour increase of the DCI pipe was significant, always higher

than that of the SS and HDPE pipes, such that the colour reached 10, and the colour of effluent in the SS and HDPE pipes also increased; however, the colour was maintained at within 4, and there was not much difference between the late effluent and the influent. Previous studies have found that the colour of the DCI pipe can significantly increase, mainly due to the dissolution of ferric ions contained in the iron-aluminum tetracalcium ($4\text{CaO}\cdot\text{Al}_2\text{O}_3\cdot\text{Fe}_2\text{O}_3$) in the cement mortar lining.^{41,42} Li *et al.* reported that the elevated pH is accompanied by high alkalinity, whereby CO_3^{2-} in bulk water might react with the iron release to generate poorly settling substances, such as siderite (FeCO_3), resulting in a rise in turbidity and colour.⁸

It can be seen from Fig. 1(c) and S2(c)† that, during operation, the turbidity of the effluent from the three tubings increased significantly. Among these, the HDPE pipe increased significantly in the first 10 days, and the effluent turbidity of the DCI pipe was unstable. Only the SS pipe remained at 0.35 NTU, and the turbidity of water from the latter three tubings was less than 0.3 NTU. During operation, the effluent turbidity of the three tubings were generally higher than the influent. The main reason for the turbidity characteristics of this kind of change may be due to the water being renewed every day, whereby the residual chlorine quickly kills the surviving microorganisms, making it difficult for the microorganisms to produce more extracellular secretions that can increase turbidity in the environment,⁴⁵ and the lining of the DCI pipe provides a haven for a small number of microorganisms. Also, the turbidity in the DCI pipe is more significant than that in the water from the SS and HDPE pipes. Simoes *et al.* reported that biofilm growth in DWDS contributes to the accumulation of inorganic particles, whereby any inorganic particle passing nearby (*e.g.* corrosion products, clays, sand) may be incorporated in the biofilms, in the distribution network, which are responsible for discoloured water and are a persistent cause of customer dissatisfaction.³¹

As shown in Fig. 1(d) and S2(d),† the trends in the consumption of residual chlorine in the three tubing sample

The zeta potentials were negative during the operation of the three tubing types in this research. Fig. 1(f) and S2(f)† show the zeta potential change. The zeta potential of the DCI pipe was gradually reduced from the initial –15.1 mV to –18 mV. The zeta potential of the SS pipe was relatively stable and was maintained at around –15 mV. The initial zeta potential of the HDPE pipe reached –19.1 mV, and this gradually increased and was maintained at –13 mV in the later stage. Previous studies have shown that under alkaline conditions, the zeta potential of the system is lower than that under acidic conditions, and the
