Cite this: *RSC Adv.*, 2019, 9, 4035

Characteristics of water quality and bacterial communities in three water supply pipelines†

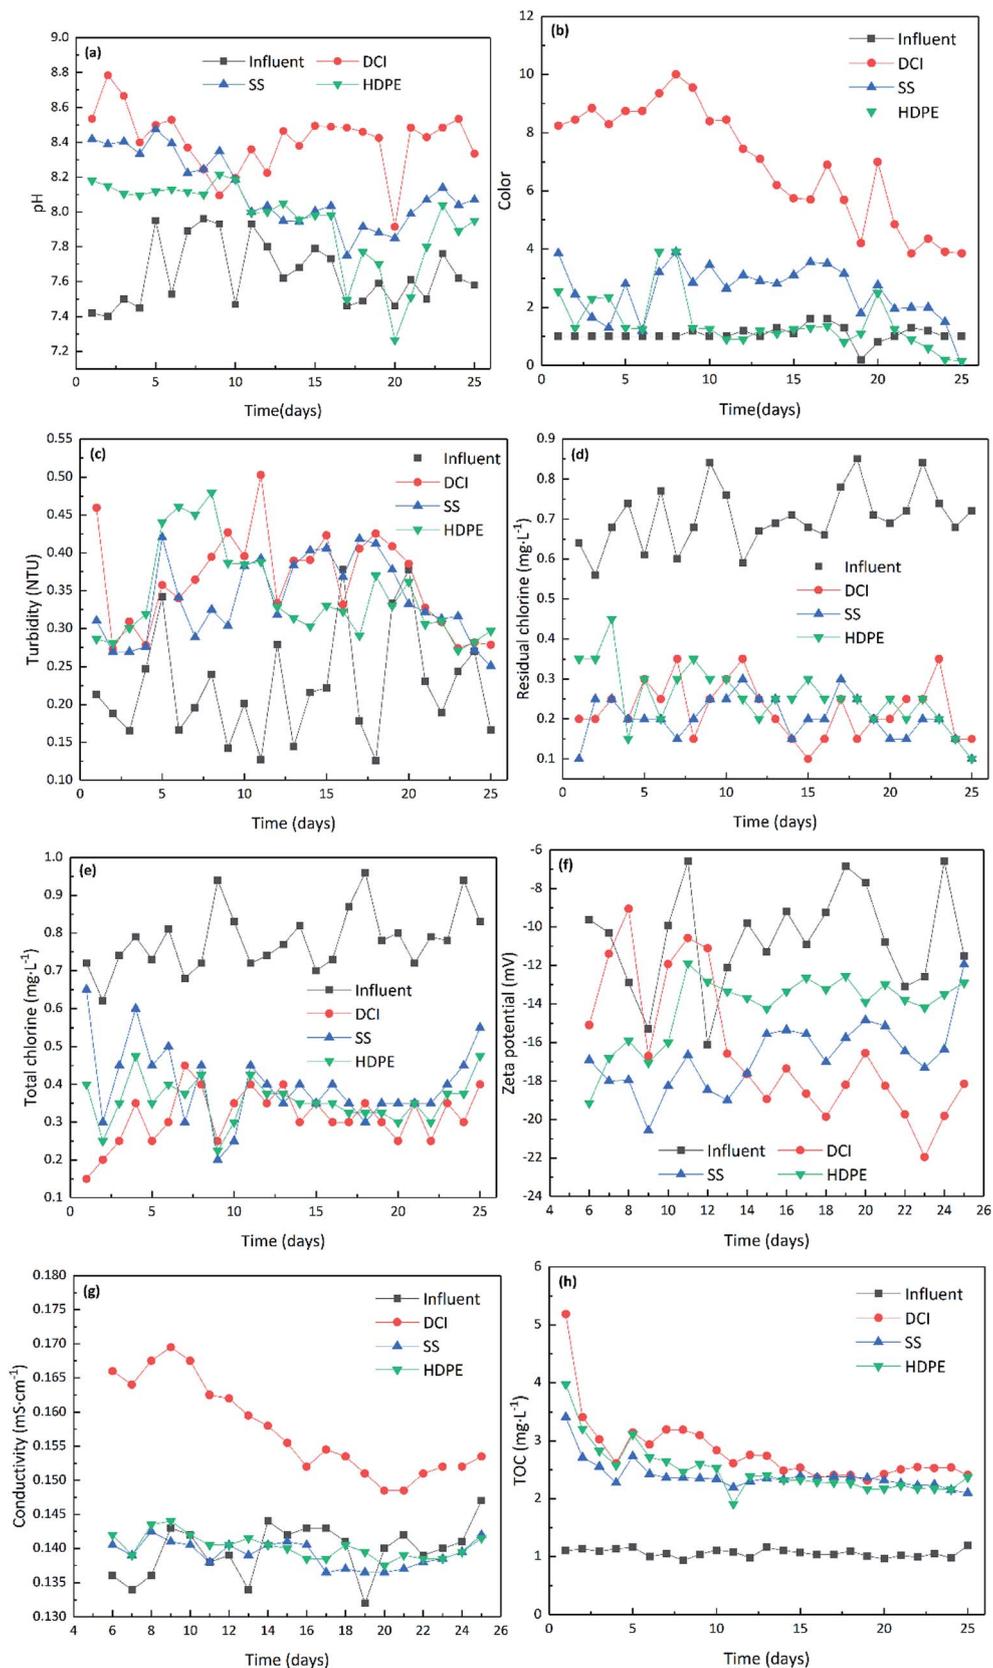
Water quality variations of the influent and effluents are shown in Fig. 1 and S2.† Fig. 1 (line chart) shows the changes in water quality index with the increase in running time within 25 days; moreover, Fig. S2† (box-plot) shows the overall situation of the water quality index over these 25 days.

Fig. 1 Variation of water quality in AR systems.

3.1.1 pH. Due to the different materials, there were significant differences in the effluent pH of the three tubings. As shown in Fig. 1(a) and S2(a),† the effluent pH values of the three tubings were always significantly higher than those of the influent, with that of the DCI pipe being the most significant. As shown in Fig. 1(a), when the pH of the influent was between 7.5 and 8.0, the pH of the effluents increased during operation, with the pH of the DCI pipe effluent always higher than 8.0, up to a highest pH of 8.8, while the pH of the SS and HDPE tubes was always less than 8.5. In the later stages of operation, the pH of the SS effluent was maintained at about 8.0, and the pH of HDPE was different from that of the influent. The laboratory simulation results are basically consistent with the actual water sample analysis results (ESI 2†). Although the lining of the DCI can protect the iron from corrosion, the dissolution of alkaline substances in the lining cause the pH to rise.^{28,41,42} Slaats *et al.* found that the corrosion of the inner walls of cement-containing pipes involves the leaching of hydroxides, causing pH changes and resulting in scaling in the water mains and domestic installations.⁴³ Bonds *et al.* reported that cement linings prevent tuberculation by creating a high pH at the pipe wall; moreover leachates from the uncoated cement lining can cause an undesirable rise in the pH of the water, particularly under low flow conditions in small-diameter pipes.⁴⁴ Due to the long HRT of this test (24 h), the dissolution of the DCI pipe resulted in a significant increase in pH.⁴³

As shown in Fig. 1(b) and S2(b),† during operation, the colour increase of the DCI pipe was significant, always higher

than that of the SS and HDPE pipes, such that the colour reached 10, and the colour of effluent in the SS and HDPE pipes also increased; however, the colour was maintained at within 4, and there was not much difference between the late effluent and the influent. Previous studies have found that the colour of the DCI pipe can significantly increase, mainly due to the dissolution of ferric ions contained in the iron-aluminum tetracalcium ($4\text{CaO}\cdot\text{Al}_2\text{O}_3\cdot\text{Fe}_2\text{O}_3$) in the cement mortar lining.^{41,42} Li *et al.* reported that the elevated pH is accompanied by high alkalinity, whereby CO_3^{2-} in bulk water might react with the iron release to generate poorly settling substances, such as siderite (FeCO_3), resulting in a rise in turbidity and colour.⁸

It can be seen from Fig. 1(c) and S2(c)† that, during operation, the turbidity of the effluent from the three tubings increased significantly. Among these, the HDPE pipe increased significantly in the first 10 days, and the effluent turbidity of the DCI pipe was unstable. Only the SS pipe remained at 0.35 NTU, and the turbidity of water from the latter three tubings was less than 0.3 NTU. During operation, the effluent turbidity of the three tubings were generally higher than the influent. The main reason for the turbidity characteristics of this kind of change may be due to the water being renewed every day, whereby the residual chlorine quickly kills the surviving microorganisms, making it difficult for the microorganisms to produce more extracellular secretions that can increase turbidity in the environment,⁴⁵ and the lining of the DCI pipe provides a haven for a small number of microorganisms. Also, the turbidity in the DCI pipe is more significant than that in the water from the SS and HDPE pipes. Simoes *et al.* reported that biofilm growth in DWDS contributes to the accumulation of inorganic particles, whereby any inorganic particle passing nearby (*e.g.* corrosion products, clays, sand) may be incorporated in the biofilms, in the distribution network, which are responsible for discoloured water and are a persistent cause of customer dissatisfaction.³¹

As shown in Fig. 1(d) and S2(d),† the trends in the consumption of residual chlorine in the three tubing sample

The zeta potentials were negative during the operation of the three tubing types in this research. Fig. 1(f) and S2(f)† show the zeta potential change. The zeta potential of the DCI pipe was gradually reduced from the initial –15.1 mV to –18 mV. The zeta potential of the SS pipe was relatively stable and was maintained at around –15 mV. The initial zeta potential of the HDPE pipe reached –19.1 mV, and this gradually increased and was maintained at –13 mV in the later stage. Previous studies have shown that under alkaline conditions, the zeta potential of the system is lower than that under acidic conditions, and the

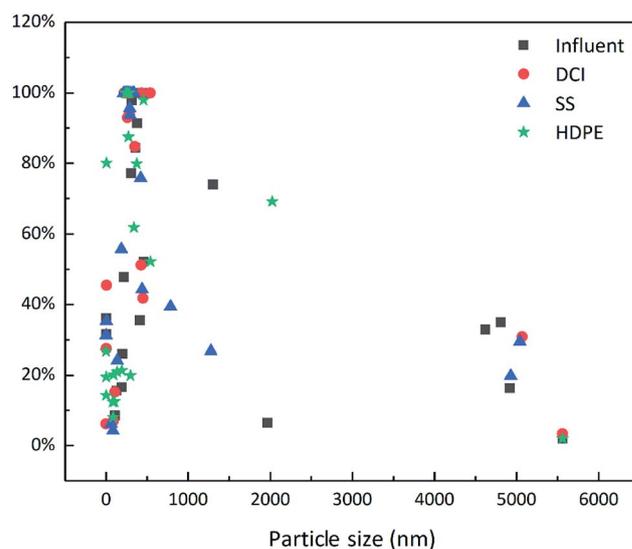
Fig. 2 shows the particle size distribution of the influent and effluents within 25 days. The particle size range (abscissa) of the particulates can be obtained from the particle size frequency distribution map, while the frequency (ordinate) of the particle size of each particulate within the particle size range can be quantified by the content of each particle size fraction present in the water. From Fig. 2, it was found that the soid content of the influent was lower, and the content of small particle sizes was more significant, with particles mainly concentrated in the 0 to 200 nm fraction, while the content of particles in the 400 to 600 nm fraction was relatively small. The large particle sizes in the effluent in the DCI and the SS pipes increased, mainly being concentrated in the 200 to 600 nm fraction, and their distribution at 400 nm was more concentrated. This is consistent with the particle-size distribution of the actual water sample (ESI 2†). The particle size of solids in the HDPE pipe samples showed no obvious change compared to the influent. Simoes *et al.* reported that biofilm growth in DWDS contributes to the accumulation of inorganic particles.³¹ Slaats *et al.* reported that when the pH increases, calcium carbonate can precipitate on

Fig. 2 Frequency distribution of particle size in the influent and effluents.

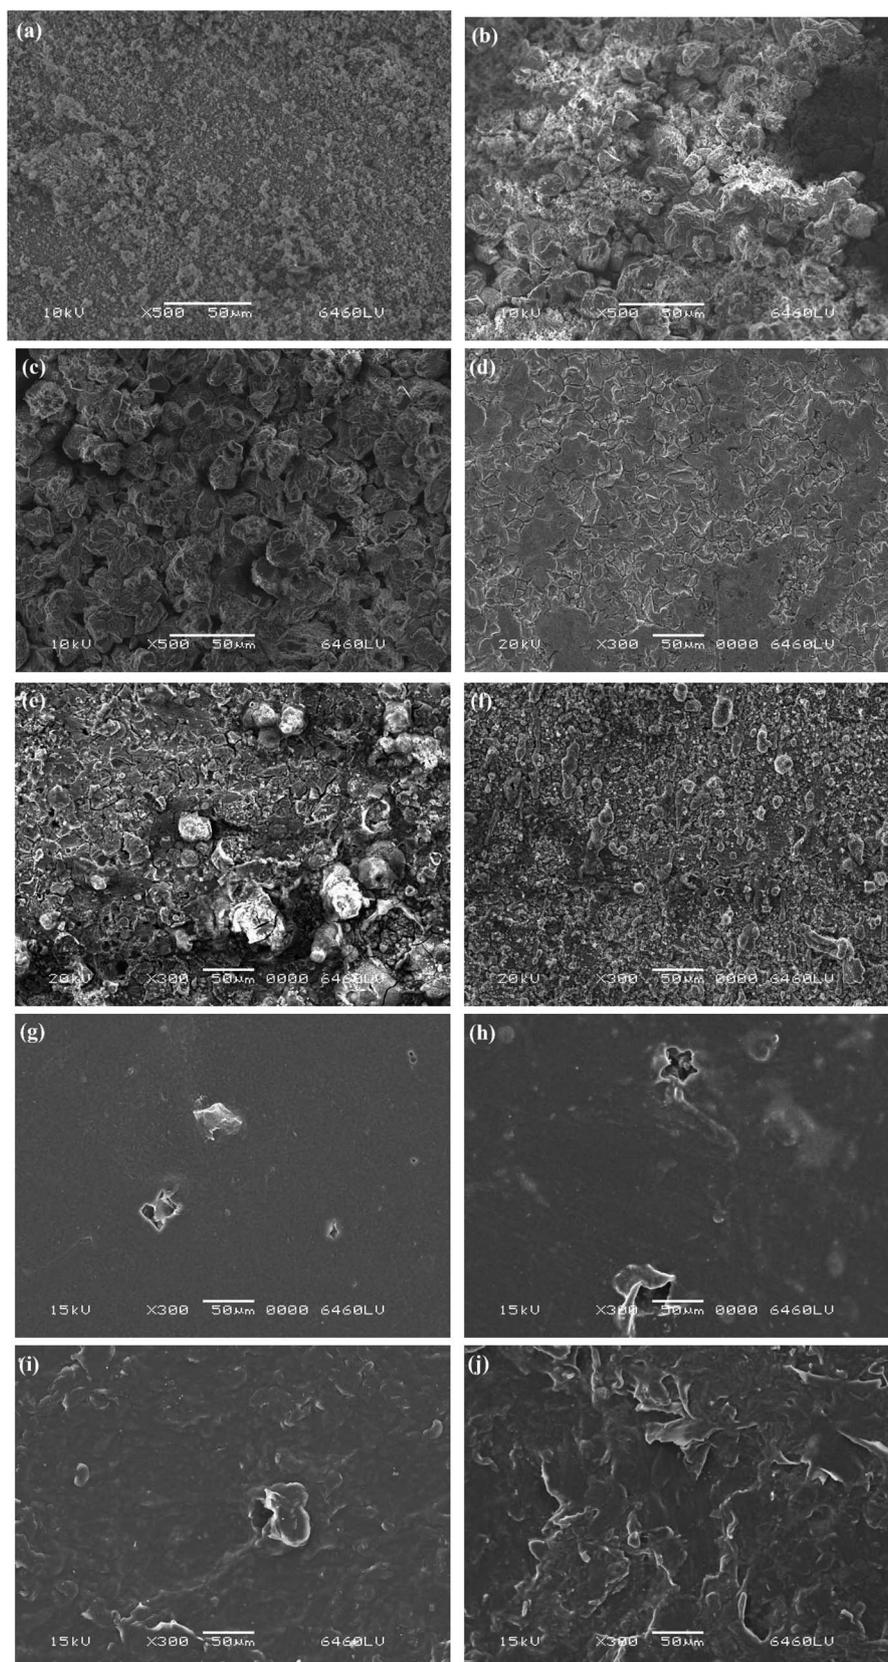
3.2.1 Micromorphology. Representative SEM images of the tubing inner walls during the different running stages are shown in Fig. 3, where it can be seen that the different tubing materials showed significant differences during operation, and even various different microstructural features could be seen in the same tubing samples.

Fig. 3 SEM image of the pipeline inner wall in the three different stages.

As shown in Fig. 3, the microstructure of the DCI pipe inner wall was loose and porous in the form of fine sand before running (Fig. 3(a)); then, relatively dense small grains appeared on the 14th day (Fig. 3(b)), and these became more prominent on the 25th day (Fig. 3(c)). Bonds *et al.* reported that the cement-mortar lining of DCI has cracks that can close and thereby the lining becomes tight after a period of exposure to water, but also the cement will eventually undergo autogenous healing, a phenomenon long recognised by the concrete industry and which occurs due to the formation of calcium carbonate and the continuing hydration of cement grains in the lining.⁴⁴

The SS pipe inner wall had a loose porous texture before running (Fig. 3(d)); then, obvious corrosion scales on the inner wall structure could be seen on the 14th day (Fig. 3(e)), and later the corrosion tubercles became smaller, and the inner walls were denser on the 25th day (Fig. 3(f)). These SEM images of SS are similar with the previous report.^{75,76} However, the corrosion of the SS pipe may not be that easy, as Zhang *et al.* reported that some loose floccus seen on the surface of their sample could represent the metabolites of bacteria.⁴⁰

Before running (Fig. 3(g)), and on the 14th day (Fig. 3(h)), the HDPE pipe inner walls were smooth, with obvious point-like small holes seen before running; the perforations therein increased, and the damage to the inner wall was clearly intensified on the 14th day, and then inner walls had become rough and compact by the 25th day (Fig. 3(i) and (j)). Leban *et al.* reported that the corrosion products were deposited especially around the perforation, with the shape of the perforations found on the pipe being of irregular shape with sharp angles.⁷⁵ These SEM images of HDPE are similar with the fouled membranes deposits and bacterial cells in the reports of Ayache *et al.*⁷⁷ and Rozej *et al.*⁶⁸, which imply that it is likely to be a change caused by biofilm formation or particle attachment.

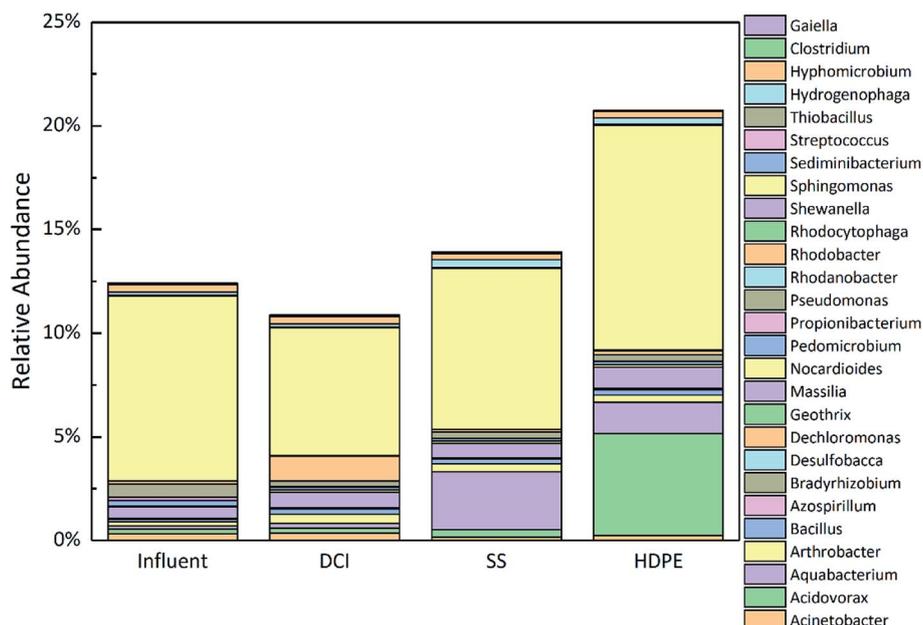
The relative abundance of the various corrosive-related bacteria in the influent and different pipeline effluents are shown in Fig. 4. *Sphingomonas* was dominant in both the influent and effluent of the three tubing material samples (8.9209%, 6.1609%, 7.7781%, and 10.8632%, respectively), followed by *Pseudomonas* (0.6265%) and *Massilia* (0.5473%) in the influent, *Rhodobacter* (1.2033%) and *Massilia* (0.7555%) in the DCI tube effluent, *Aquabacterium* (2.8047%) and *Massilia* (0.6892%) in the SS tube effluent and *Acidovorax* (4.9221%) and *Aquabacterium* (1.5092%) in the HDPE tube effluent. It could thus be seen that the different tubing materials affected the different corrosive bacterial communities.^{28,45,82,84,87,95,96}

Fig. 4 Relative community abundance of corrosion microorganisms at the genus level.

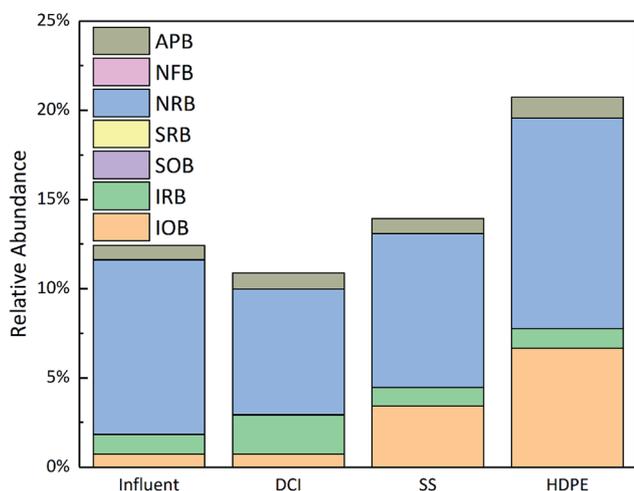
In Fig. 5, the bacterial community was counted according to the different functional types. It was found that NRB was always the most corrosive bacteria in the water from the influent to the effluent. Compared with the pipeline microbial community found in previous research, the relative abundance of the microbial community in this study was relatively low, mainly due to the initial use of new pipelines, and as stable microbial community structures had not yet formed inside the pipeline. Previous researchs has found that *Acidovorax* (IOB), *Aquabacterium* (IOB), *Sediminibacterium* (IOB) and *Desulfobacca* (SRB) promote corrosion, while *Thiobacillus* (SOB), *Geothrix* (IRB), *Pseudomonas* (IRB) *Bacillus* (IRB), etc. suppress corrosion.^{24,97–99} Therefore, it can be found from the overall microbial community structure that the microbial community that inhibits corrosion in the pipeline gives the main benefit, whereby the deterioration of the water quality of the pipeline is reduced and the corrosion of the inner wall of the pipeline is reduced.

Fig. 5 Relative abundance of different corrosive functional bacteria at the genus level.
