Characteristics of water quality and bacterial communities in three water supply pipelines†

Dongpo Liu, ^{ab} Juntao Jin, ^{*ac} Sichen Liang^{ad} and Jinsong Zhang^{ab}

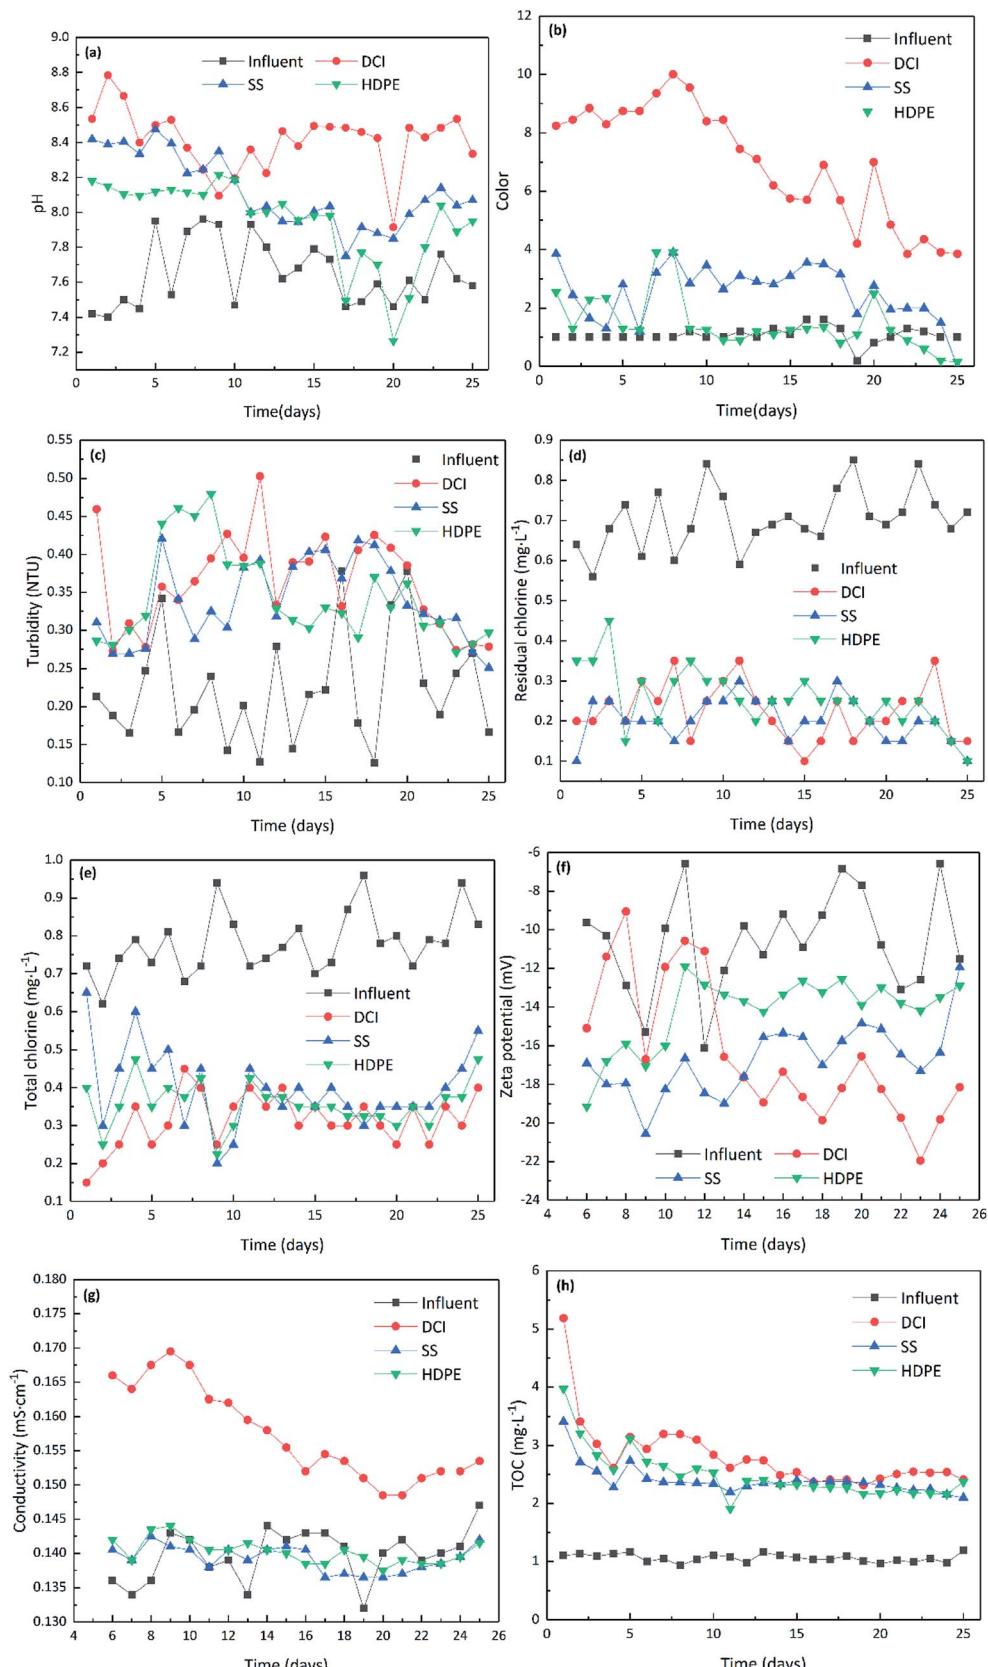
Water quality variations of the influent and effluents are shown in Fig. 1 and S2.[†] Fig. 1 (line chart) shows the changes in water quality index with the increase in running time within 25 days; moreover, Fig. S2[†] (box-plot) shows the overall situation of the water quality index over these 25 days.

Fig. 1 Variation of water quality in AR systems.

3.1.1 pH. Due to the different materials, there were significant differences in the effluent pH of the three tubings. As shown in Fig. 1(a) and S2(a),[†] the effluent pH values of the three tubings were always significantly higher than those of the influent, with that of the DCI pipe being the most significant. As shown in Fig. 1(a), when the pH of the influent was between 7.5 and 8.0, the pH of the effluents increased during operation, with the pH of the DCI pipe effluent always higher than 8.0, up to a highest pH of 8.8, while the pH of the SS and HDPE tubes was always less than 8.5. In the later stages of operation, the pH of the SS effluent was maintained at about 8.0, and the pH of HDPE was different from that of the influent. The laboratory simulation results are basically consistent with the actual water sample analysis results (ESI 2[†]). Although the lining of the DCI can protect the iron from corrosion, the dissolution of alkaline substances in the lining cause the pH to rise.^{28,41,42} Slaats *et al.* found that the corrosion of the inner walls of cement-containing pipes involves the leaching of hydroxides, causing pH changes and resulting in scaling in the water mains and domestic installations.⁴³ Bonds *et al.* reported that cement linings prevent tuberculation by creating a high pH at the pipe wall; moreover leachates from the uncoated cement lining can cause an undesirable rise in the pH of the water, particularly under low flow conditions in small-diameter pipes.⁴⁴ Due to the long HRT of this test (24 h), the dissolution of the DCI pipe resulted in a significant increase in pH.⁴³

As shown in Fig. 1(b) and S2(b),[†] during operation, the colour increase of the DCI pipe was significant, always higher

than that of the SS and HDPE pipes, such that the colour reached 10, and the colour of effluent in the SS and HDPE pipes also increased; however, the colour was maintained at within 4, and there was not much difference between the late effluent and the influent. Previous studies have found that the colour of the DCI pipe can significantly increase, mainly due to the dissolution of ferric ions contained in the iron-aluminum tetracalcium ($4\text{CaO}\cdot\text{Al}_2\text{O}_3\cdot\text{Fe}_2\text{O}_3$) in the cement mortar lining.^{41,42} Li *et al.* reported that the elevated pH is accompanied by high alkalinity, whereby CO_3^{2-} in bulk water might react with the iron release to generate poorly settling substances, such as siderite (FeCO_3), resulting in a rise in turbidity and colour.⁸

It can be seen from Fig. 1(c) and S2(c)† that, during operation, the turbidity of the effluent from the three tubings increased significantly. Among these, the HDPE pipe increased significantly in the first 10 days, and the effluent turbidity of the DCI pipe was unstable. Only the SS pipe remained at 0.35 NTU, and the turbidity of water from the latter three tubings was less than 0.3 NTU. During operation, the effluent turbidity of the three tubings were generally higher than the influent. The main reason for the turbidity characteristics of this kind of change may be due to the water being renewed every day, whereby the residual chlorine quickly kills the surviving microorganisms, making it difficult for the microorganisms to produce more extracellular secretions that can increase turbidity in the environment,⁴⁵ and the lining of the DCI pipe provides a haven for a small number of microorganisms. Also, the turbidity in the DCI pipe is more significant than that in the water from the SS and HDPE pipes. Simoes *et al.* reported that biofilm growth in DWDS contributes to the accumulation of inorganic particles, whereby any inorganic particle passing nearby (e.g. corrosion products, clays, sand) may be incorporated in the biofilms, in the distribution network, which are responsible for discoloured water and are a persistent cause of customer dissatisfaction.³¹

As shown in Fig. 1(d) and S2(d),† the trends in the consumption of residual chlorine in the three tubing sample

The zeta potentials were negative during the operation of the three tubing types in this research. Fig. 1(f) and S2(f)† show the zeta potential change. The zeta potential of the DCI pipe was gradually reduced from the initial –15.1 mV to –18 mV. The zeta potential of the SS pipe was relatively stable and was maintained at around –15 mV. The initial zeta potential of the HDPE pipe reached –19.1 mV, and this gradually increased and was maintained at –13 mV in the later stage. Previous studies have shown that under alkaline conditions, the zeta potential of the system is lower than that under acidic conditions, and the

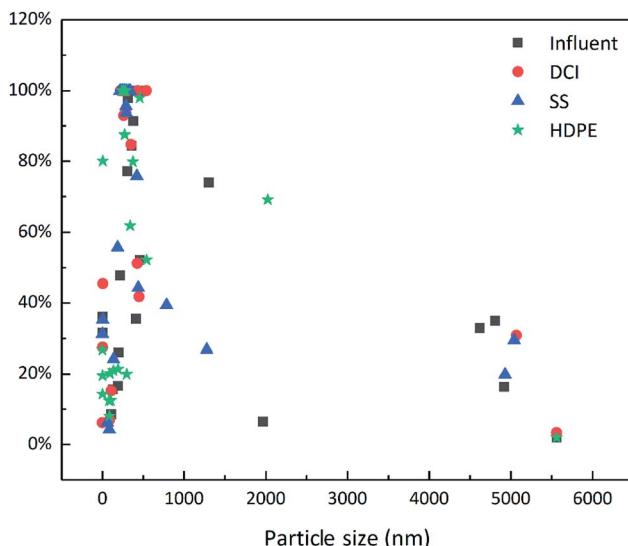
Fig. 2 shows the particle size distribution of the influent and effluents within 25 days. The particle size range (abscissa) of the particulates can be obtained from the particle size frequency distribution map, while the frequency (ordinate) of the particle size of each particulate within the particle size range can be quantified by the content of each particle size fraction present in the water. From Fig. 2, it was found that the solid content of the influent was lower, and the content of small particle sizes was more significant, with particles mainly concentrated in the 0 to 200 nm fraction, while the content of particles in the 400 to 600 nm fraction was relatively small. The large particle sizes in the effluent in the DCI and the SS pipes increased, mainly being concentrated in the 200 to 600 nm fraction, and their distribution at 400 nm was more concentrated. This is consistent with the particle-size distribution of the actual water sample (ESI 2†). The particle size of solids in the HDPE pipe samples showed no obvious change compared to the influent. Simoes *et al.* reported that biofilm growth in DWDS contributes to the accumulation of inorganic particles.³¹ Slaats *et al.* reported that when the pH increases, calcium carbonate can precipitate on

Fig. 2 Frequency distribution of particle size in the influent and effluents.

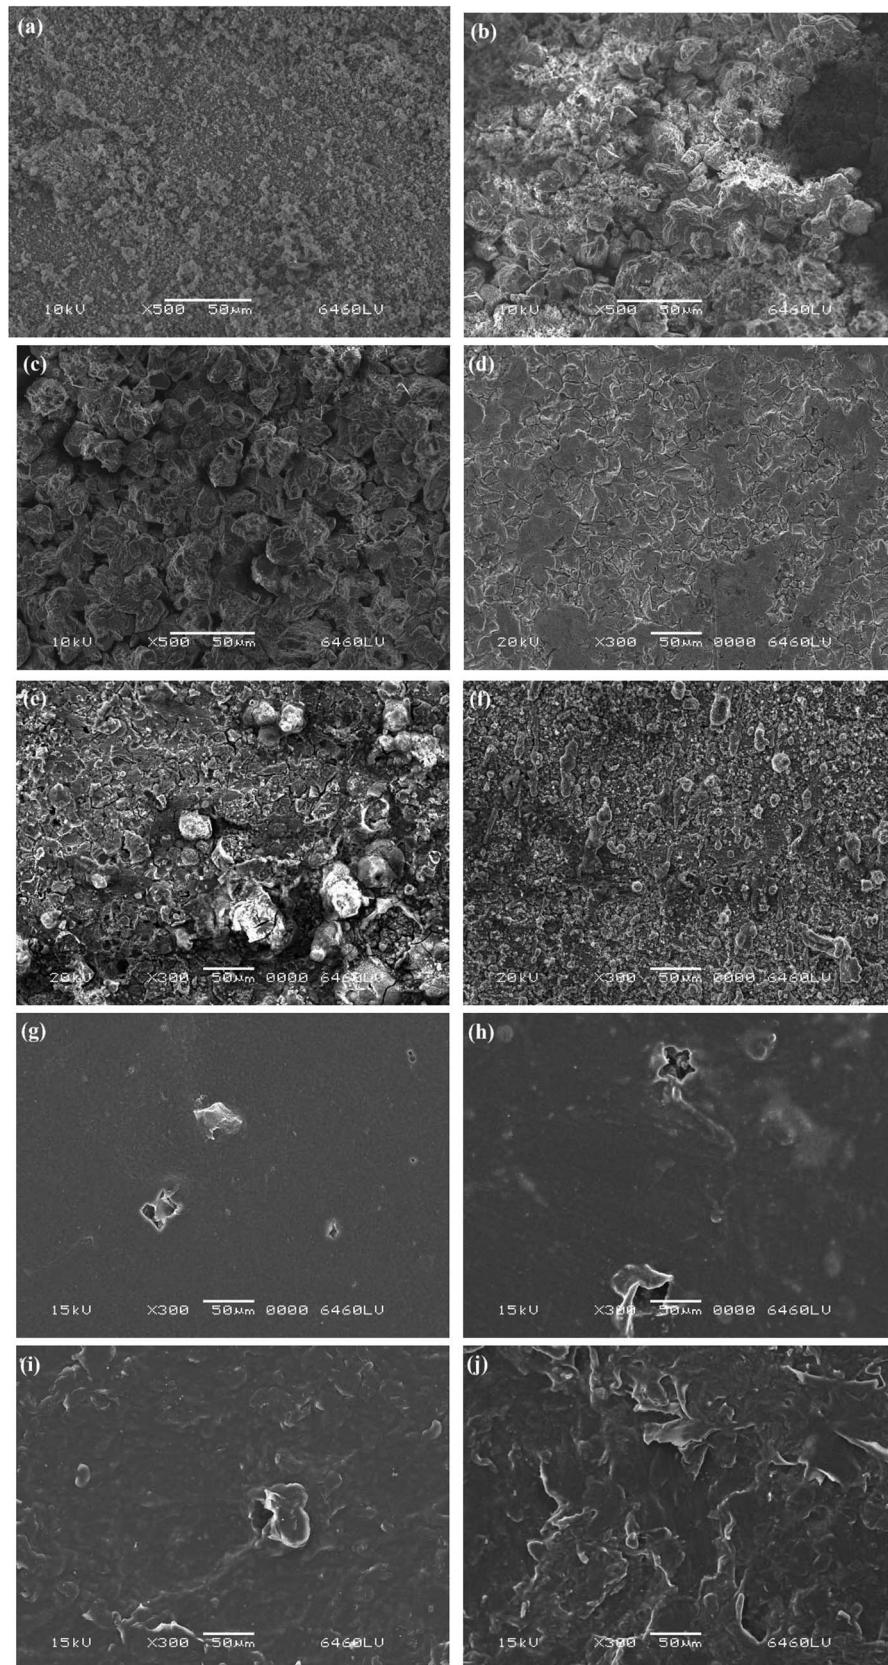
3.2.1 Micromorphology. Representative SEM images of the tubing inner walls during the different running stages are shown in Fig. 3, where it can be seen that the different tubing materials showed significant differences during operation, and even various different microstructural features could be seen in the same tubing samples.

Fig. 3 SEM image of the pipeline inner wall in the three different stages.

As shown in Fig. 3, the microstructure of the DCI pipe inner wall was loose and porous in the form of fine sand before running (Fig. 3(a)); then, relatively dense small grains appeared on the 14th day (Fig. 3(b)), and these became more prominent on the 25th day (Fig. 3(c)). Bonds *et al.* reported that the cement-mortar lining of DCI has cracks that can close and thereby the lining becomes tight after a period of exposure to water, but also the cement will eventually undergo autogenous healing, a phenomenon long recognised by the concrete industry and which occurs due to the formation of calcium carbonate and the continuing hydration of cement grains in the lining.⁴⁴

The SS pipe inner wall had a loose porous texture before running (Fig. 3(d)); then, obvious corrosion scales on the inner wall structure could be seen on the 14th day (Fig. 3(e)), and later the corrosion tubercles became smaller, and the inner walls were denser on the 25th day (Fig. 3(f)). These SEM images of SS are similar with the previous report.^{75,76} However, the corrosion of the SS pipe may not be that easy, as Zhang *et al.* reported that some loose floccus seen on the surface of their sample could represent the metabolites of bacteria.⁴⁰

Before running (Fig. 3(g)), and on the 14th day (Fig. 3(h)), the HDPE pipe inner walls were smooth, with obvious point-like small holes seen before running; the perforations therein increased, and the damage to the inner wall was clearly intensified on the 14th day, and then inner walls had become rough and compact by the 25th day (Fig. 3(i) and (j)). Leban *et al.* reported that the corrosion products were deposited especially around the perforation, with the shape of the perforations found on the pipe being of irregular shape with sharp angles.⁷⁵ These SEM images of HDPE are similar with the fouled membranes deposits and bacterial cells in the reports of Ayache *et al.*⁷⁷ and Rožej *et al.*⁶⁸, which imply that it is likely to be a change caused by biofilm formation or particle attachment.

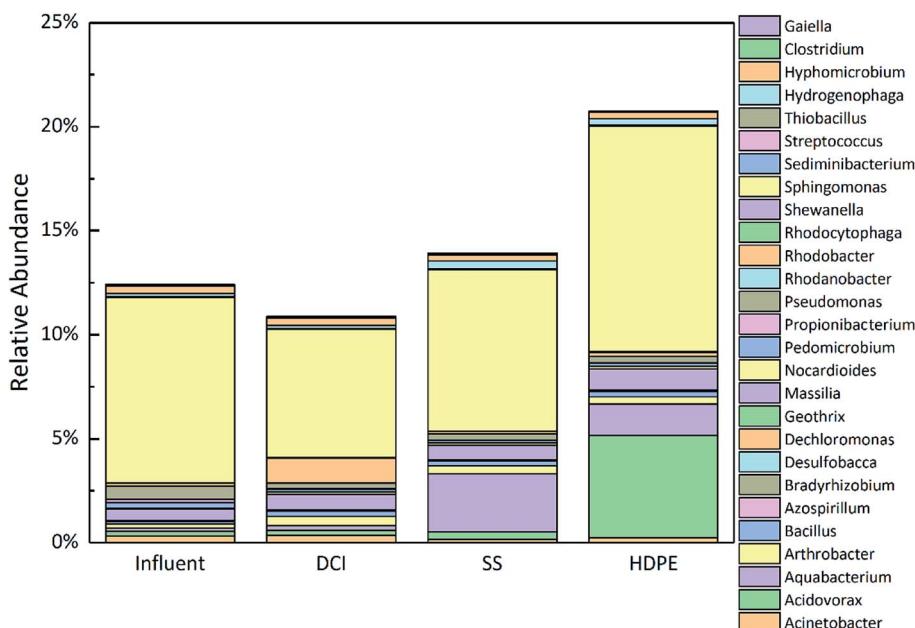
The relative abundance of the various corrosive-related bacteria in the influent and different pipeline effluents are shown in Fig. 4. *Sphingomonas* was dominant in both the influent and effluent of the three tubing material samples (8.9209%, 6.1609%, 7.7781%, and 10.8632%, respectively), followed by *Pseudomonas* (0.6265%) and *Massilia* (0.5473%) in the influent, *Rhodobacter* (1.2033%) and *Massilia* (0.7555%) in the DCI tube effluent, *Aquabacterium* (2.8047%) and *Massilia* (0.6892%) in the SS tube effluent and *Acidovorax* (4.9221%) and *Aquabacterium* (1.5092%) in the HDPE tube effluent. It could thus be seen that the different tubing materials affected the different corrosive bacterial communities.^{28,45,82,84,87,95,96}

Fig. 4 Relative community abundance of corrosion microorganisms at the genus level.

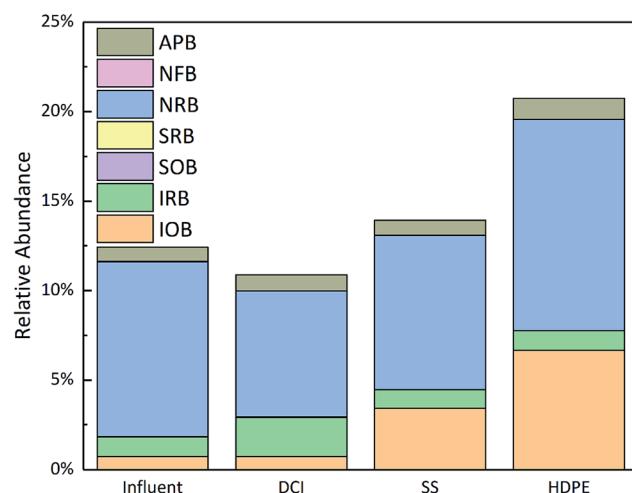
In Fig. 5, the bacterial community was counted according to the different functional types. It was found that NRB was always the most corrosive bacteria in the water from the influent to the effluent. Compared with the pipeline microbial community found in previous research, the relative abundance of the microbial community in this study was relatively low, mainly due to the initial use of new pipelines, and as stable microbial community structures had not yet formed inside the pipeline. Previous research has found that *Acidovorax* (IOB), *Aquabacterium* (IOB), *Sediminibacterium* (IOB) and *Desulfobacca* (SRB) promote corrosion, while *Thiobacillus* (SOB), *Geothrix* (IRB), *Pseudomonas* (IRB) *Bacillus* (IRB), etc. suppress corrosion.^{24,97-99} Therefore, it can be found from the overall microbial community structure that the microbial community that inhibits corrosion in the pipeline gives the main benefit, whereby the deterioration of the water quality of the pipeline is reduced and the corrosion of the inner wall of the pipeline is reduced.

Fig. 5 Relative abundance of different corrosive functional bacteria at the genus level.
