Cite this: *RSC Adv.*, 2019, 9, 24935

DOI: 10.1039/c9ra04027g

Failure behavior of nylon products for red phosphorus flame retardant electrical connectors

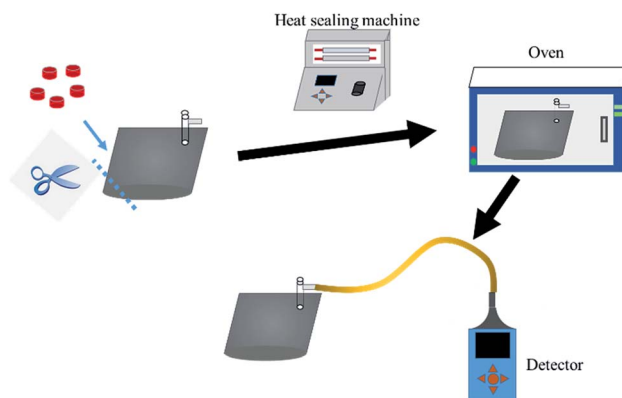
Fig. 2 Schematic diagram of phosphine detection.

Phosphine released by red phosphorus would rapidly reacts with air and water to form an acid under high temperature and humidity. In order to determine phosphine release, 2 g product was deposited in a sealed and dried 500 ml aluminum foil gas collection bag (Fig. 2). After 7 d, 14 d and 21 d, the concentration of phosphine gas in the bag was determined by the BH-90A phosphine detector.

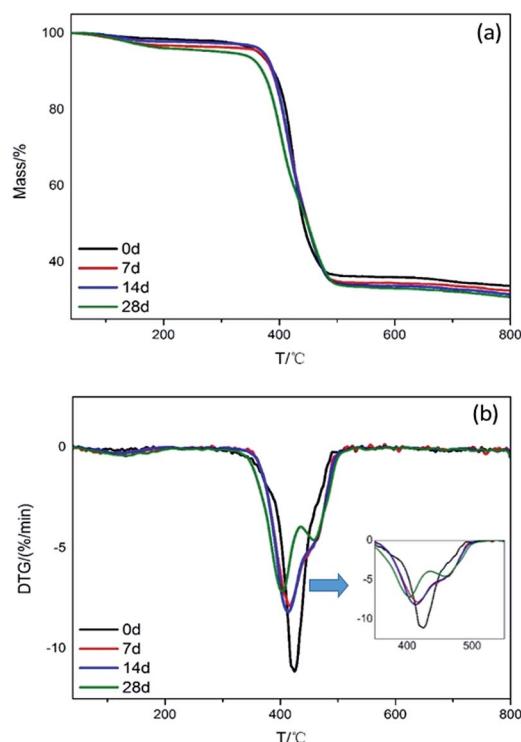
Fig. 3 TGA and DTG curves of connectors in N_2 atmosphere.

Thermal degradation behaviors of the connectors were investigated by TG and DTG, corresponding curves and data are

presented in Fig. 3 and summarized in Table 1. As the environmental test progressing, the initial decomposition temperature ($T_{5\%}$, temperature based on 5% mass loss), the maximum mass loss rate (R_{max}), temperature corresponding to the maximum mass loss rate (T_{max}) and the value of char residues (CR) for connectors at 800 °C all reduced, indicating that the thermal stability of connectors exposed to high temperature and humidity environment diminished. The appearance of the mass loss rate peak for 28 days indicates that the connector produced a new component in the high temperature and humidity environment. Reduced CR indicated that the phosphine released from red phosphorus reacted with water to form various oxygen-containing, phosphorus-based acids, such as phosphoric acid, phosphorous acid, and hypophosphorous acid,

and then partially transferred to the copper sheet by corrosion, resulting in a reduced char forming ability.

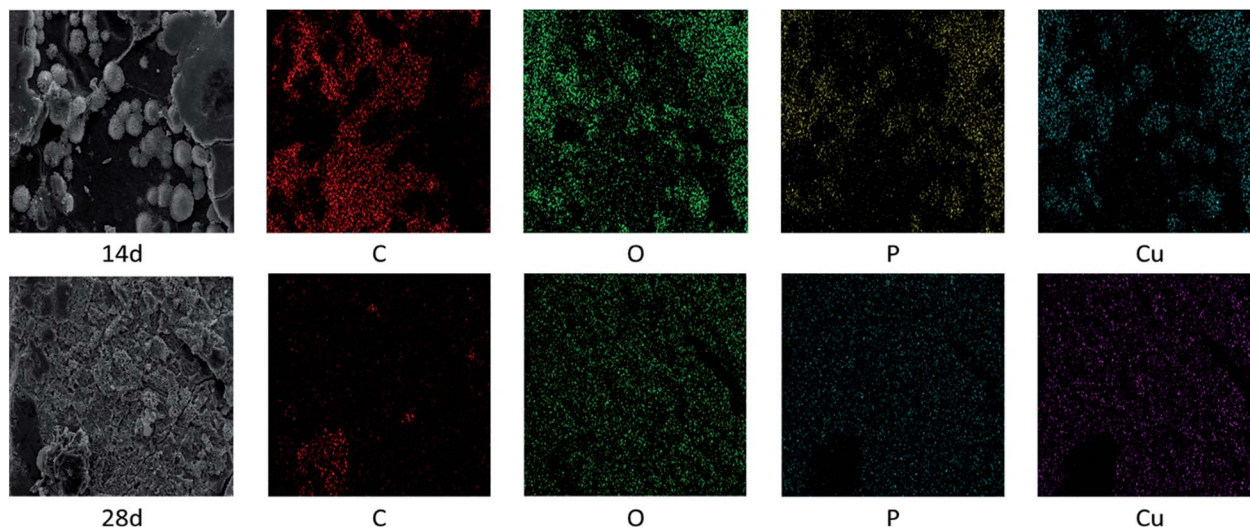
Fig. 6 and Table 2 exhibits the evolution of the elemental dispersion on the surface of connectors. As showed in Fig. 5, the spherical substance was mainly composed of P, O, and Cu elements. The elemental content given in Table 2 indicated that the substance was increasing over time. Phosphorus could not be detected on the surface at the beginning and after 7 days until the globular substance containing phosphorus was formed. With the time increase, the concentration gradient of phosphorus was produced from inside to surface. At the same time, the content of oxygen increased. It proved that phosphorus reacted with water and air to form phosphoric acid through these cracks in the high temperature and humidity environment and the phosphoric acid corroded the copper sheet attached to the connectors to form copper phosphate species on the surface.

Fig. 6 EDS images of connectors tested for 14 d and 28 d.

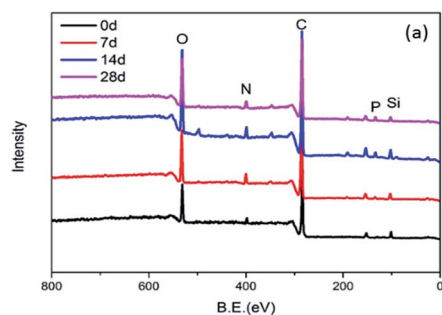
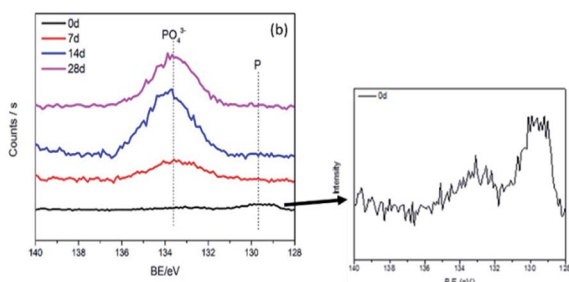
X-ray photoelectron energy spectrum analysis. XPS spectrum of survey scan for connectors is exhibited in Fig. 7 and elemental content of connectors tested for different days is showed in Table 3. The intensity of carbon and oxygen is very strong with traces of N and Si existing. Nevertheless, the signal intensity of phosphorus is very low.

The P 2p high-resolution spectra of connectors are exhibited in Fig. 7. There are two main peaks, 129.4 eV corresponding to red phosphorus; 133.4 eV corresponding to phosphate anion.²⁴ The presence of these peaks affirms that red phosphorus was

Fig. 7 Wide-scan (a) and P 2p high-resolution (b) XPS spectra for connectors.

oxidized to phosphate. The intensities of peaks increases gradually and reaches a stable state, confirming that phosphate concentration increased with test prolonging, especially in the first 14 days.

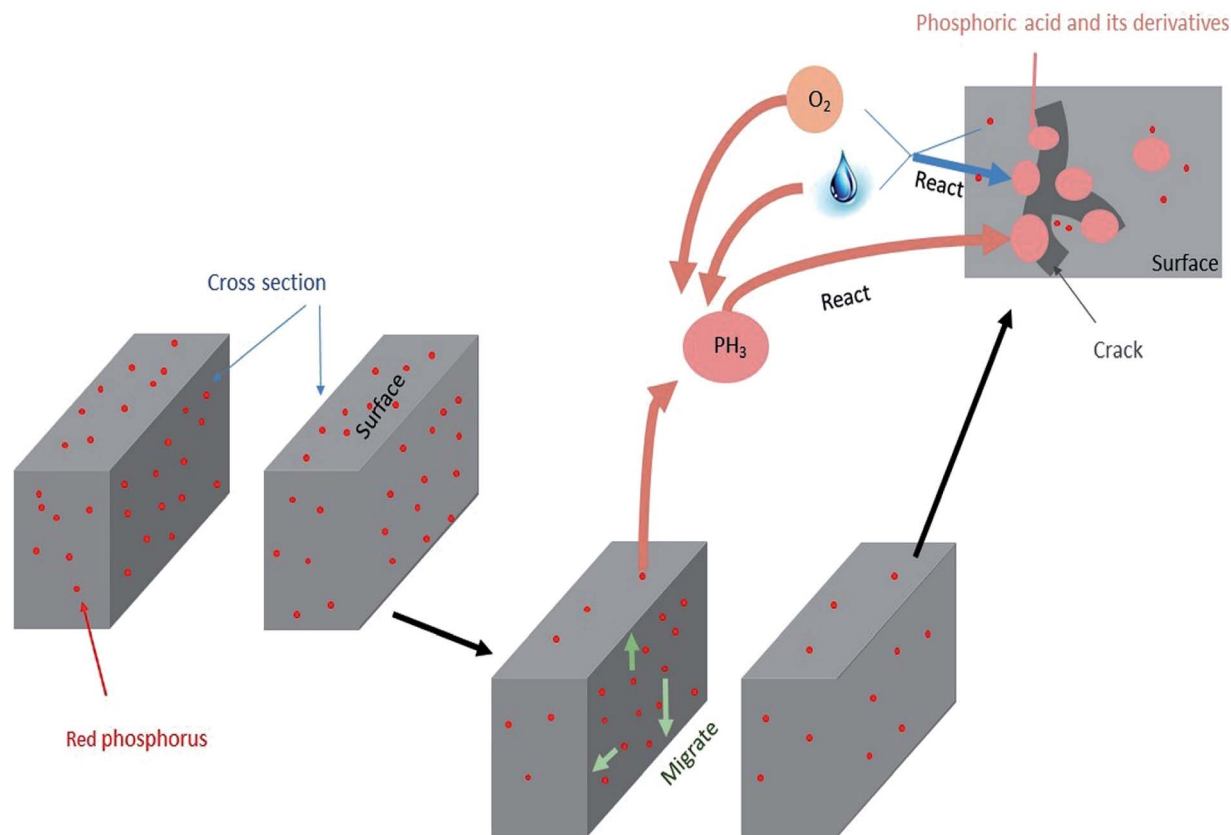
Fig. 9 Failure behaviour mechanism diagram.

The mechanism of failure behaviour is revealed in Fig. 9. After connectors had undergone high temperature and humidity environmental testing, red phosphorus migrated to the surface and accumulated into several areas. At the same time, significant degradation occurred, the decomposition temperature was advanced and -OH and phosphorus oxides were formed. The surface morphology of connector became rough with cracks increasing and the copper attached to connector formed copper phosphate. The content of phosphorus and oxygen on the surface increased and the chemical environment of phosphorus changed from elemental phosphorus to phosphoric acid derivatives. The amount of phosphine released increased and it reacted with water and oxygen to form acids. Correspondingly, the formation of phosphoric acid derivatives accelerated the degradation process of nylon. Surface cracks caused by degradation resulted in red phosphorus to be further oxidized to an acid. The mutual promotion caused the failure behavior of the red phosphorus flame retardant PA66 electrical connector.
