# Failure behavior of nylon products for red phosphorus flame retardant electrical connectors

The failure behavior of red phosphorus flame retardant electrical connectors was investigated by their thermal degradation, changes of surface morphology and elements under an accelerating environmental experiment. The results showed that the nylon electrical connector degraded and cracks were generated on the surface. The temperature of maximum weight loss rate was advanced in the thermogravimetric analysis and the third weight loss peaks appeared after 28 days. The relative atomic content of O and P increased from 0 day to 28 days. The chemical environment of C changed. Partially, C–C bonds broke and became C–O bonds. The release of phosphine increased and this further oxidized to an acid with P=O and P–O groups in a warm and humid environment.

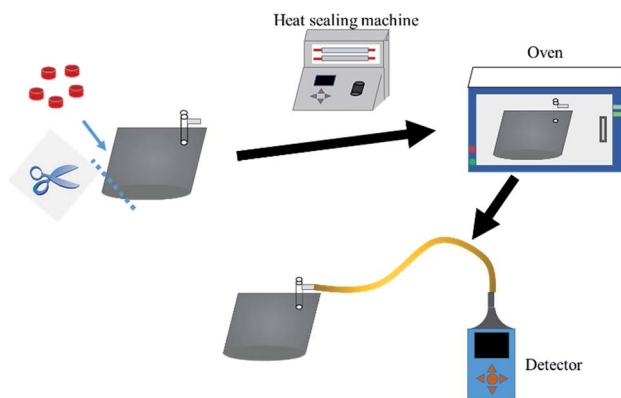
Fig. 2 Schematic diagram of phosphine detection.

Phosphine released by red phosphorus would rapidly reacts with air and water to form an acid under high temperature and humidity. In order to determine phosphine release, 2 g product was deposited in a sealed and dried 500 ml aluminum foil gas collection bag (Fig. 2). After 7 d, 14 d and 21 d, the concentration of phosphine gas in the bag was determined by the BH-90A phosphine detector.

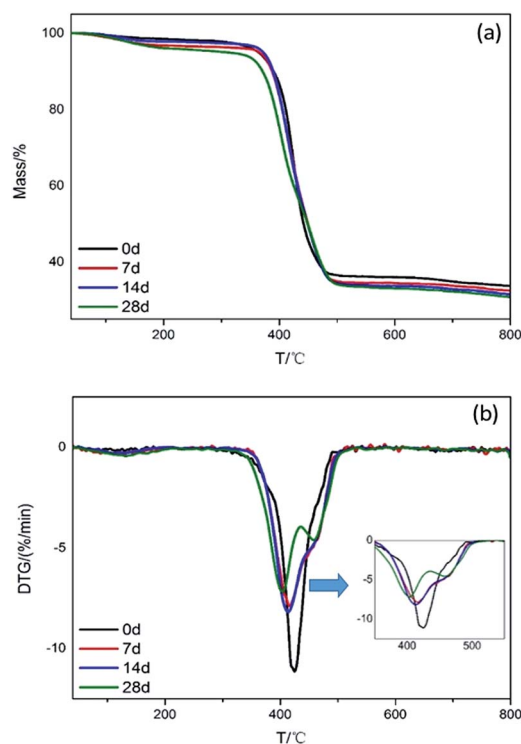
presented in Fig. 3 and summarized in Table 1. As the environmental test progressing, the initial decomposition temperature ( $T_{5\%}$ , temperature based on 5% mass loss), the maximum mass loss rate ( $R_{\text{max}}$ ), temperature corresponding to the maximum mass loss rate ( $T_{\text{max}}$ ) and the value of char residues (CR) for connectors at 800 °C all reduced, indicating that the thermal stability of connectors exposed to high temperature and humidity environment diminished. The appearance of the mass loss rate peak for 28 days indicates that the connector produced a new component in the high temperature and humidity environment. Reduced CR indicated that the phosphine released from red phosphorus reacted with water to form various oxygen-containing, phosphorus-based acids, such as phosphoric acid, phosphorous acid, and hypophosphorous acid,

Fig. 3 TGA and DTG curves of connectors in  $\text{N}_2$  atmosphere.

and then partially transferred to the copper sheet by corrosion, resulting in a reduced char forming ability.

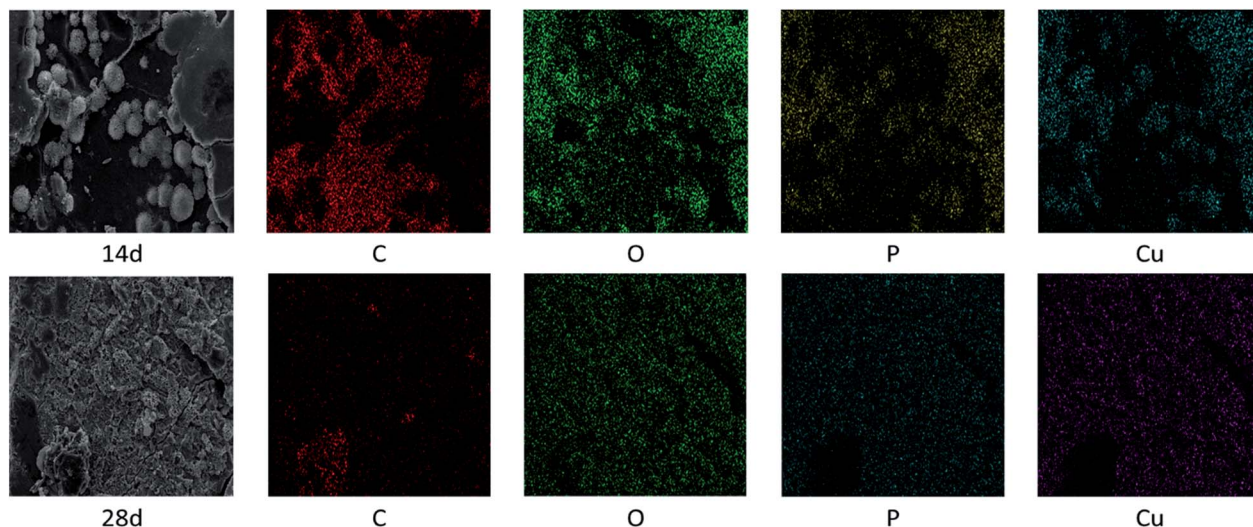
Fig. 6 and Table 2 exhibits the evolution of the elemental dispersion on the surface of connectors. As showed in Fig. 5, the spherical substance was mainly composed of P, O, and Cu elements. The elemental content given in Table 2 indicated that the substance was increasing over time. Phosphorus could not be detected on the surface at the beginning and after 7 days until the globular substance containing phosphorus was formed. With the time increase, the concentration gradient of phosphorus was produced from inside to surface. At the same time, the content of oxygen increased. It proved that phosphorus reacted with water and air to form phosphoric acid through these cracks in the high temperature and humidity environment and the phosphoric acid corroded the copper sheet attached to the connectors to form copper phosphate species on the surface.

Fig. 6 EDS images of connectors tested for 14 d and 28 d.
