# Failure behavior of nylon products for red phosphorus flame retardant electrical connectors

The failure behavior of red phosphorus flame retardant electrical connectors was investigated by their thermal degradation, changes of surface morphology and elements under an accelerating environmental experiment. The results showed that the nylon electrical connector degraded and cracks were generated on the surface. The temperature of maximum weight loss rate was advanced in the thermogravimetric analysis and the third weight loss peaks appeared after 28 days. The relative atomic content of O and P increased from 0 day to 28 days. The chemical environment of C changed. Partially, C–C bonds broke and became C–O bonds. The release of phosphine increased and this further oxidized to an acid with P=O and P–O groups in a warm and humid environment.

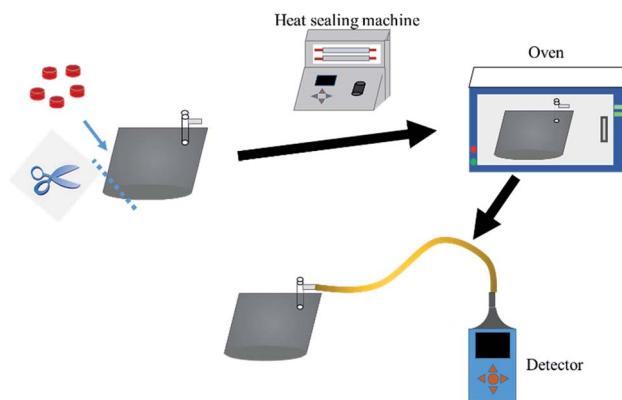
Fig. 2 Schematic diagram of phosphine detection.

Phosphine released by red phosphorus would rapidly reacts with air and water to form an acid under high temperature and humidity. In order to determine phosphine release, 2 g product was deposited in a sealed and dried 500 ml aluminum foil gas collection bag (Fig. 2). After 7 d, 14 d and 21 d, the concentration of phosphine gas in the bag was determined by the BH-90A phosphine detector.
