Failure behavior of nylon products for red phosphorus flame retardant electrical connectors

The failure behavior of red phosphorus flame retardant electrical connectors was investigated by their thermal degradation, changes of surface morphology and elements under an accelerating environmental experiment. The results showed that the nylon electrical connector degraded and cracks were generated on the surface. The temperature of maximum weight loss rate was advanced in the thermogravimetric analysis and the third weight loss peaks appeared after 28 days. The relative atomic content of O and P increased from 0 day to 28 days. The chemical environment of C changed. Partially, C–C bonds broke and became C–O bonds. The release of phosphine increased and this further oxidized to an acid with P=O and P–O groups in a warm and humid environment.

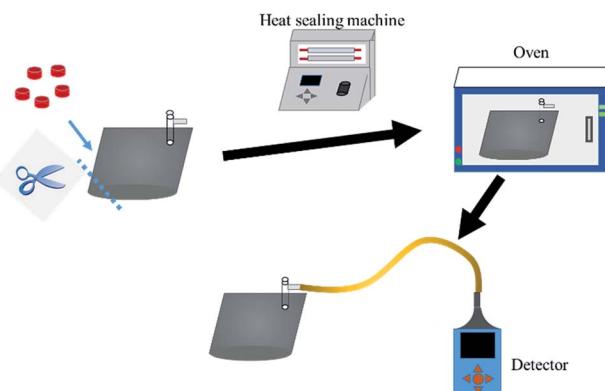
Fig. 2 Schematic diagram of phosphine detection.

Phosphine released by red phosphorus would rapidly react with air and water to form an acid under high temperature and humidity. In order to determine phosphine release, 2 g product was deposited in a sealed and dried 500 ml aluminum foil gas collection bag (Fig. 2). After 7 d, 14 d and 21 d, the concentration of phosphine gas in the bag was determined by the BH-90A phosphine detector.

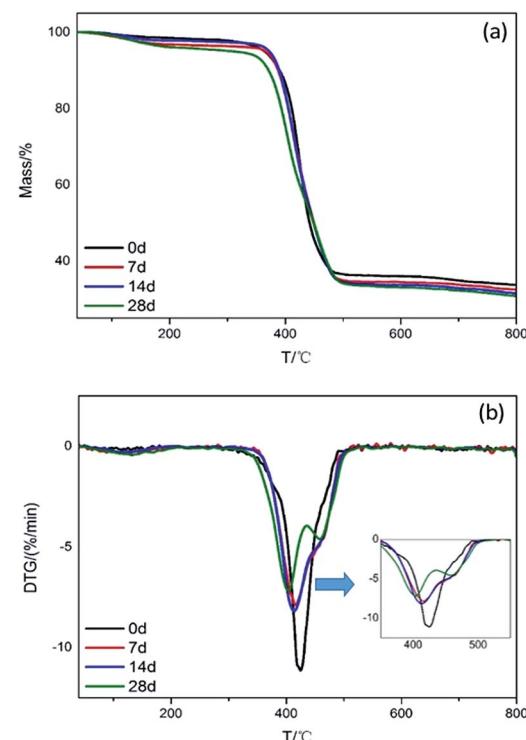
Fig. 3 TGA and DTG curves of connectors in N₂ atmosphere.

presented in Fig. 3 and summarized in Table 1. As the environmental test progressing, the initial decomposition temperature ($T_{5\%}$, temperature based on 5% mass loss), the maximum mass loss rate (R_{\max}), temperature corresponding to the maximum mass loss rate (T_{\max}) and the value of char residues (CR) for connectors at 800 °C all reduced, indicating that the thermal stability of connectors exposed to high temperature and humidity environment diminished. The appearance of the mass loss rate peak for 28 days indicates that the connector produced a new component in the high temperature and humidity environment. Reduced CR indicated that the phosphine released from red phosphorus reacted with water to form various oxygen-containing, phosphorus-based acids, such as phosphoric acid, phosphorous acid, and hypophosphorous acid,

and then partially transferred to the copper sheet by corrosion, resulting in a reduced char forming ability.

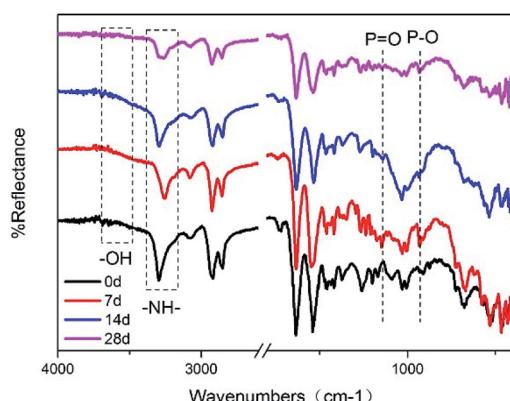
Fig. 4 FTIR spectrum of environment tested connectors after different days.

Fig. 4 is an FTIR spectrum of the connectors after environmental testing. Compared with the initial connectors, the intensity of stretching vibration of -OH for the connectors environmentally tested was enhanced. The peaks representing stretching vibration of P=O and P-O were found at 931 cm⁻¹ and 1143 cm⁻¹,²² illustrated that the red phosphorus in the product released PH₃ and then formed acids. At the same time, the generated phosphoric acid would accelerate the degradation of the polyamide. The peak representing -NH- shows significant changes, transferring to -NH₂,²³ especially for connectors tested by 28 days.

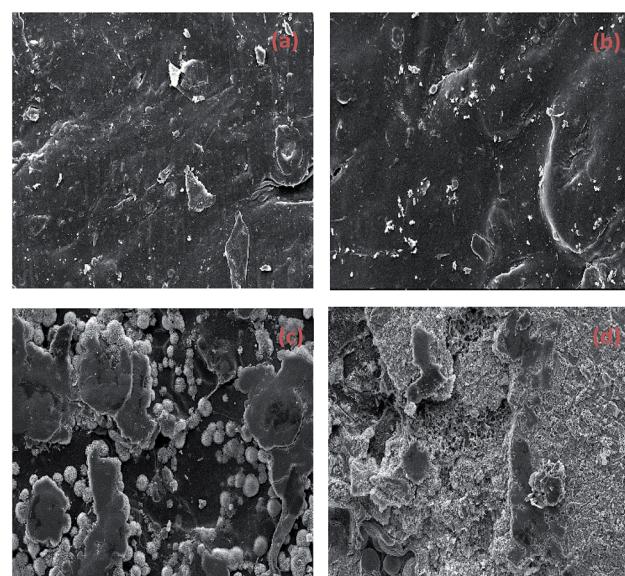
Fig. 5 SEM images of connectors tested for 0 d (a), 7 d (b), 14 d (c), 28 d (d).

Scanning electron microscopy. Fig. 5 is SEM images of connectors and its surface under 80 °C, 75% RH environment for 0 d, 7 d, 14 d and 28 d respectively. The surface of the original sample was relatively smooth. However, with the high temperature and humidity environment test progressing, cracks appeared on the surface, resulting in many flaky layers and increasing the roughness. Green globular substances appeared on the surface and section area of the sample after a period of time. It can be observed that the globular substance dispersed on the edge of the cracks after 14 days. After 28 days,

the globes increased so much that it is too dense to observe a single sphere and the entire surface becomes shattered.

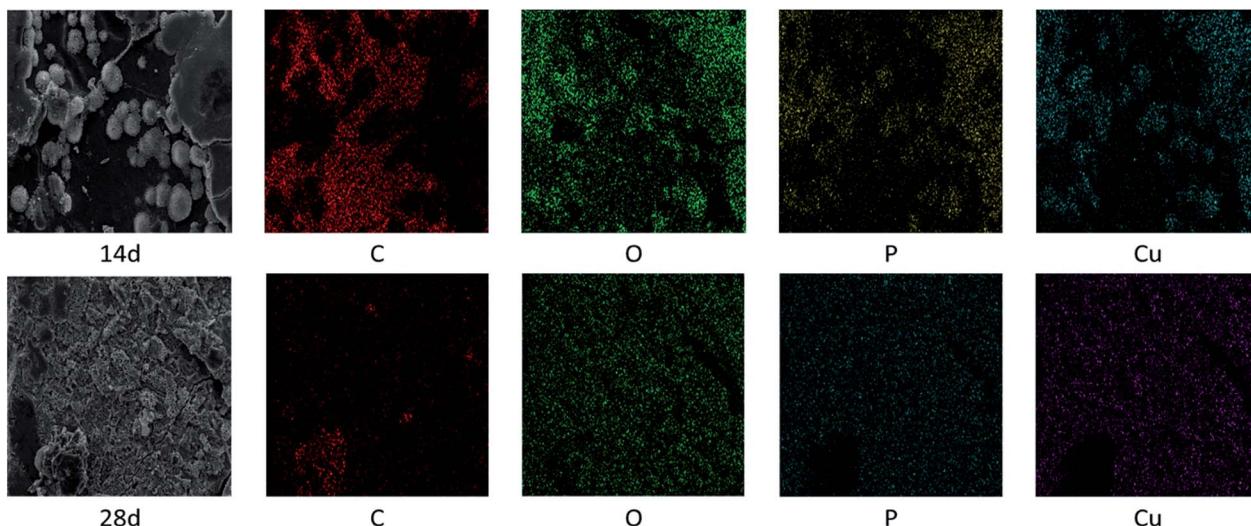
Fig. 6 EDS images of connectors tested for 14 d and 28 d.

Fig. 6 and Table 2 exhibits the evolution of the elemental dispersion on the surface of connectors. As showed in Fig. 5, the spherical substance was mainly composed of P, O, and Cu elements. The elemental content given in Table 2 indicated that the substance was increasing over time. Phosphorus could not be detected on the surface at the beginning and after 7 days until the globular substance containing phosphorus was formed. With the time increase, the concentration gradient of phosphorus was produced from inside to surface. At the same time, the content of oxygen increased. It proved that phosphorus reacted with water and air to form phosphoric acid through these cracks in the high temperature and humidity environment and the phosphoric acid corroded the copper sheet attached to the connectors to form copper phosphate species on the surface.

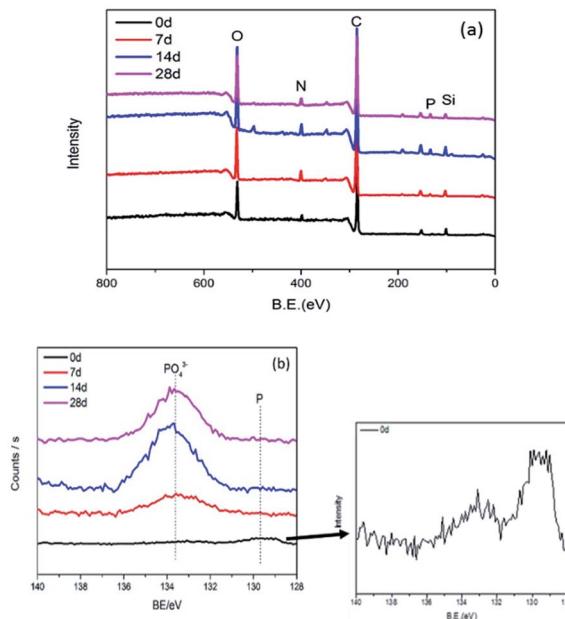
Fig. 7 Wide-scan (a) and P 2p high-resolution (b) XPS spectra for connectors.

X-ray photoelectron energy spectrum analysis. XPS spectrum of survey scan for connectors is exhibited in Fig. 7 and elemental content of connectors tested for different days is showed in Table 3. The intensity of carbon and oxygen is very strong with traces of N and Si existing. Nevertheless, the signal intensity of phosphorus is very low.

The P 2p high-resolution spectra of connectors are exhibited in Fig. 7. There are two main peaks, 129.4 eV corresponding to red phosphorus; 133.4 eV corresponding to phosphate anion.²⁴ The presence of these peaks affirms that red phosphorus was

oxidized to phosphate. The intensities of peaks increases gradually and reaches a stable state, confirming that phosphate concentration increased with test prolonging, especially in the first 14 days.

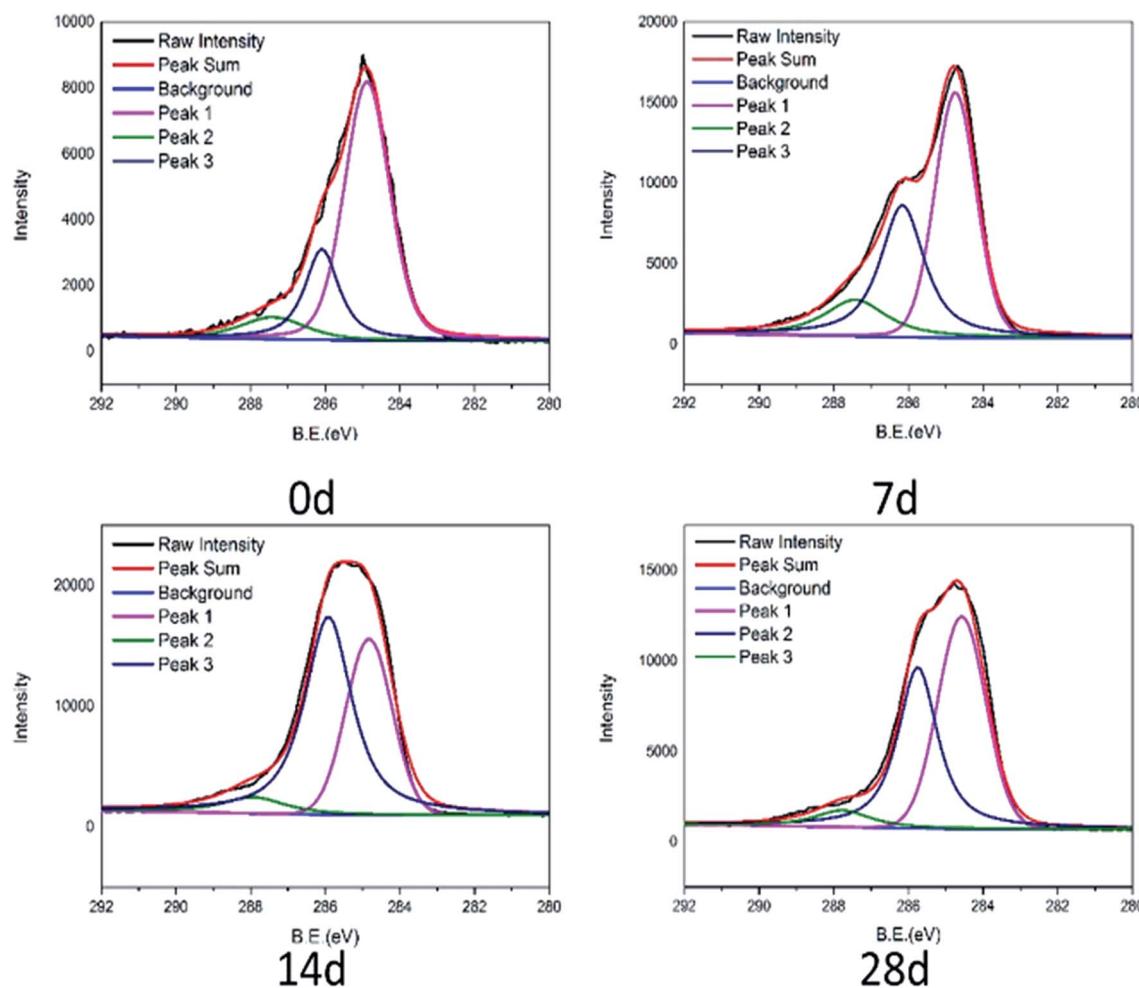
Fig. 8 C 1s high-resolution XPS element spectra of connectors.

The C 1s spectra of tested connectors are fitted into three peaks to know the types of functional groups of PA66 from connectors in Fig. 8. The three peaks centered at 284.6 eV corresponding to C-C; 286.0–286.3 eV corresponding to C–O; 287.5–287.7 eV corresponding to C=O.²⁵ While compared with the C 1s of the initial product, the intensity of the carbon–oxygen bond significantly increased. It is expected that PA66 was degraded and carbon–carbon bonds partially were broken,

oxidized to carbon–oxygen bonds. The degradation of PA66 is a complicated process, mainly involving not only the hydrolysis of amide bonds, but also the breakage of molecular chains, accompanied by the formation of various small molecular compounds. The carbon–carbon bond is broken further, accelerating oxidation to cause the rise of the carbon–oxygen bond. This would generate cracks and further reduce the thermal stability of the connector, making it flammability.²⁶

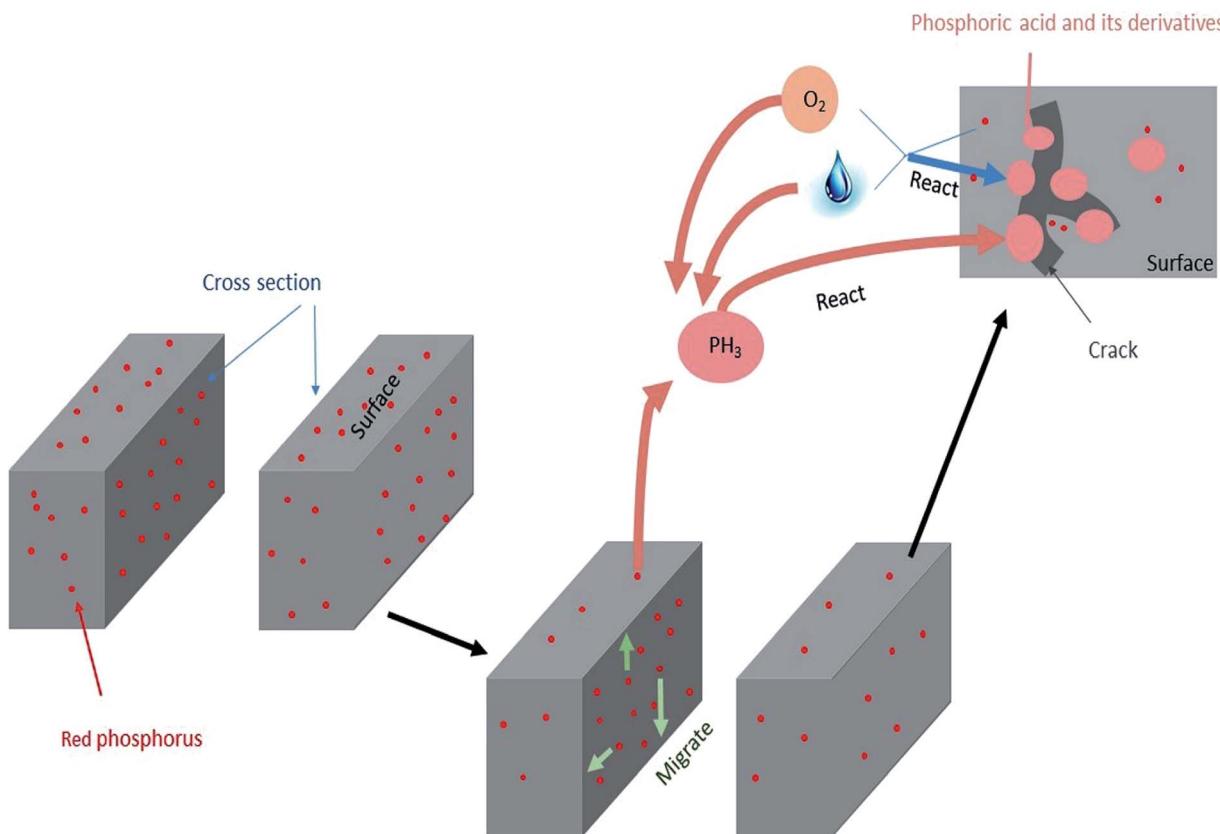
Fig. 9 Failure behaviour mechanism diagram.

The mechanism of failure behaviour is revealed in Fig. 9. After connectors had undergone high temperature and humidity environmental testing, red phosphorus migrated to the surface and accumulated into several areas. At the same time, significant degradation occurred, the decomposition temperature was advanced and $-\text{OH}$ and phosphorus oxides were formed. The surface morphology of connector became rough with cracks increasing and the copper attached to connector formed copper phosphate. The content of phosphorus and oxygen on the surface increased and the chemical environment of phosphorus changed from elemental phosphorus to phosphoric acid derivatives. The amount of phosphine released increased and it reacted with water and oxygen to form acids. Correspondingly, the formation of phosphoric acid derivatives accelerated the degradation process of nylon. Surface cracks caused by degradation resulted in red phosphorus to be further oxidized to an acid. The mutual promotion caused the failure behavior of the red phosphorus flame retardant PA66 electrical connector.
