## Failure behavior of nylon products for red phosphorus flame retardant electrical connectors

The failure behavior of red phosphorus flame retardant electrical connectors was investigated by their thermal degradation, changes of surface morphology and elements under an accelerating environmental experiment. The results showed that the nylon electrical connector degraded and cracks were generated on the surface. The temperature of maximum weight loss rate was advanced in the thermogravimetric analysis and the third weight loss peaks appeared after 28 days. The relative atomic content of O and P increased from 0 day to 28 days. The chemical environment of C changed. Partially, C–C bonds broke and became C–O bonds. The release of phosphine increased and this further oxidized to an acid with P=O and P–O groups in a warm and humid environment.

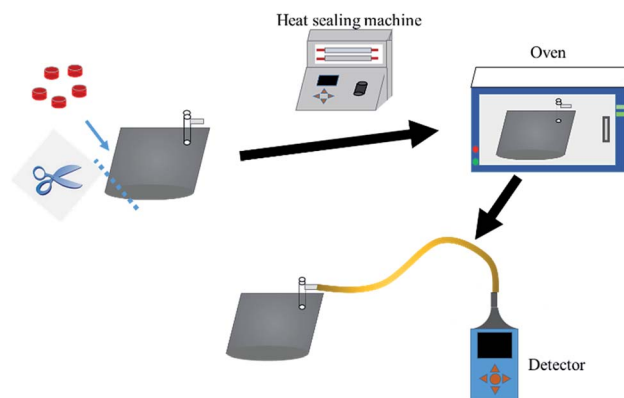
Fig. 2 Schematic diagram of phosphine detection.

Phosphine released by red phosphorus would rapidly reacts with air and water to form an acid under high temperature and humidity. In order to determine phosphine release, 2 g product was deposited in a sealed and dried 500 ml aluminum foil gas collection bag (Fig. 2). After 7 d, 14 d and 21 d, the concentration of phosphine gas in the bag was determined by the BH-90A phosphine detector.
