# Failure behavior of nylon products for red phosphorus flame retardant electrical connectors

The failure behavior of red phosphorus flame retardant electrical connectors was investigated by their thermal degradation, changes of surface morphology and elements under an accelerating environmental experiment. The results showed that the nylon electrical connector degraded and cracks were generated on the surface. The temperature of maximum weight loss rate was advanced in the thermogravimetric analysis and the third weight loss peaks appeared after 28 days. The relative atomic content of O and P increased from 0 day to 28 days. The chemical environment of C changed. Partially, C–C bonds broke and became C–O bonds. The release of phosphine increased and this further oxidized to an acid with P=O and P–O groups in a warm and humid environment.

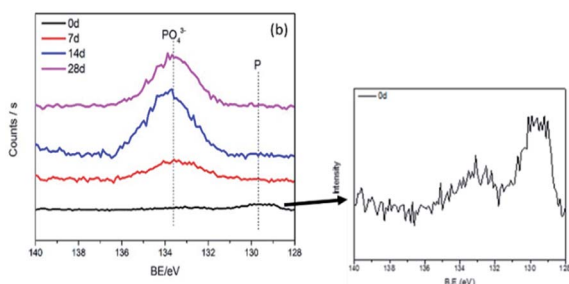
**X-ray photoelectron energy spectrum analysis.** XPS spectrum of survey scan for connectors is exhibited in Fig. 7 and elemental content of connectors tested for different days is showed in Table 3. The intensity of carbon and oxygen is very strong with traces of N and Si existing. Nevertheless, the signal intensity of phosphorus is very low.

The P 2p high-resolution spectra of connectors are exhibited in Fig. 7. There are two main peaks, 129.4 eV corresponding to red phosphorus; 133.4 eV corresponding to phosphate anion.<sup>24</sup> The presence of these peaks affirms that red phosphorus was

Fig. 7 Wide-scan (a) and P 2p high-resolution (b) XPS spectra for connectors.

oxidized to phosphate. The intensities of peaks increases gradually and reaches a stable state, confirming that phosphate concentration increased with test prolonging, especially in the first 14 days.
