Cite this: *Environ. Sci.: Water Res. Technol.*, 2021, 7, 274

This study was conducted to determine if the thermal degradation of various plastic drinking water pipes (i.e., PEX, HDPE, PP, PVC, and CPVC) may be a source of drinking water contamination. Widespread volatile organic compound (VOC) contamination was found in water distribution systems following three wildfires in California. A potential source of this contamination was thought to be due to the degradation of plastic components in drinking water distribution systems. Eleven plastic drinking water pipes, across eight brands, were exposed to elevated temperatures (200 °C to 400 °C), and subsequently submerged in water or in *n*-hexane to observe the extent of VOC leaching. Results indicated that thermally damaged drinking water pipes can be sources of VOC leaching, with ten of the eleven materials leaching benzene, a carcinogen, into water. As exposure temperature increased, an increase in VOC leaching was observed in the polyethylene materials. Conversely, in the vinyl materials the significant mass loss associated with high exposure temperature was inversely proportional to the amount of BTEX leaching that was observed

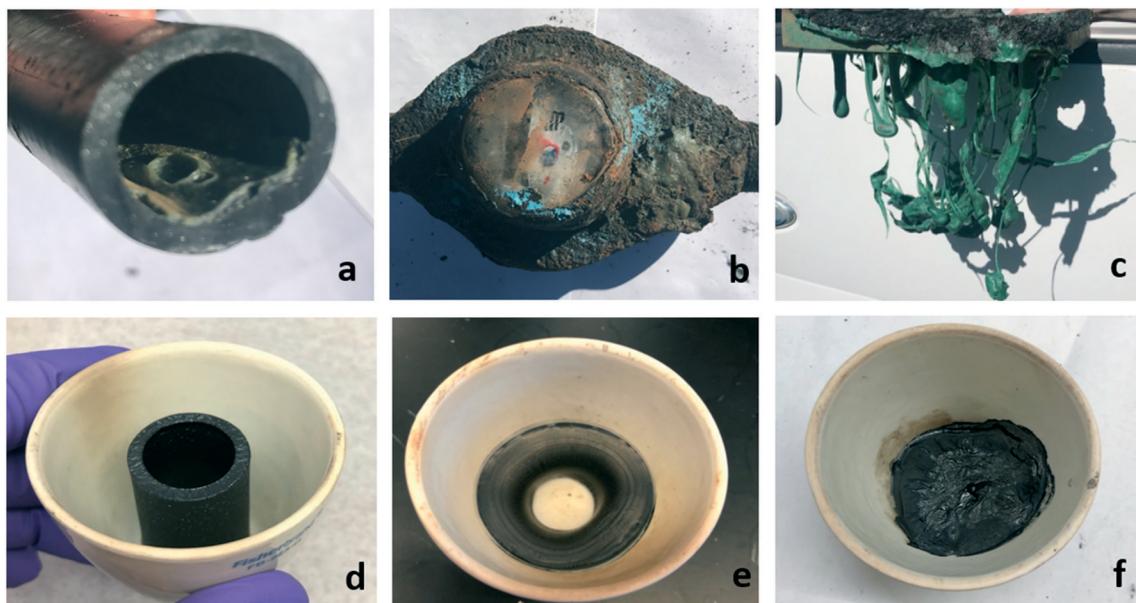
Fig. 1 Images of fire-damaged water system components including (a) a HDPE plastic pipe, (b) a water meter, and (c) a water meter cover following the Camp Fire. Thermally degraded pipe samples in laboratory experiments include the (d) PEX-c pipe degraded at 300 °C, (e) HDPE pipe degraded at 300 °C, and (f) HDPE pipe degraded at 400 °C.

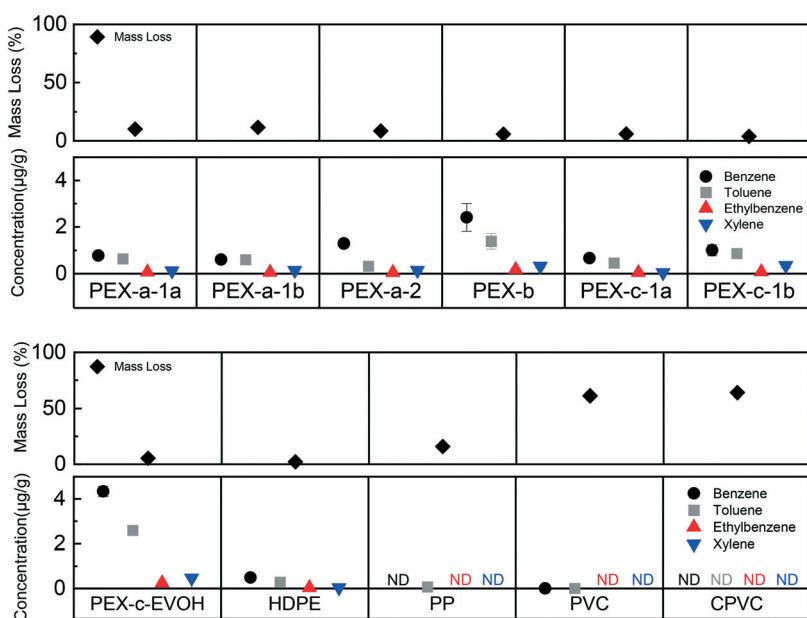
Fig. 2 Average amount of benzene, toluene, ethylbenzene, and xylene leaching observed after burning each material at 400 °C and extracting in water for 7 days. The error bars reflect the standard deviation of the measurements ( $n = 3$ ). If no error bars are visible, this indicates the error bars are smaller than the symbol size. ND indicates the compound was not detected above the MDL.

Results showed that plastic pipe thermal exposure can generate BTEX, which can then leach from cooled plastics into water. BTEX was not found from new and non-thermally degraded plastics in water, while 10 of 11 thermally degraded plastic pipes leached at least one BTEX component (Fig. 2). The chemical leaching differences between products is likely attributed to differences between plastic characteristics and experimental conditions. PE materials lost less mass due to isothermal heating (5 wt% to 10 wt%) compared to the PVC and CPVC samples (61 wt% and 64 wt%, respectively) (Fig. 2). A detectable, but significantly lower amount of benzene and toluene was observed for the PVC pipe, and no BTEX was found for the CPVC pipe (Fig. 2). Additionally, there was a general trend of compound concentration leaching across the plastics where benzene > toluene > ethylbenzene ≈ xylene (Fig. 2). This trend could be attributed to several factors including compound production, water solubility, air volatilization, polymer solubility parameters, and/or partitioning into the aqueous phase. Octanol-water coefficients and solubility values mirror the trend of concentrations observed (Table S4†), indicating that benzene would most readily partition into the aqueous phase.

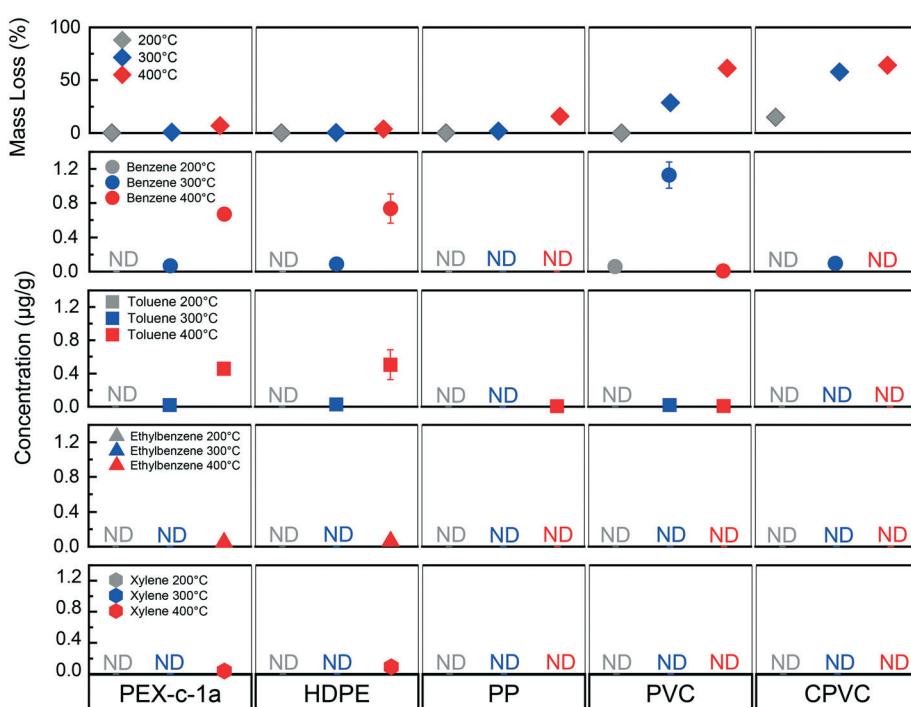
Fig. 3 Mean BTEX concentration after extracting each burned material at 200 °C, 300 °C, and 400 °C in water. The error bars reflect the standard deviation of the measurements ( $n = 3$ ). If no error bars are visible, it indicates they were smaller than the symbol size. ND indicates the compound was not detected.

Different concentrations of BTEX were found in water after changing the isothermal heating temperature, such that two patterns emerged (Fig. 3). For the HDPE and PEX pipes, the amount of BTEX that leached into the water increased as the plastic degradation temperature increased from 200 °C to 400 °C (Fig. 3). Conversely, the greatest benzene concentration was found for the PVC pipe when exposed to 300 °C, with relatively less concentrations at 200 °C and 400 °C (Fig. 3). The CPVC pipe showed a similar pattern for benzene as the PVC pipe, however, at much lower concentrations (Fig. 3). This spike phenomenon for vinyl materials can potentially be explained by the lower amount of mass loss, where not all benzene produced during degradation volatilized out of the solid. The 300 °C exposure temperature was greater than the onset degradation temperature (Table 1) where dehydrochlorination would occur. However, the PVC pipe mass loss was only 23 wt% as opposed to 61 wt% at the 400 °C condition resulting in a more structurally intact plastic after degradation (Fig. S2†).

Despite structural similarities for the vinyl pipes, benzene was only detected in water exposed to the CPVC pipe at a fraction of the amount it was found in water exposed to the PVC material (Fig. 3). This difference may be explained by the additional chlorine atoms present on the CPVC polymer chains resulting in a greater number of chlorine substituted aromatic products when CPVC was thermally degraded.<sup>34</sup> A previous CPVC pyrolysis study found significantly more

Compared to vinyl pipes, greater BTEX concentrations were found as the degradation temperature increased for the HDPE and PEX materials (Fig. 3). The onset degradation temperature for both of these materials exceeds 430 °C (Table 1) which can explain why little to no BTEX leaching was observed at 200 °C and 300 °C. The increase in leaching between 300 °C and 400 °C can be attributed to the plastic pipes beginning to degrade and generating BTEX and other compounds. Elevated temperatures lead to the polymer chain undergoing chain scission resulting in the formation of alkenes.<sup>32</sup> As the pipe is exposed to greater temperatures, the amount of polymer chain scission that occurs also increases. The increase in scission results in more alkene fragments that may subsequently undergo aromatization. A similar pattern was observed in a study of HDPE combustion by others, in which the benzene concentration in the air increased as the combustion temperatures increased from 500 °C to 800 °C.<sup>51</sup> However, the increase in potential BTEX formation does not necessarily indicate that this trend of increased leaching as a function of temperature will

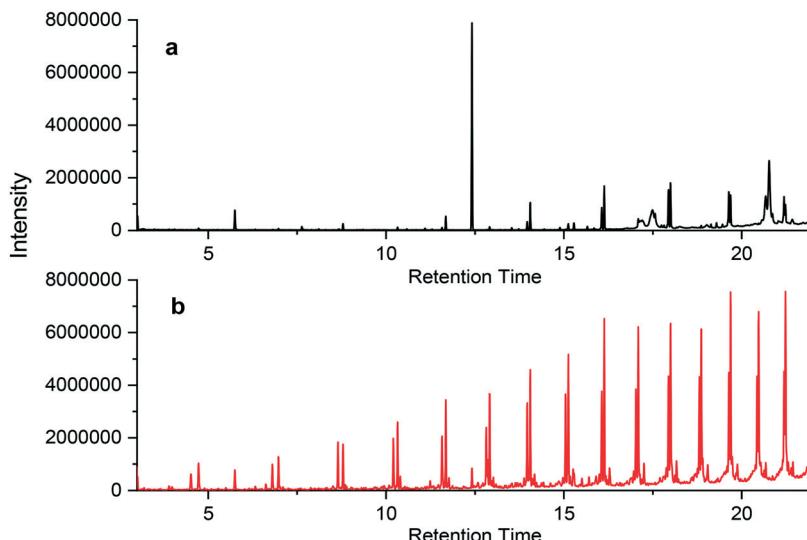
**Fig. 4** Chromatographs of PEX-c-1a when (a) unburned and (b) burned at 400 °C, where samples were extracted in *n*-hexane. The internal standard is the peak at 5.8 minutes.

**Leaching promoted by hexane extraction.** As expected, a greater number of peaks were observed in the *n*-hexane extracts (32 to 134) compared to the water extracts (3 to 22) for all plastics (see example for PEX-c-1a in Fig. 4 and all other pipe types in Fig. S17–S26†). For the degraded PEX, HDPE, and PP pipes, between 100 to 134 unique compounds were leached into *n*-hexane, whereas for the degraded PVC and CPVC pipes between 30 to 41 compounds were leached (Fig. 4 and S17–S26†). While most compounds extracted from the new pipes were either straight chain or branched alkanes of varying lengths (Table S3†), thermal exposure led alkenes to represent the majority of compounds detected in the leachate (Table S5†). These aliphatic hydrocarbons are products of alkane hydrocarbon chain scission and are not typical drinking water contaminants. They have low aqueous solubility, which is why they were only detected in the hexane extracts and are generally less toxic than their cyclical or aromatic counterparts.<sup>56,57</sup>

Generally, both the magnitude of the peak and the number of compounds increased after burning the materials. However, one notable exception occurred for the PEX-c pipes; one peak (retention time of 12.5 min) for the unburned pipe was significantly larger than that of any of the burned peaks (Fig. 4 and S21†). This peak likely represented the compound, di-*tert*-butylbenzene, which has been shown to be an ultraviolet light or radiolysis degradation product of the antioxidant Irgafos 168®.<sup>58,59</sup> This compound was only observed in the leachate of the PEX-c materials, in which the crosslinking occurs using beta irradiation. This may explain why the magnitude of this degradation product was so large.<sup>60</sup> This peak decreased substantially in the burned plastic extract (Fig. 4 and S21†), indicating it may have been thermally decomposed.
