Cite this: *Environ. Sci.: Water Res. Technol.*, 2021, 7, 274

This study was conducted to determine if the thermal degradation of various plastic drinking water pipes (*i.e.*, PEX, HDPE, PP, PVC, and CPVC) may be a source of drinking water contamination. Widespread volatile organic compound (VOC) contamination was found in water distribution systems following three wildfires in California. A potential source of this contamination was thought to be due to the degradation of plastic components in drinking water distribution systems. Eleven plastic drinking water pipes, across eight brands, were exposed to elevated temperatures (200 °C to 400 °C), and subsequently submerged in water or in *n*-hexane to observe the extent of VOC leaching. Results indicated that thermally damaged drinking water pipes can be sources of VOC leaching, with ten of the eleven materials leaching benzene, a carcinogen, into water. As exposure temperature increased, an increase in VOC leaching was observed in the polyethylene materials. Conversely, in the vinyl materials the significant mass loss associated with high exposure temperature was inversely proportional to the amount of BTEX leaching that was observ

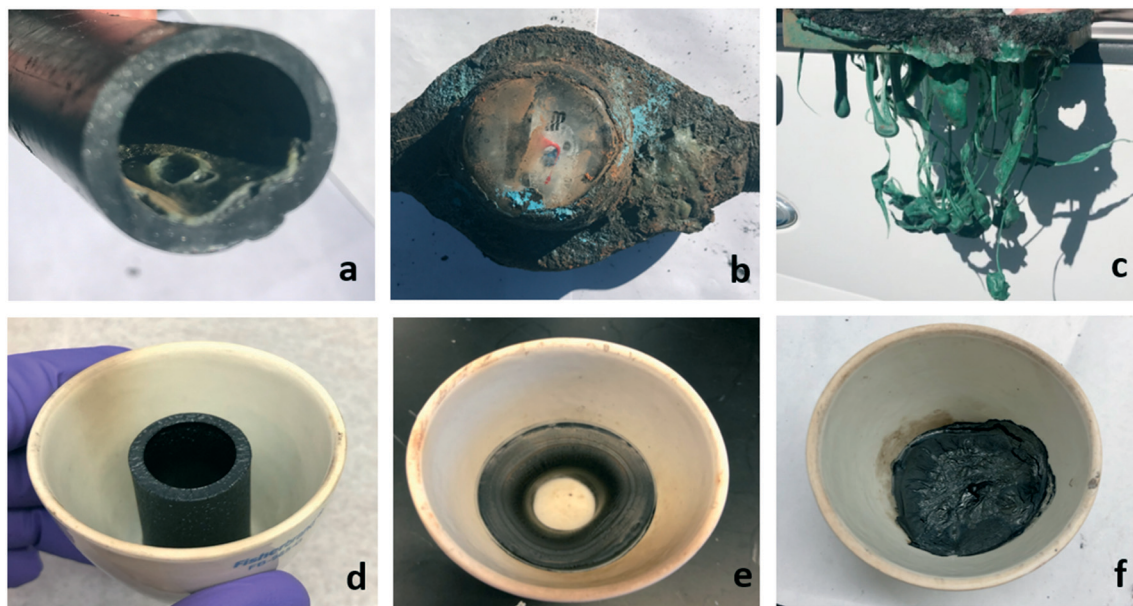
**Fig. 1** Images of fire-damaged water system components including (a) a HDPE plastic pipe, (b) a water meter, and (c) a water meter cover following the Camp Fire. Thermally degraded pipe samples in laboratory experiments include the (d) PEX-c pipe degraded at 300 °C, (e) HDPE pipe degraded at 300 °C, and (f) HDPE pipe degraded at 400 °C.
